APPENDIX AB

Albuquerque, New Mexico (2012) Vibratory Roller Compaction

Abeel_2012

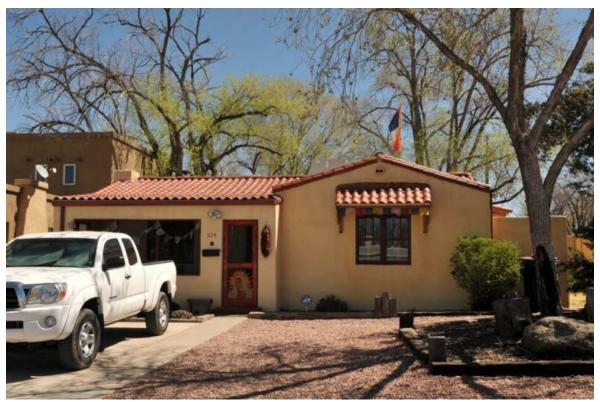
Figure AB-1 – Photograph of the residential structure in Albuquerque, New Mexico

This report presents the structural and crack response of a 80-year old, one-story adobe house (Figure AB-1) to construction activities involving vibratory rollers and the long-term effects of weather on crack motions. The structure was instrumented with single-axis velocity geophones to measure whole structure and mid-wall vibratory motions during road compaction. Displacement-type gauges were used to measure the movement of an existing exterior wall crack and a section of un-cracked wall material. A single exterior tri-axial geophone was buried in the ground outside the structure to record ground motions. Locations of instrumentation are shown in Figure AB-2. Context and details of instrumentation are shown in Figures AB-3 and AB-4.

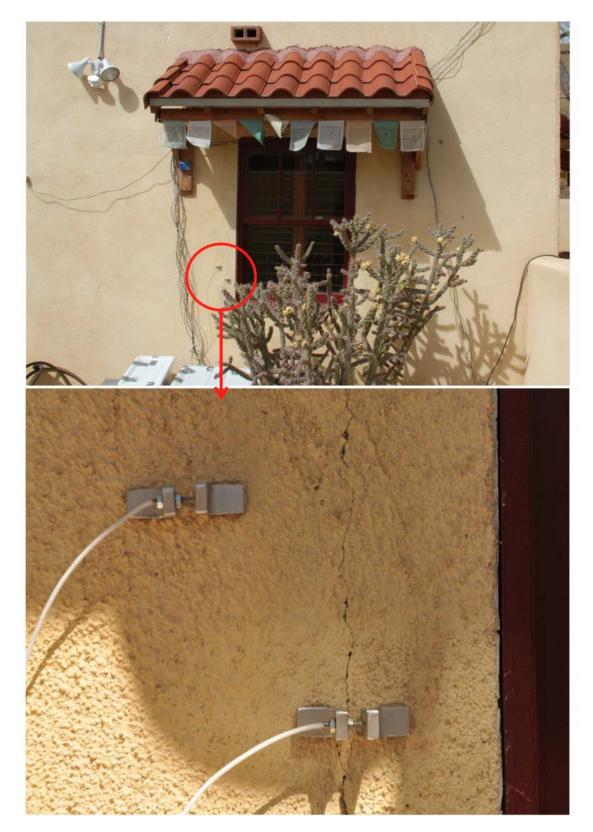
Figure AB-4 - Crack displacement gauges mounted over an existing crack and un-cracked wall section

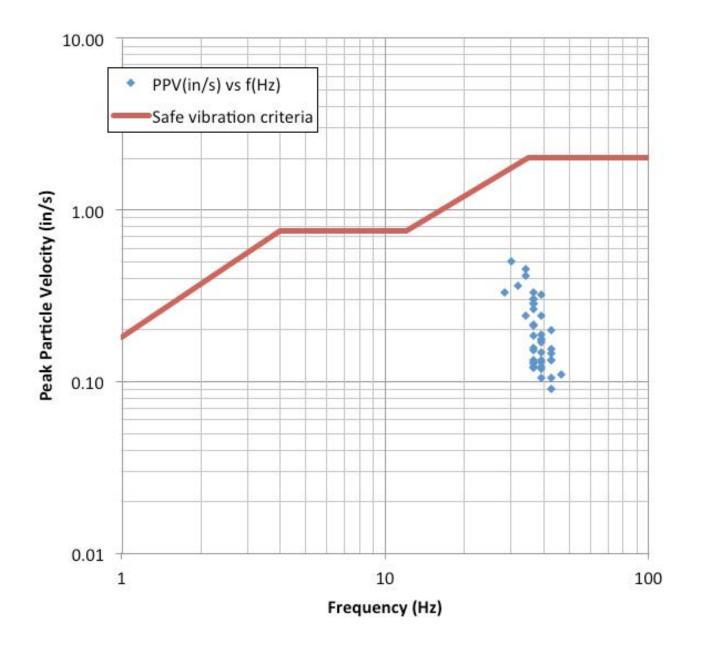
Figure AB-5 compares the USBM RI 8507 vibration control limits to peak particle velocities (PPV) and frequency of ground motion at the PPV (peak frequency) by the house. The maximum ground velocities recorded adjacent to the structure fall below the control limit, shown as the thick line, at which cosmetic cracking may begin.

Figure AB-5 - Peak particle velocity versus frequency at the peak velocity showing threshold damage limits

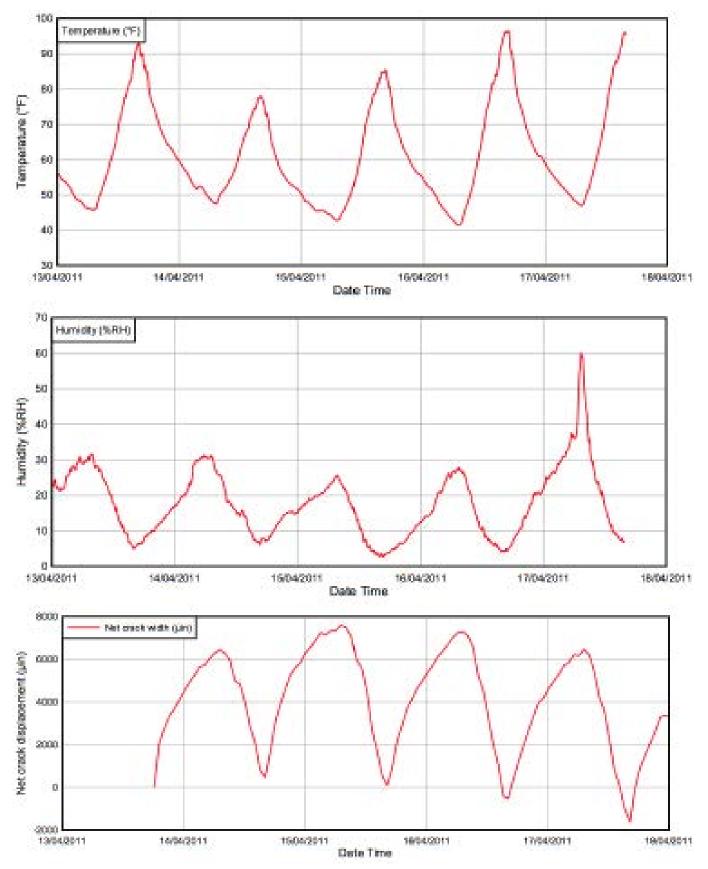
Long-term changes in the crack width due to fluctuations in temperature and humidity were measured and recorded on an hourly basis throughout the week between April 13th, 2011 and April 18th, 2011. Changes in crack width were plotted against time and shown in Figure AB-6 (bottom plot) in comparison to changes in temperature (top plot) and relative humidity (middle plot).

The largest half-day movement was 8081.5 micro-in, and overall movement was 9227 micro-in. These daily crack width changes are far greater than 595.5 micro-in, the largest dynamic change during any compacting event.

The instrumentation of the residential house and the observation of the structural and crack response occurred over a period of a week during which vibratory rollers were used to compact an adjacent road. These measurements showed that the change in temperature and humidity are more than 15 times greater than any ground motion that occurred during work.

Figure AB-6 - Variations in ambient temperature, humidity, and corresponding net crack displacement over 6 days
