APPENDIX AUS

Singleton, Australia (2002)

Rix's Creek Blasting

Richards & Moore_2002

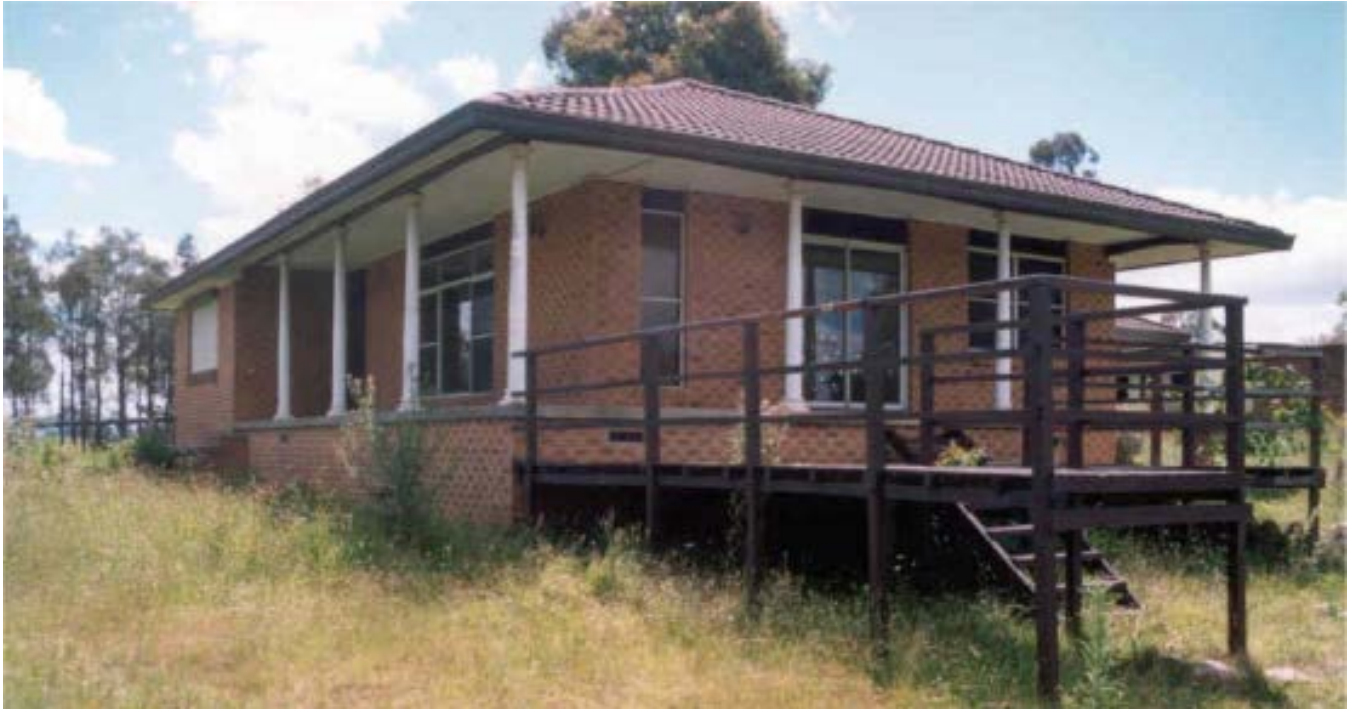
Figure AUS-1 – Photograph of the residential structure in Singleton, Australia. (South-east view)

Prior to the project, a number of cracks had developed over the life of the house generally consistent with loss of foundation support and settlement of footings, although some related directly to poor building practices. The growth pattern of all cracks was recorded between March 2000 and April 2001. The width of seven cracks in the house structure have been accurately monitored with DE-MEC gauge measurements between installed targets.

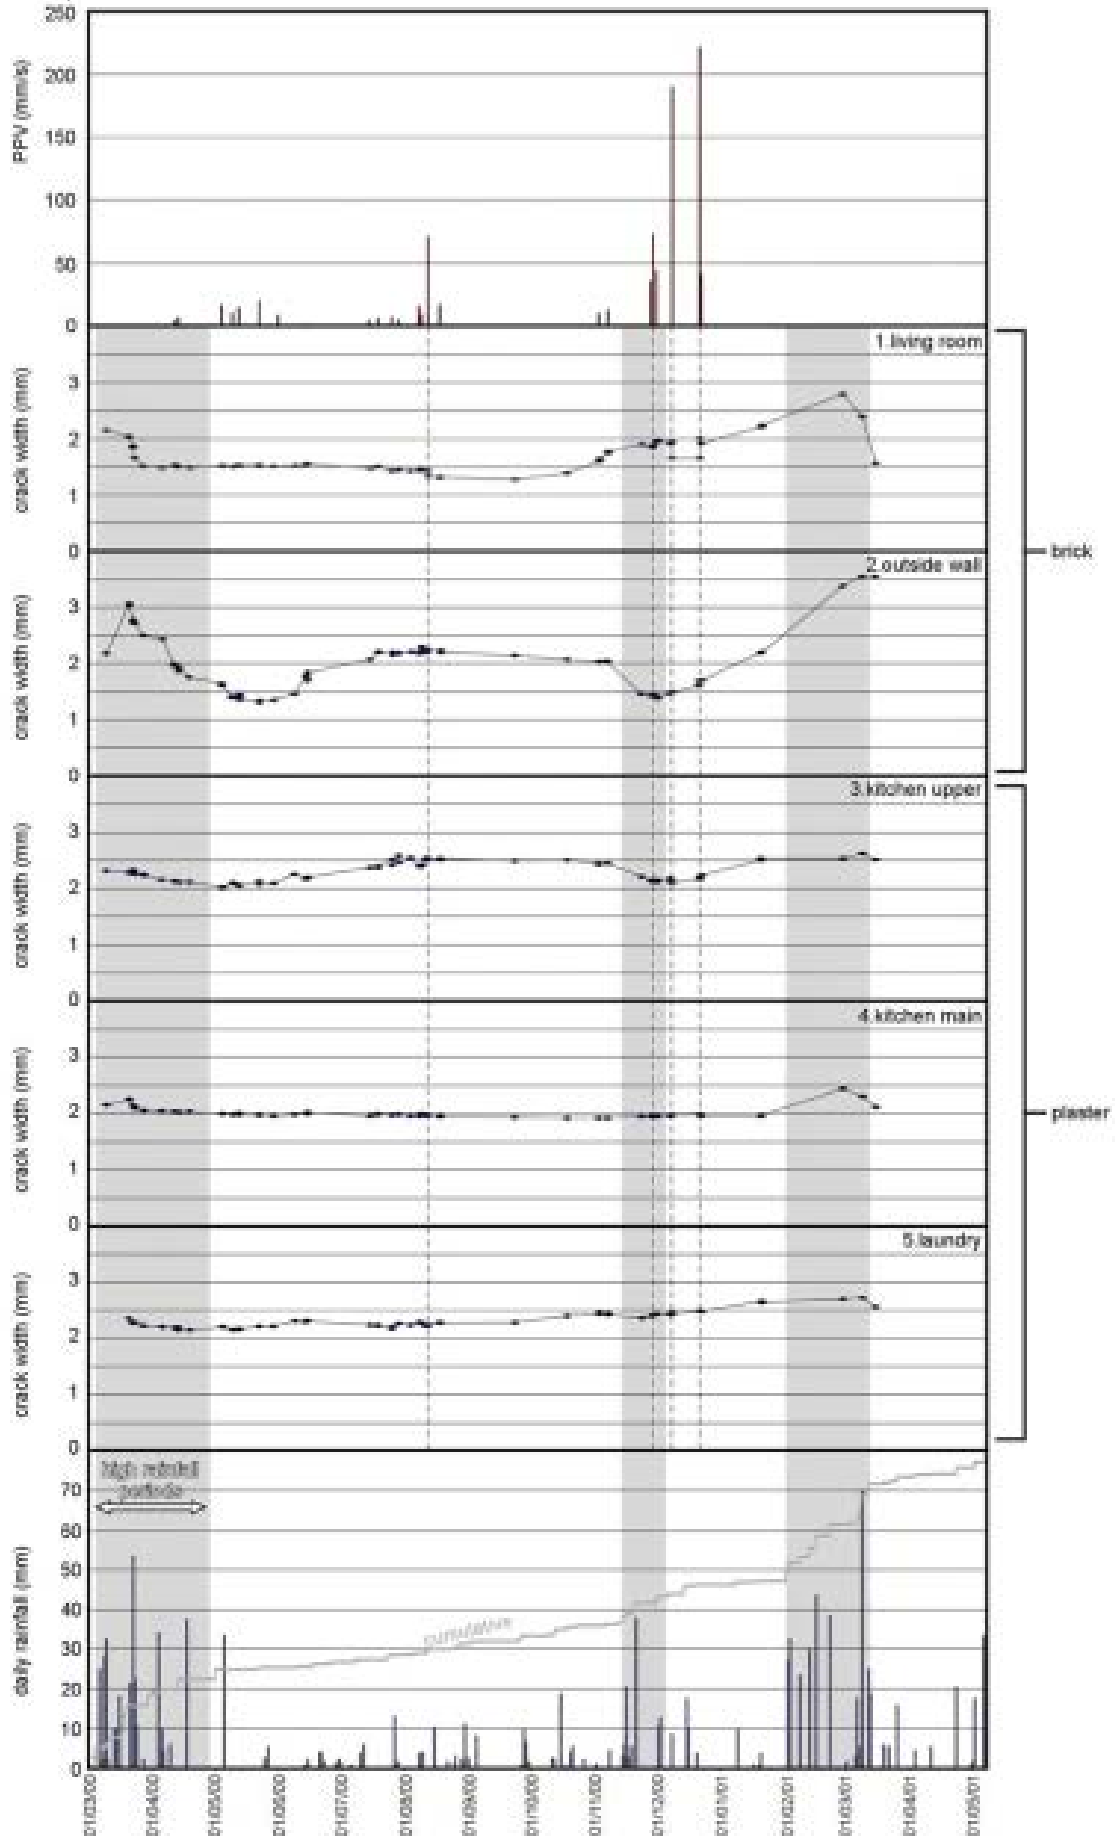
The monitored cracks are described in Table AUS-2 together with the maximum movement during blasting and movement after blasting ceased. The peak air vibration exceeded 145 dBL, but no glass damage resulted in windows or sliding doors. Crack width movement diagrams are shown in Figures AUS-3 and AUS-4 and cumulative rainfall total, together with peak ground vibration measurements and daily rainfall totals. From these figures it can be seen that the rainfall pattern shows a strong correlation with the variation in width of some cracks. These cracks have responded to a high rainfall period after the cessation of blasting.

At the locations where the crack width was monitored, the movement is complex and relates more closely to ground moisture variation than to blasting events. There was considerable movement of crack widths after the conclusion of blasting that is clearly related to high rainfall episodes.

Figure AUS-3 – Crack width movement diagrams compared to PPV and rainfall

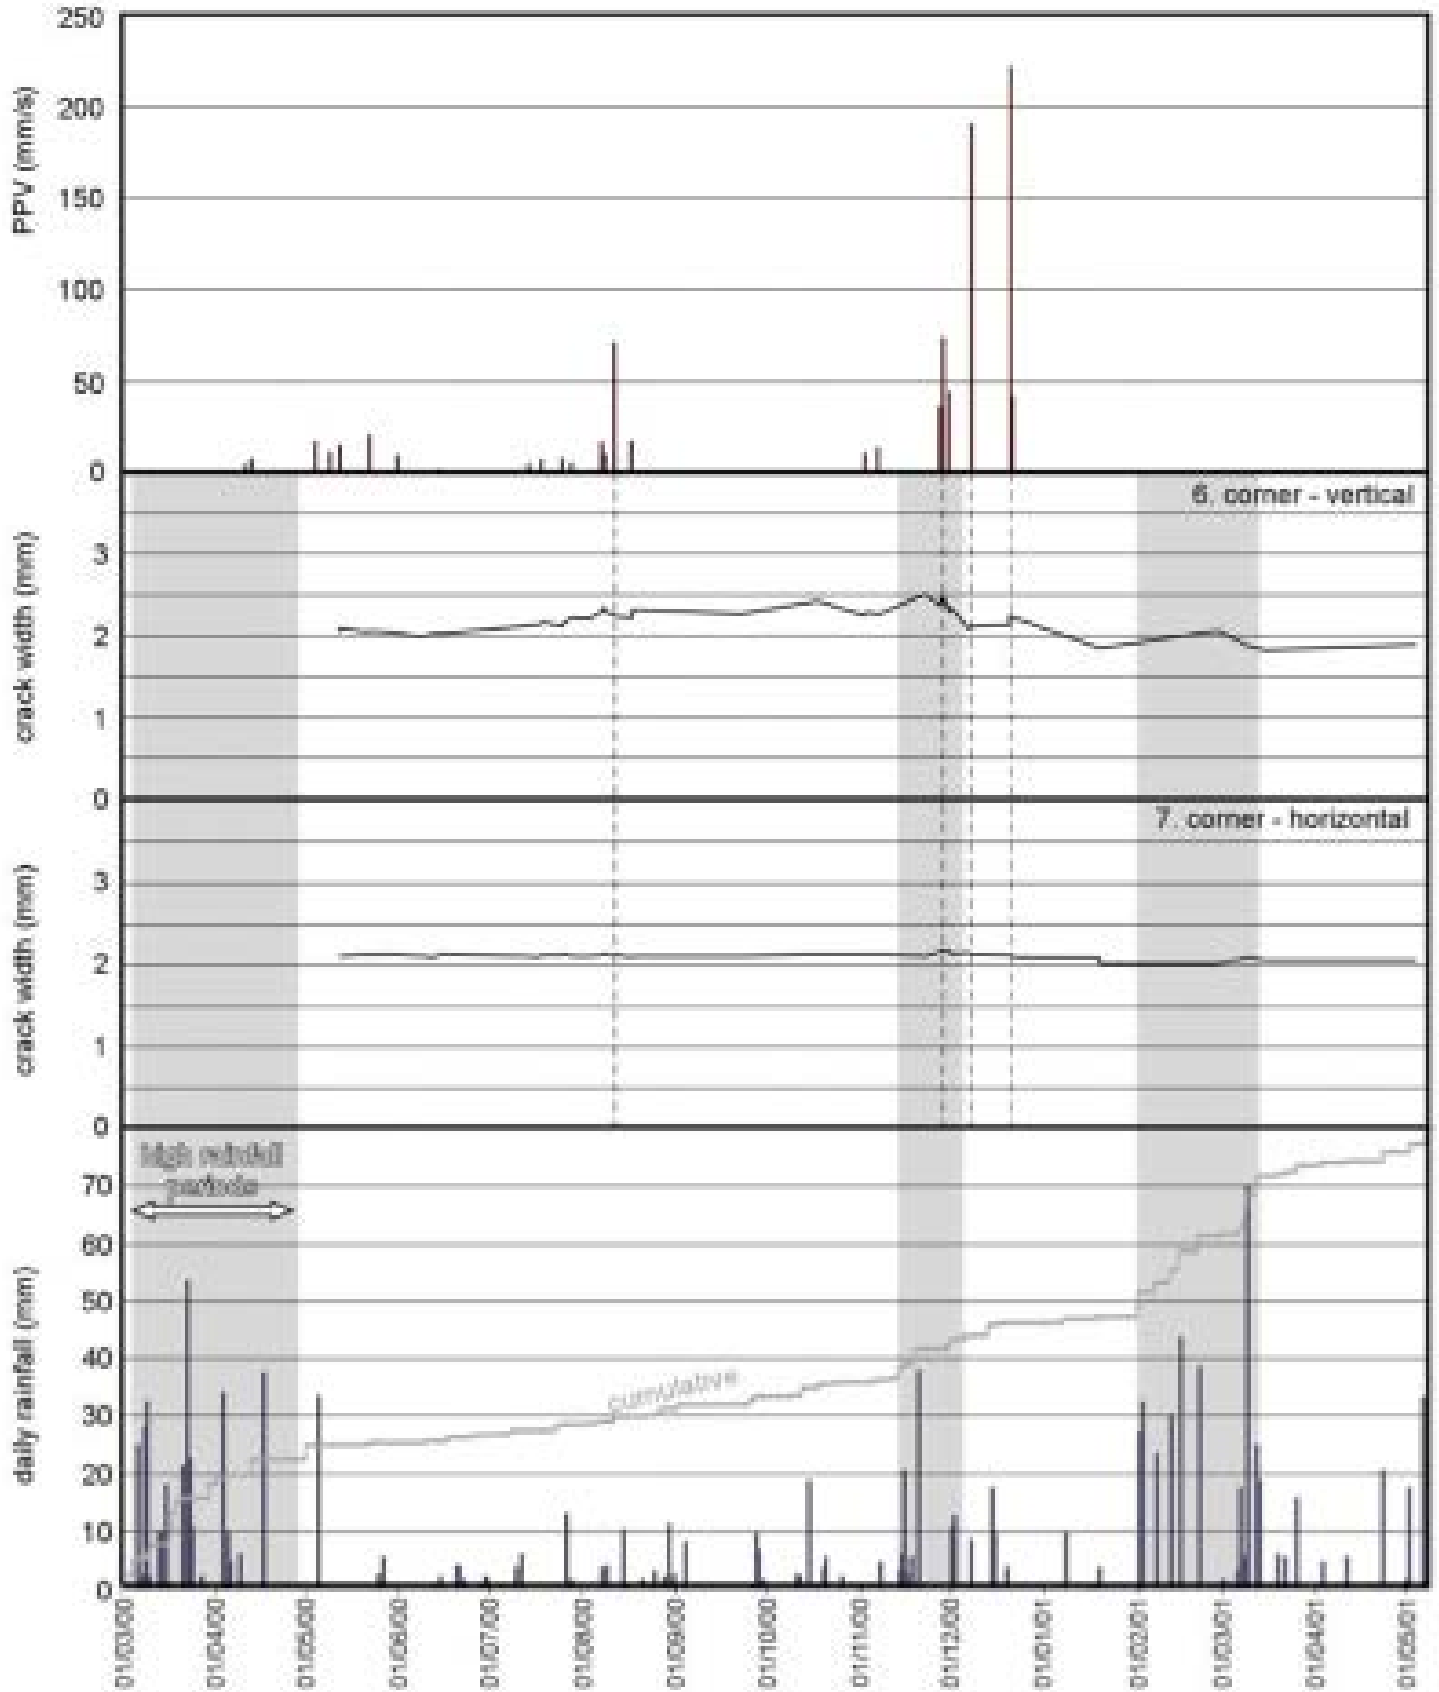
Figure AUS-4 – Crack width movement diagrams compared to PPV and rainfall (continued)

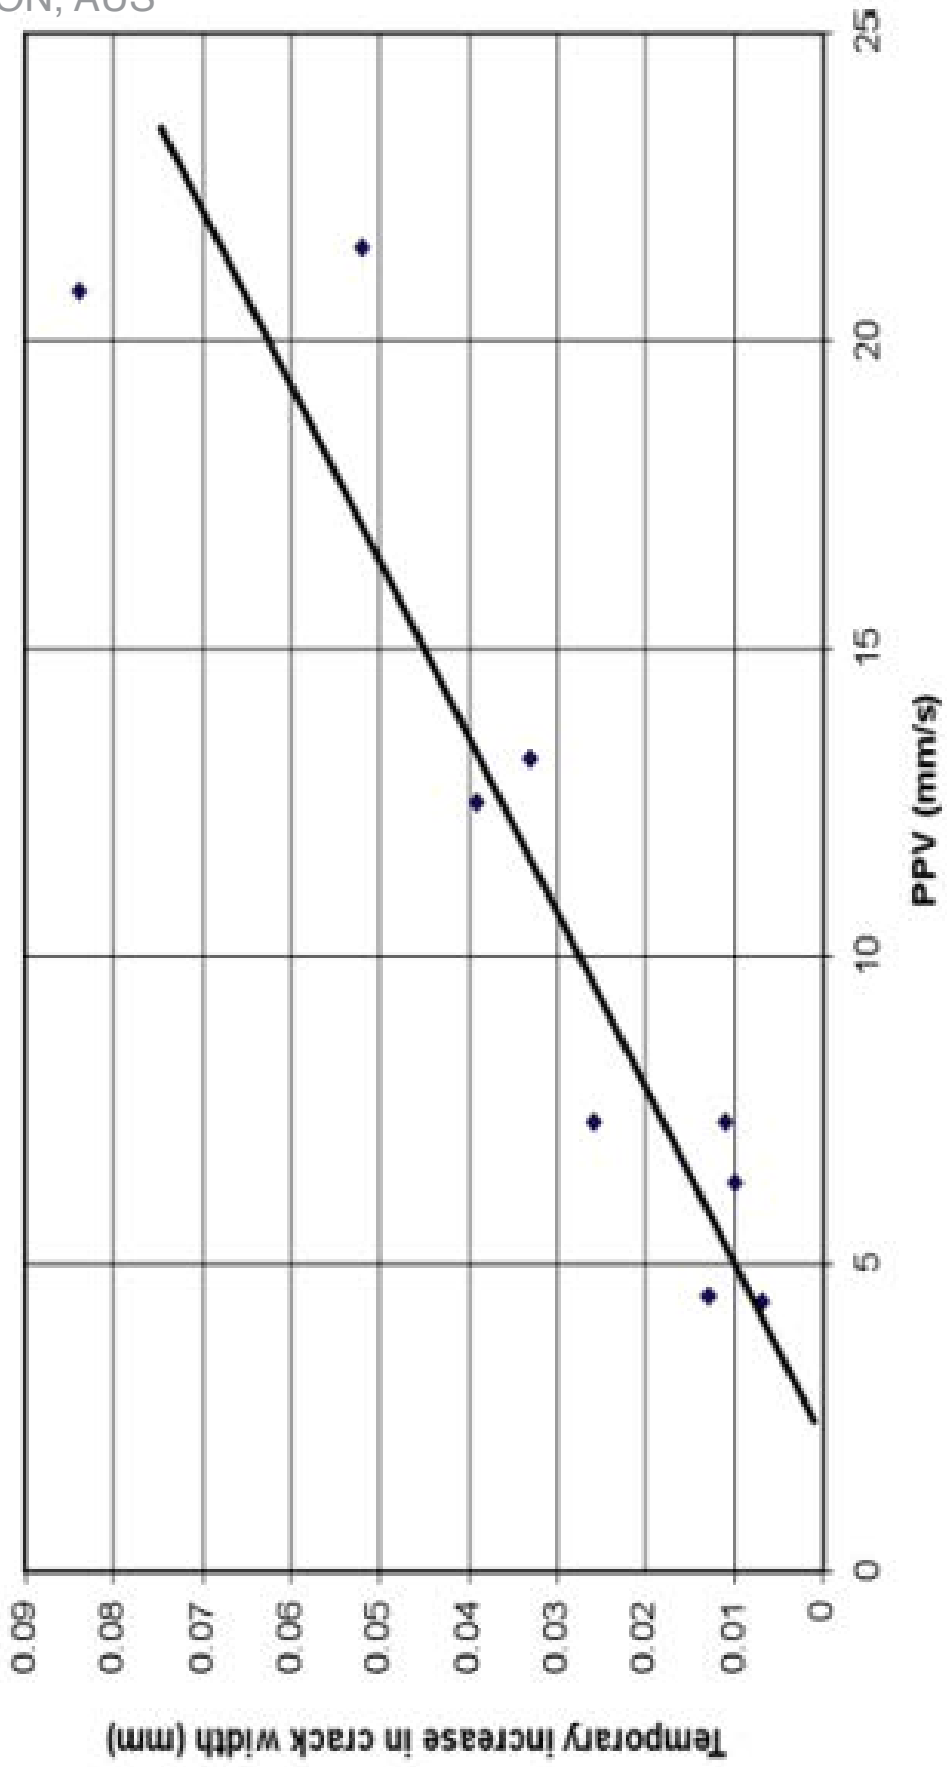
The horizontal strain gauge placed across the brickwork crack below the kitchen window in the test house enabled the changing width of the crack to be measured in response to ground vibration. Figure AUS-5 shows the plot of increased crack width versus PPV. There is a close correlation and it may be reasonably concluded that a ground PPV of 20 mm/s results in cracks temporarily opening between 0.05 mm and 0.08 mm. This further reinforces the observation that at vibration levels below 20 mm/s, the brick wall is behaving elastically and returns to its original position. At vibration levels above 70 mm/s, there is permanent widening.

Figure AUS-5 – Change of crack width versus PPV - crack no.4
