APPENDIX DT

Detroit, Michigan (2006) Vibrations and Crack Monitoring

Dowding_2007

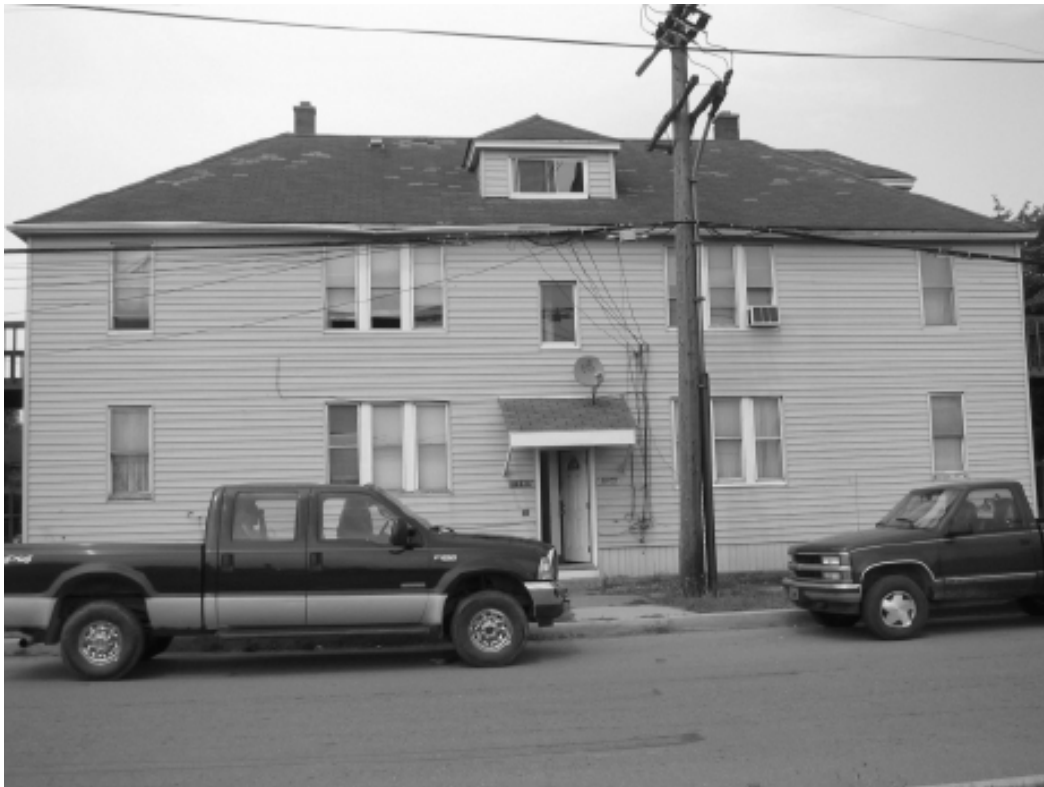
Figure DT-1 – Photograph of the residential structure in Detroit, Michigan

The test structure is an elderly, two-story wood-frame house with plaster and lath walls in Detroit, Michigan 48217. The structure, shown in Figure DT-1, at the edge of a residential neighborhood is located in close proximity to Interstate 75 and railroad tracks. The test structure was fitted with Vibri-Tech ground motion, air over pressure and crack displacement sensors as shown in Figure DT-2. Crack displacement and null sensors (Transtek series 200 LVDTs) were placed in the stairwell above the back doorway to the upstairs apartment of the test structure as shown in Figure DT-3. They were installed across an existing crack and on the adjacent un-cracked wall (null sensor).

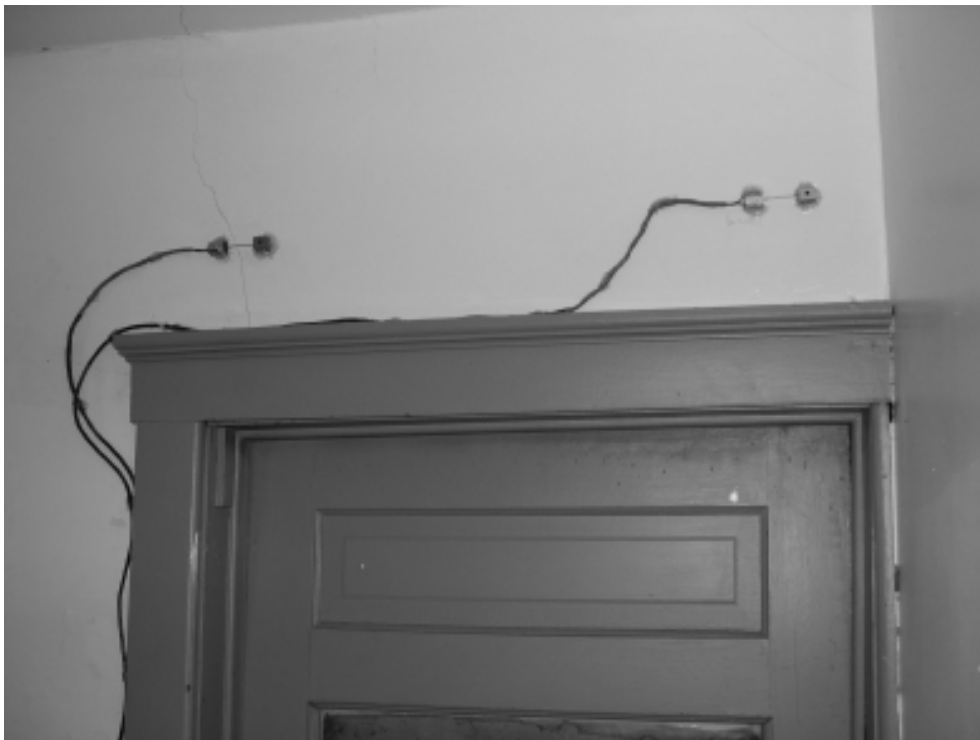
Figure DT-3 - Crack displacement sensor (left) and null sensor (right) installed in the stairwell above the back doorway to the upstairs apartment of the test structure.

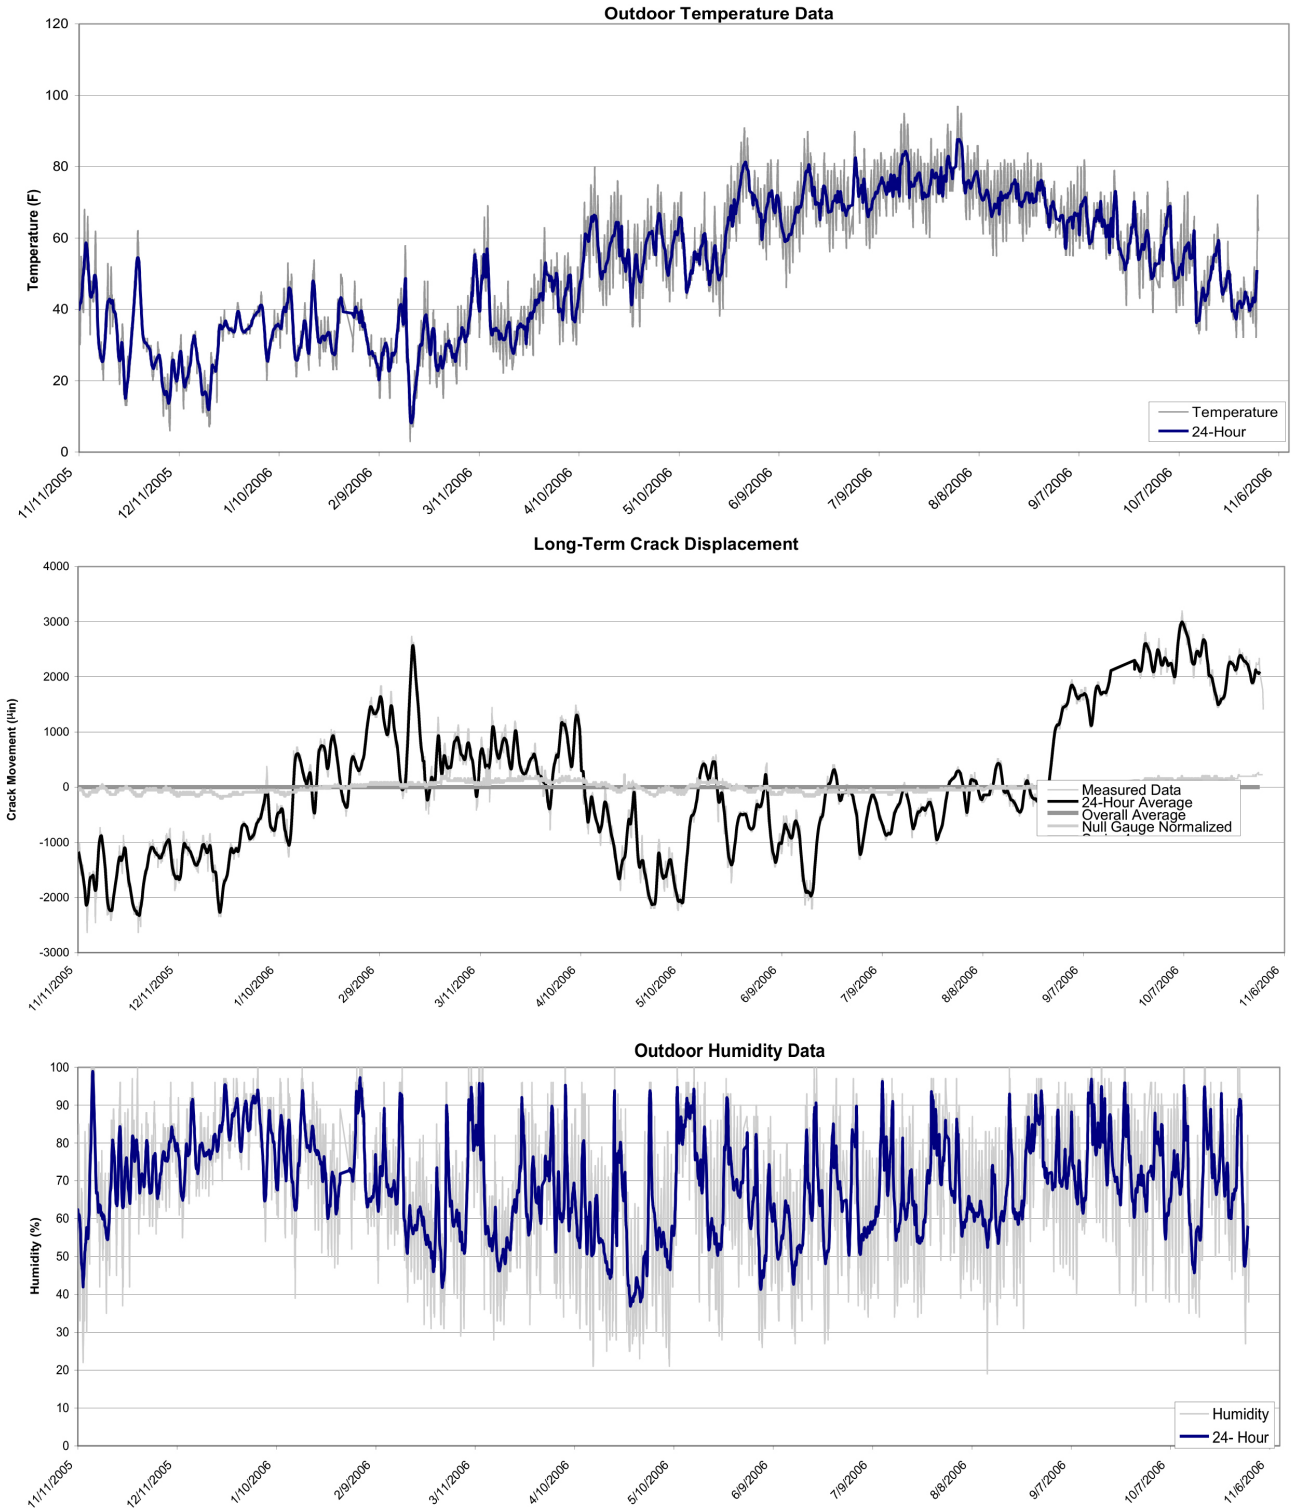
Crack response is compared to long term trends in outdoor temperature and humidity in Figures DT-4. These comparisons show that the crack response is affected by a combination of outdoor temperature and humidity. Thunderstorm activity can also produce crack response. Figure DT-5 compares ground motion, air over pressure, and crack response time histories produced by a nearby lightning strike during a thunderstorm on 14 July 2006.

Figure DT-4 - Long-term crack response compared to outdoor temperature and humidity

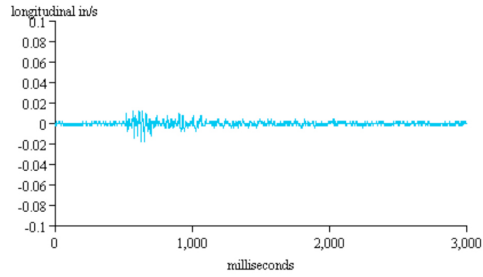
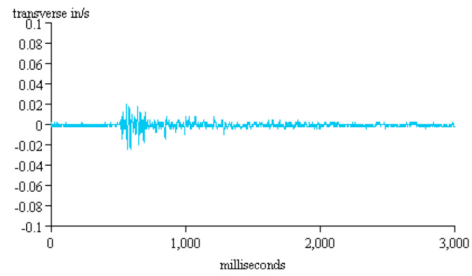
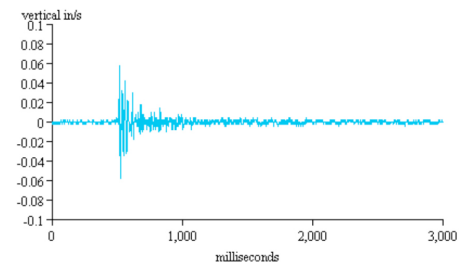
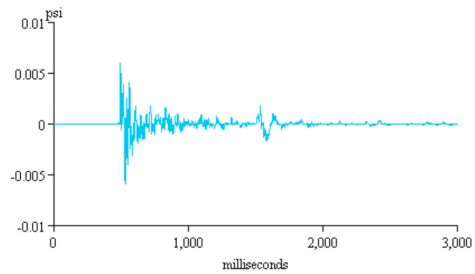
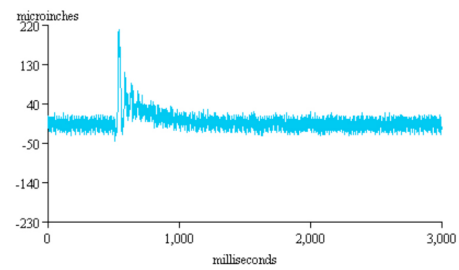
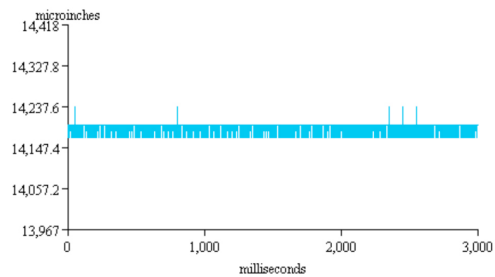
This event produced crack response of approximately 210 μin (5.3 μm) that corresponds in time to the large measured air over pressure event and vertical ground particle velocity, likely caused by a nearby lightning strike. Records of response to wind gusts are presented in Micrometer Crack Response book (Dowding, 2008).

Figure DT-5 - Comparison of air overpressure, ground motion, and crack response recorded on 14 July 2006 at 17:06:55 from a suspected nearby lightning strike during a thunderstorm

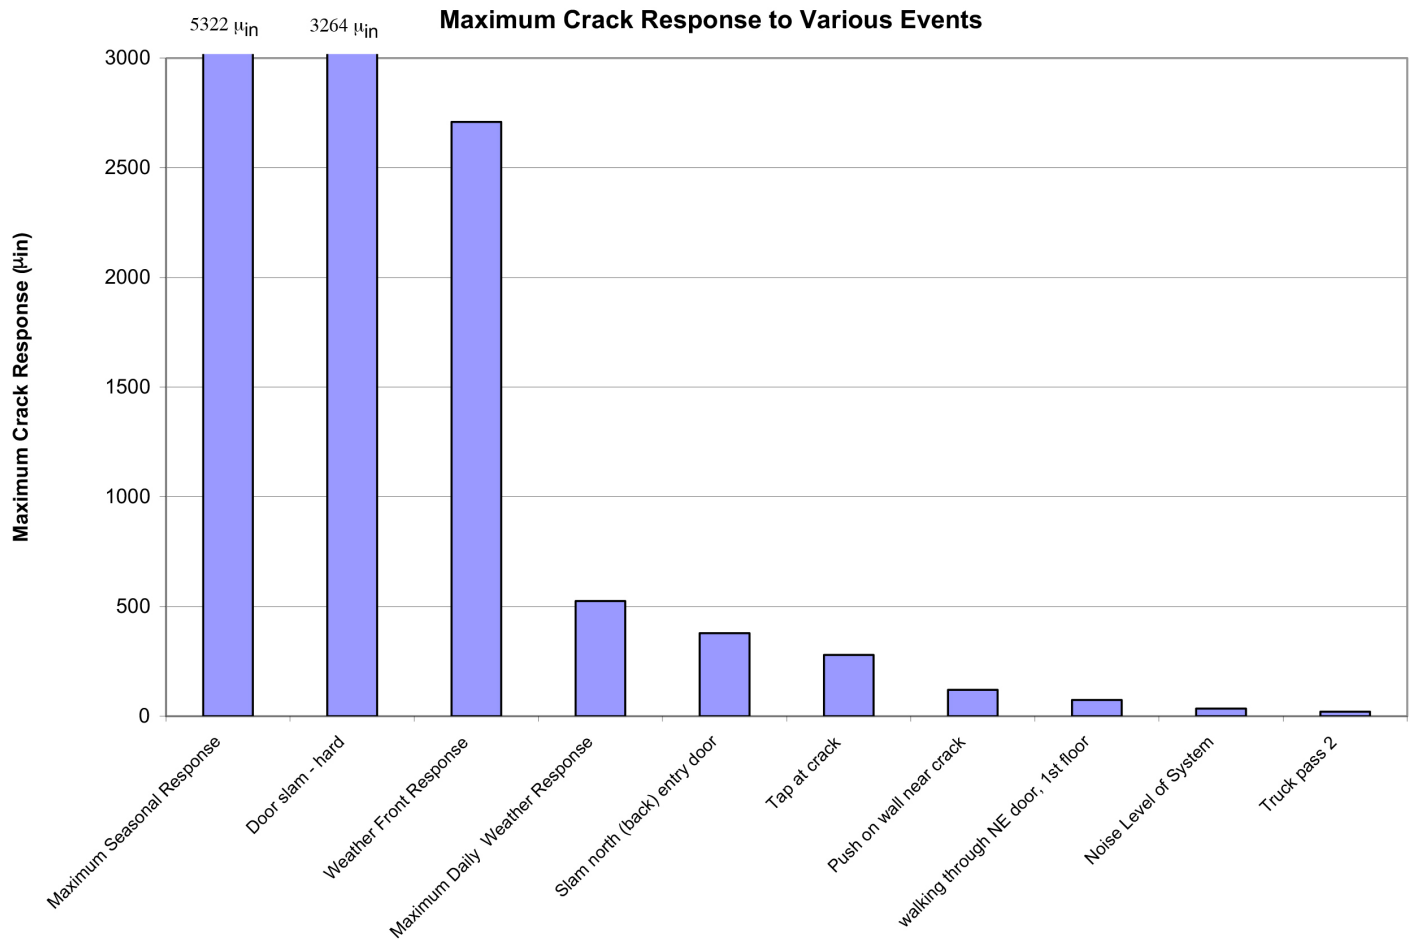
The magnitude of all measured crack responses are compared in Figure DT-6. The noise level of 35 μin (0.9 μm) is also noted on the chart. Climatological variation produces the largest crack response, with the exception of slamming the door directly below the crack. Occupant activity is a greater source of crack response than any external activity such as blasting and passing trucks.

Figure DT-6 - Comparison of crack responses to various occupant activities and environmental conditions

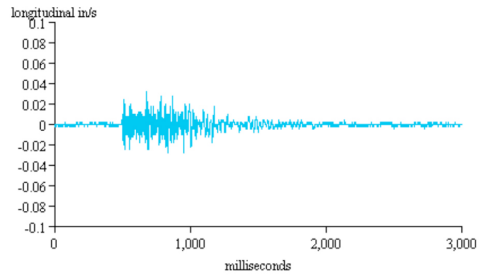
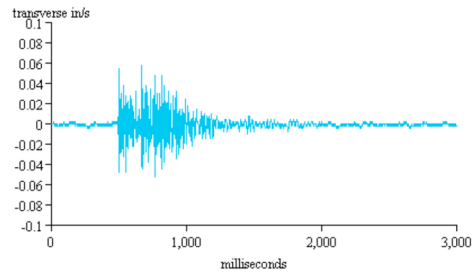
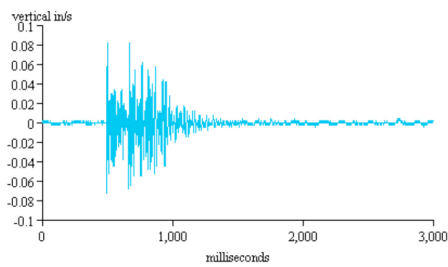
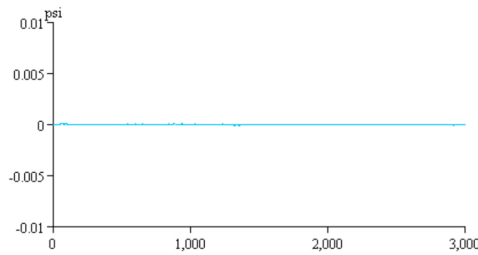
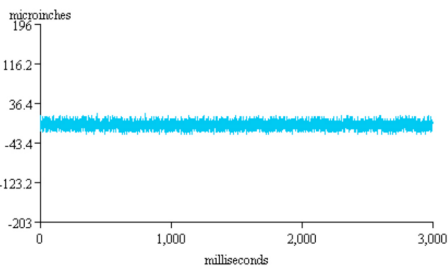
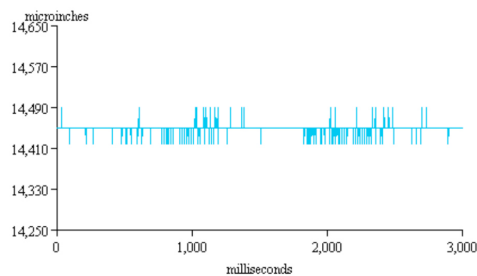
Figure DT-7 presents time histories of the maximum recorded blast vibration event at the test structure during surveillance. Peak particle velocity for this maximum event is 0.083 ips (2.1 mm/s) with a dominant excitation frequency of 76 Hz. Excitation frequencies are considerably higher than the 5-20 Hz range of natural response frequencies. The blast induced crack response was less than the noise level.

Figure DT-7 - Event record with the greatest ground motion recorded of 0.083 ips (2.1 mm/s) on 26 October 2006 that produced no crack response
