# APPENDIX FWII

## Franklin, Wisconsin (2008-09)

### Phase II - Quarry Blasting

*Meissner & Dowding\_2000*

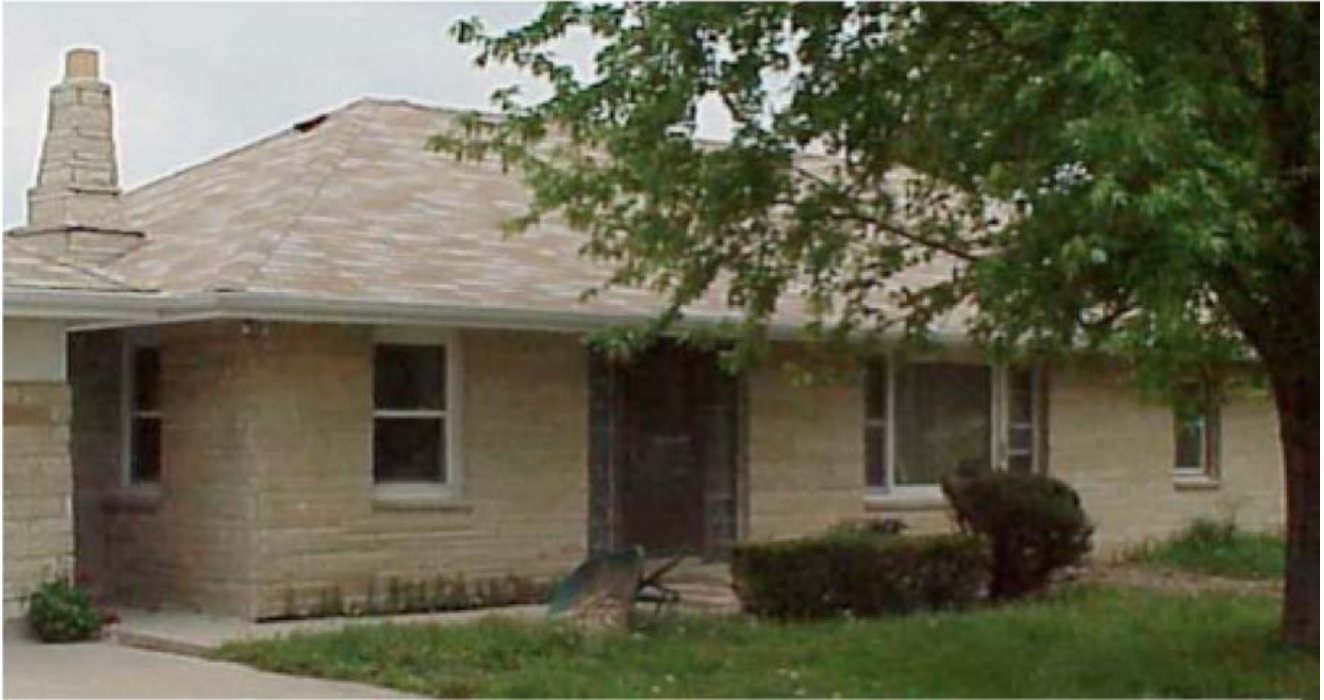
**Figure FWII-1** – Photograph of the residential structure in Franklin, WI

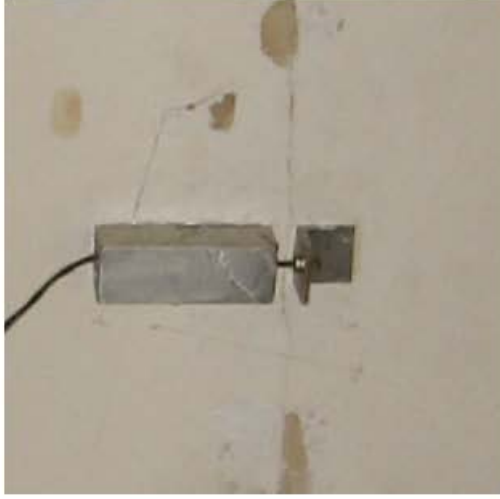
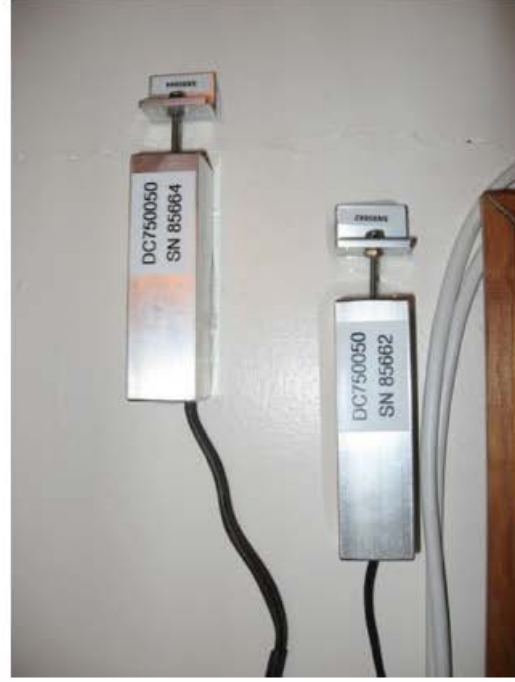
Ceiling Crack

Figure FWII-3 - Location of cracks monitored including context (left) and closeup (right). The ceiling crack appears on the top while the door crack appears on the bottom.

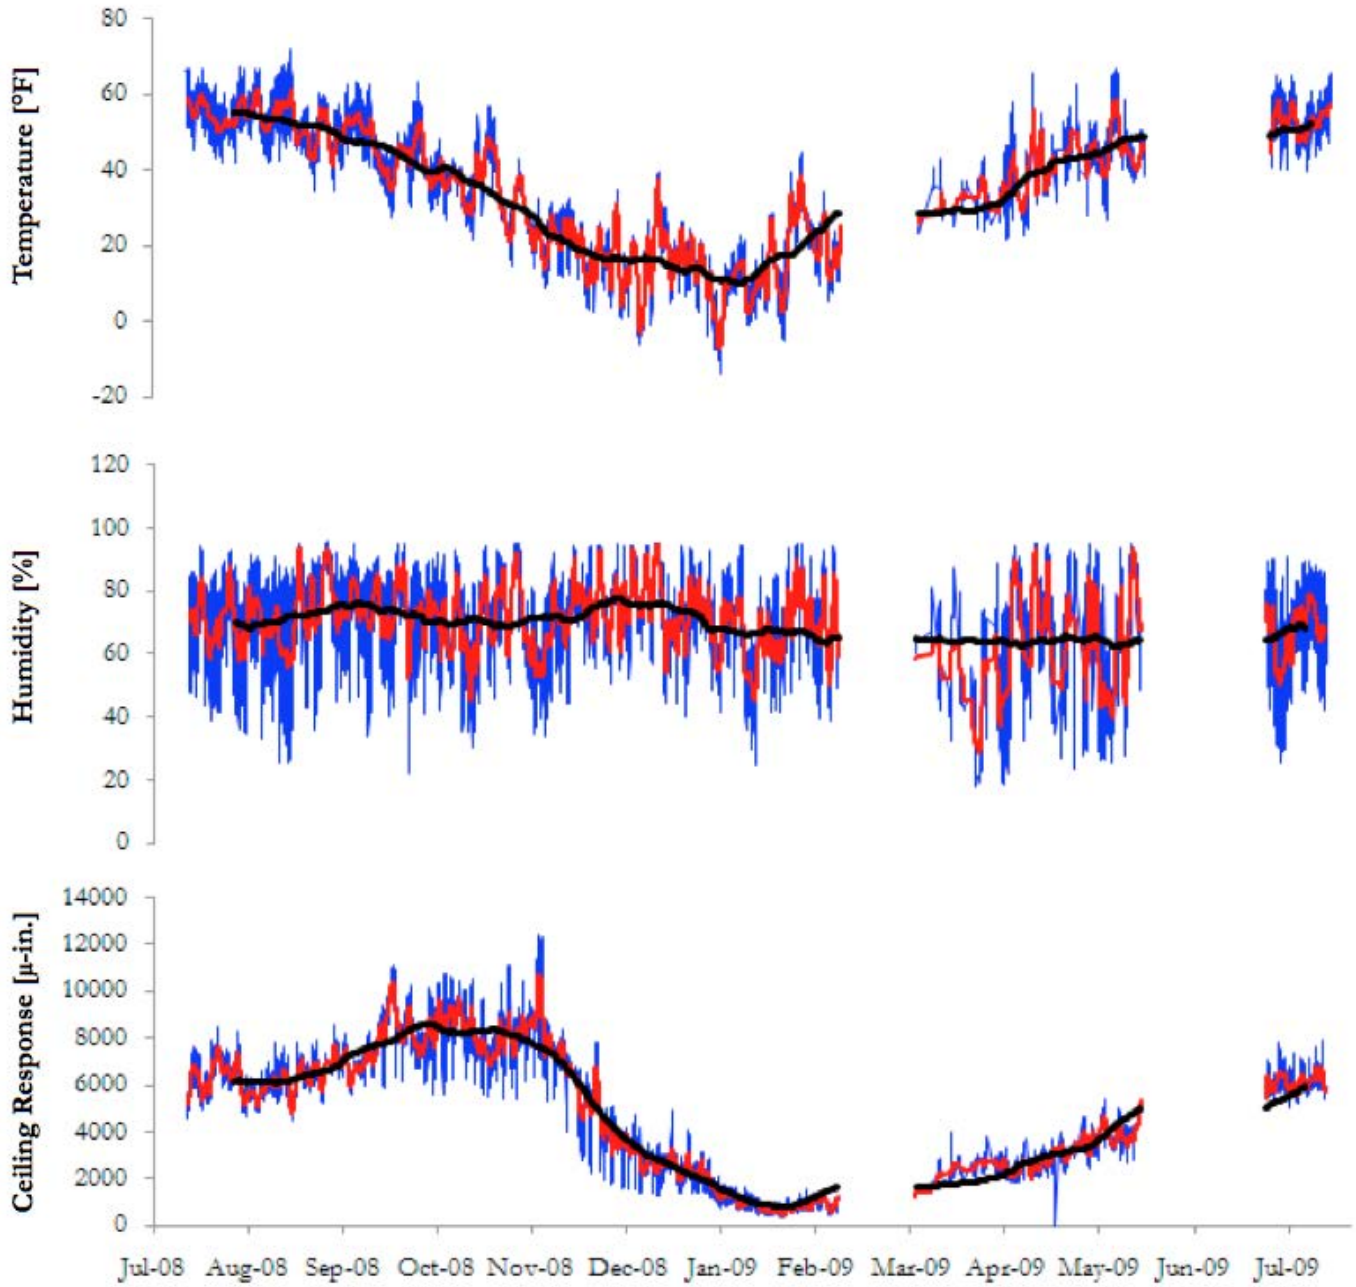
The crack sensors and outdoors temperature and humidity sensors were read every hour, registering a total of 6503 data points during the observation period. The results can be seen in Figure FWII-4 where individual readings are plotted in blue, the 24-hour central moving average in red and the 30-day central moving average in black. The same data plotted for a shorter period demonstrate that temperature variations correlate well with crack displacement. Since the red line is the 24-hour moving average and the black that for 30-day, the distance between them is indicative of the magnitude of change; a large, continuous change in temperature causes a deviation in crack response.

Figure FWII-4 - Correlation of outdoor temperature and humidity with ceiling crack response over a 1-year period.

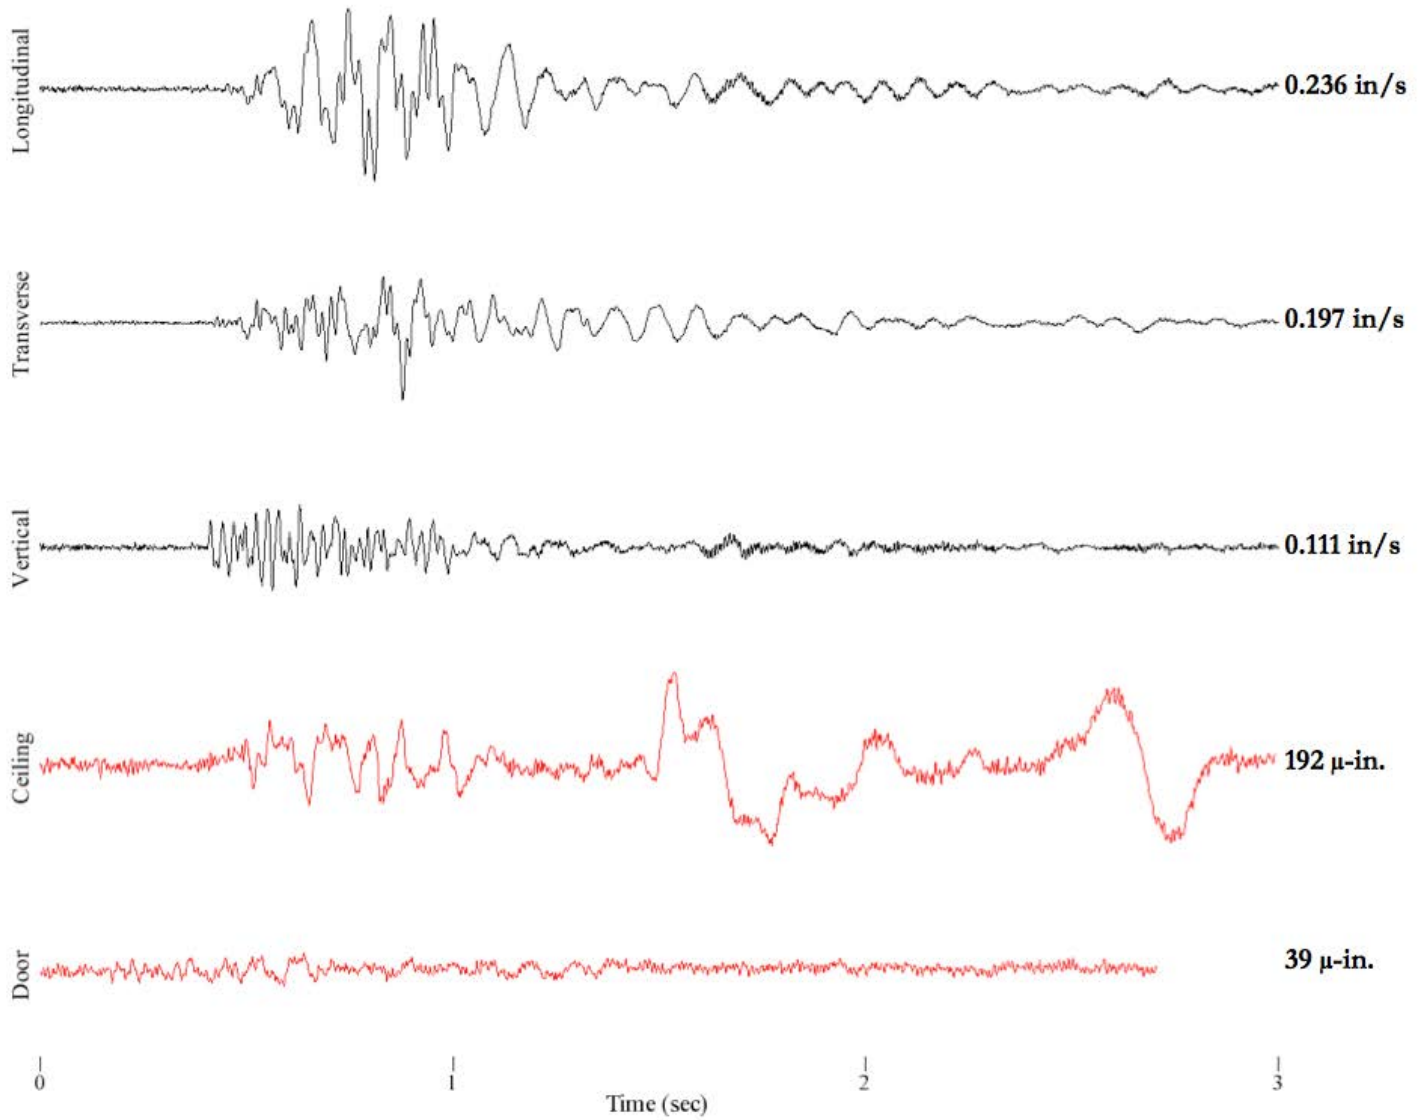
Crack responses for a total of 64 dynamic events were recorded. For each event, the peak ground motion in three orthogonal directions was recorded along with the crack response in microinches. Table FWII-1 presents blast event data with zero to peak crack responses. Figure FWII-5 compares the time histories of ground motion and crack response for an event on July 16th, 2009. The ceiling crack exhibits a zero-to-peak response of 192  $\mu$ -in while the door only responds 39  $\mu$ -in.

**Figure FWII-6** - Comparison of ground motion and crack response time histories for a blast on July 16th, 2009 at 10:45 AM

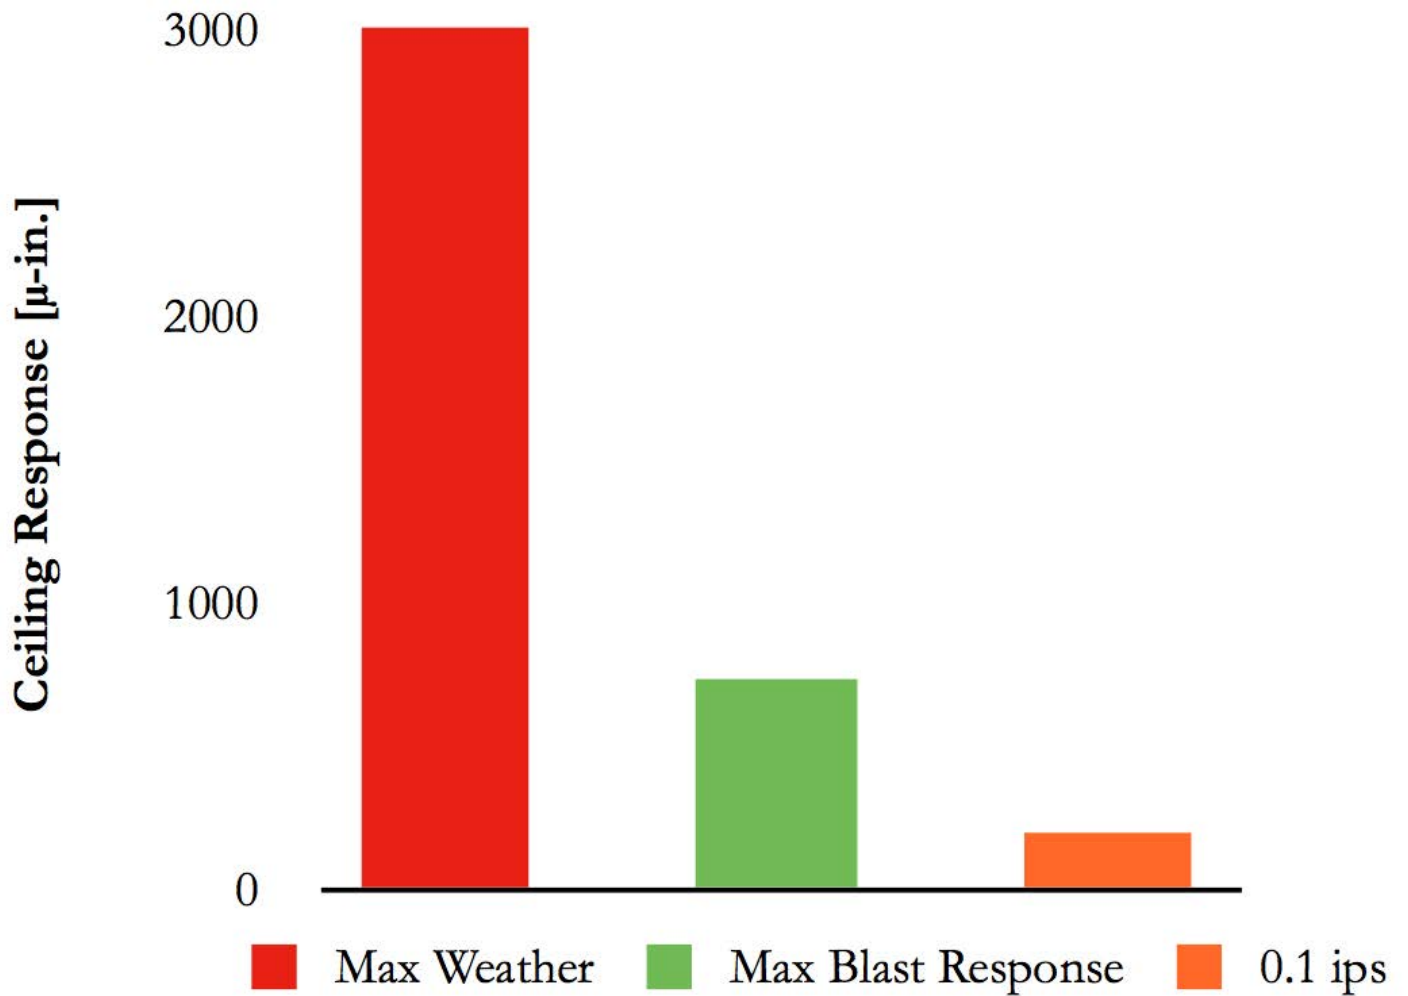
Figure FWII-6 below compares the climatological response of the ceiling crack to its dynamic response. Response of the crack to weather fronts is 3x greater than the maximum response to blasting and 10x greater than response to ground motion at 0.1 ips.

Figure FWII-7 - Bar chart comparison of ceiling responses to weather fronts and blasting
