APPENDIX UNII

Universal, Indiana (2009)

Surface Coal Mine Blasting

Dowding & Meissner_2011

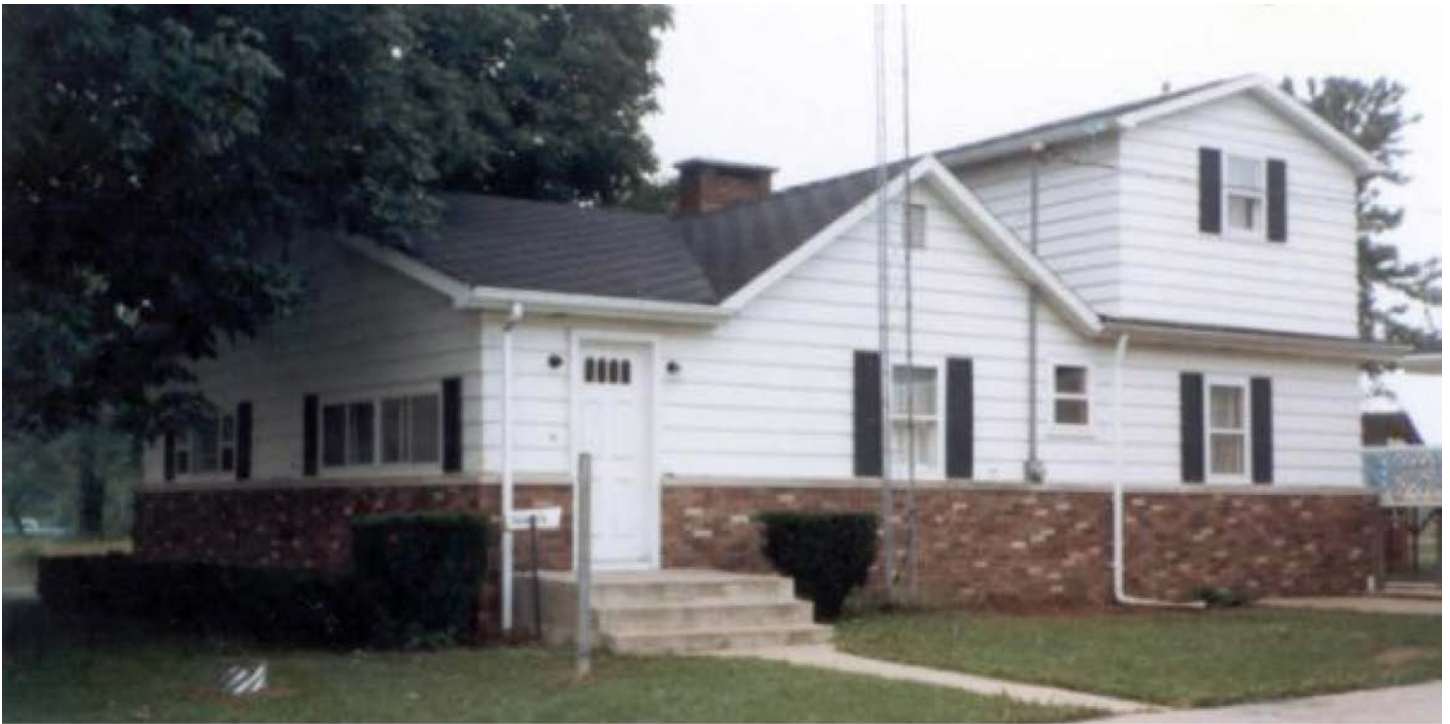
Figure UNII-1 – Photograph of the residential structure in Blanford, Indiana

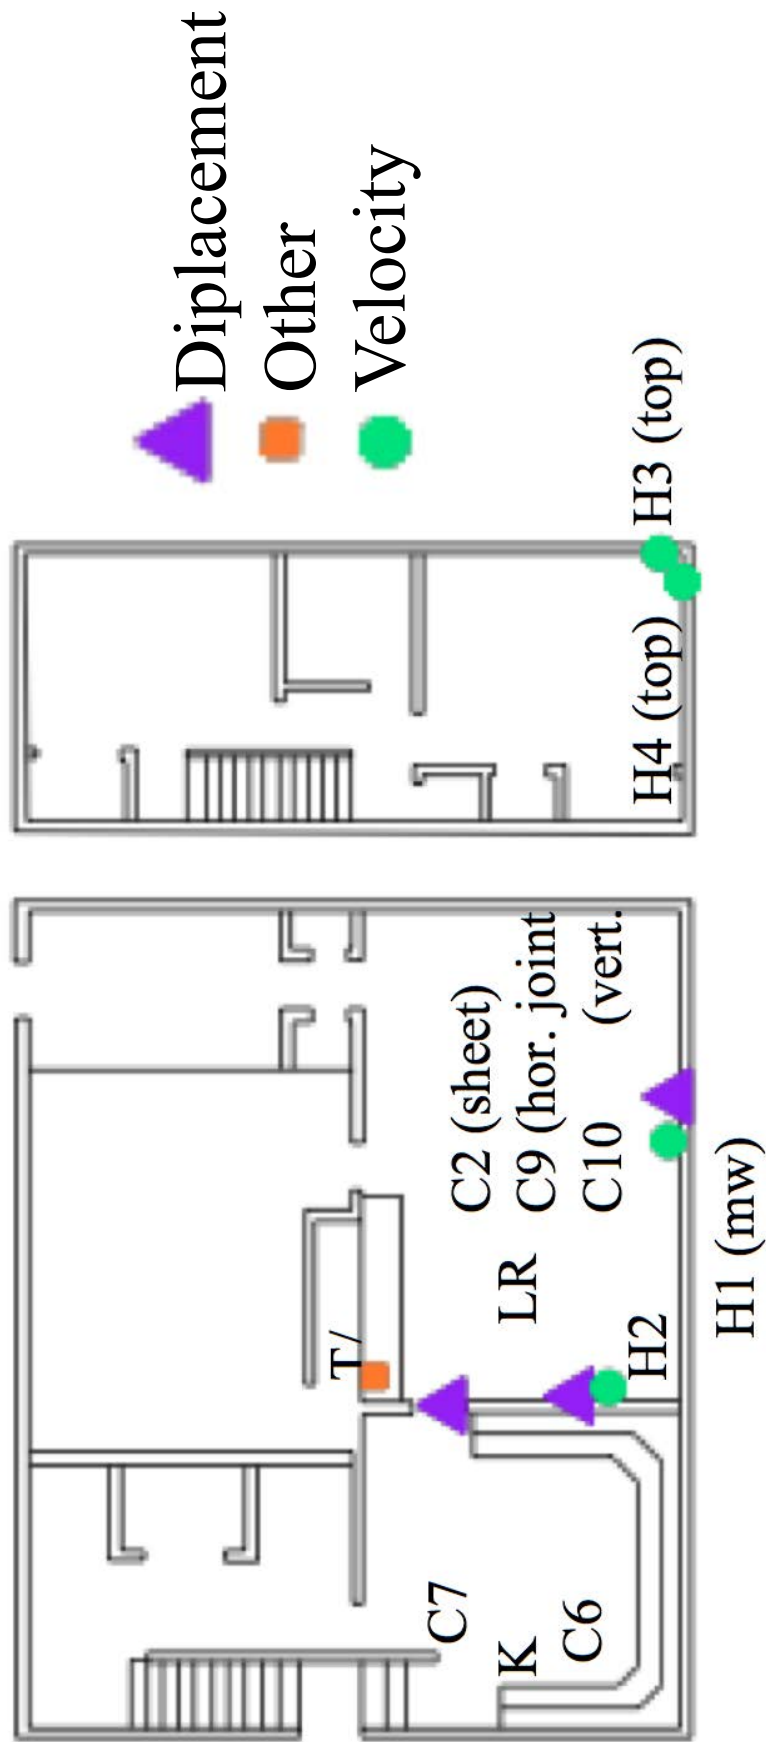
Figure UNII-2 - Instrument locations

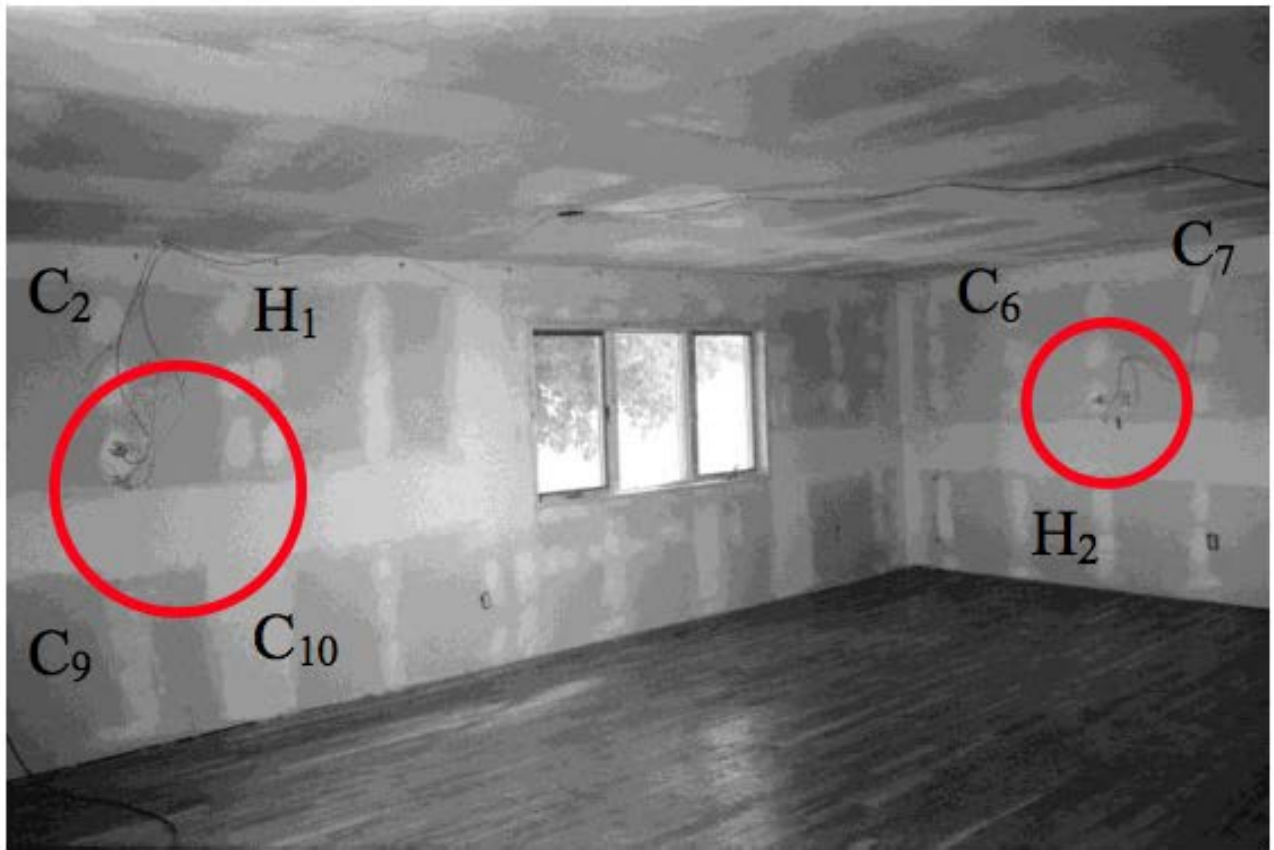
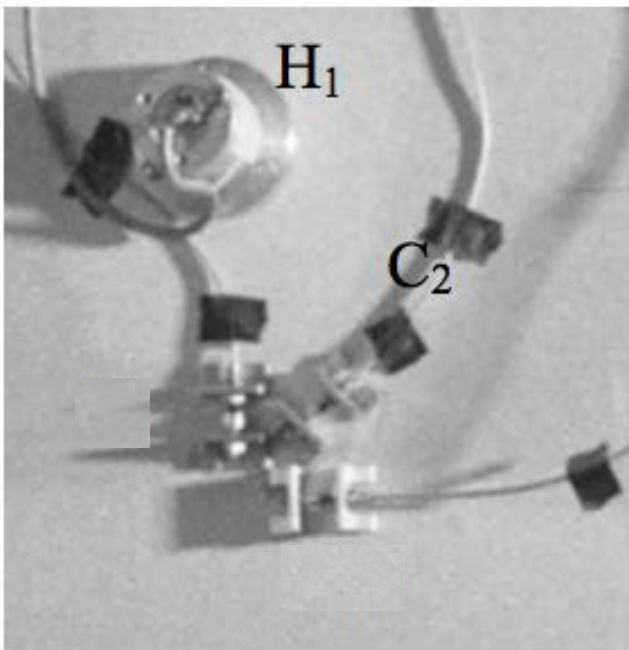
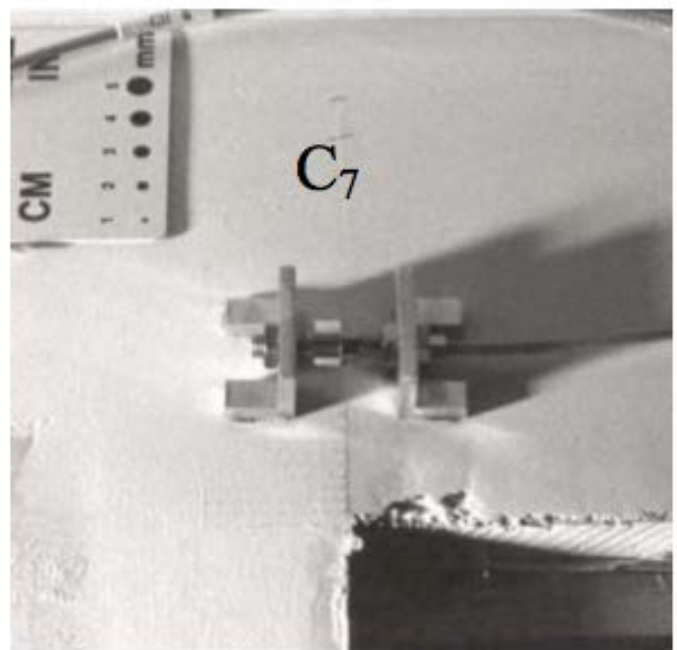
Context (top) and details (bottom) of the instrument installations are shown in Figure UNII-3. The living room walls in the house contain the instrumented dry wall joints as shown in the drawing and center photograph. Horizontal and vertical un-cracked dry wall joints are C9 and C10. Uncracked locations near the centers of the drywall sheets are C2 and C6. Drywall joint crack, C7, shown in the bottom right most photograph, is at the doorway (adjacent to C6) between the living room and the

kitchen. This crack is not fully extended, and did not extend during the observation period. Out-of plane, mid-wall motions were measured with velocity transducers as shown in the bottom left photograph.

Figure UNII-3 - Installation details for the house. The photograph on top shows context of instrumentation and with detail on the bottom. C9&10 cross un-cracked drywall joints; C7 crosses a cracked drywall joint; and C2&6 are located on drywall sheets. H1&2 are on out of wall planes on the first story.

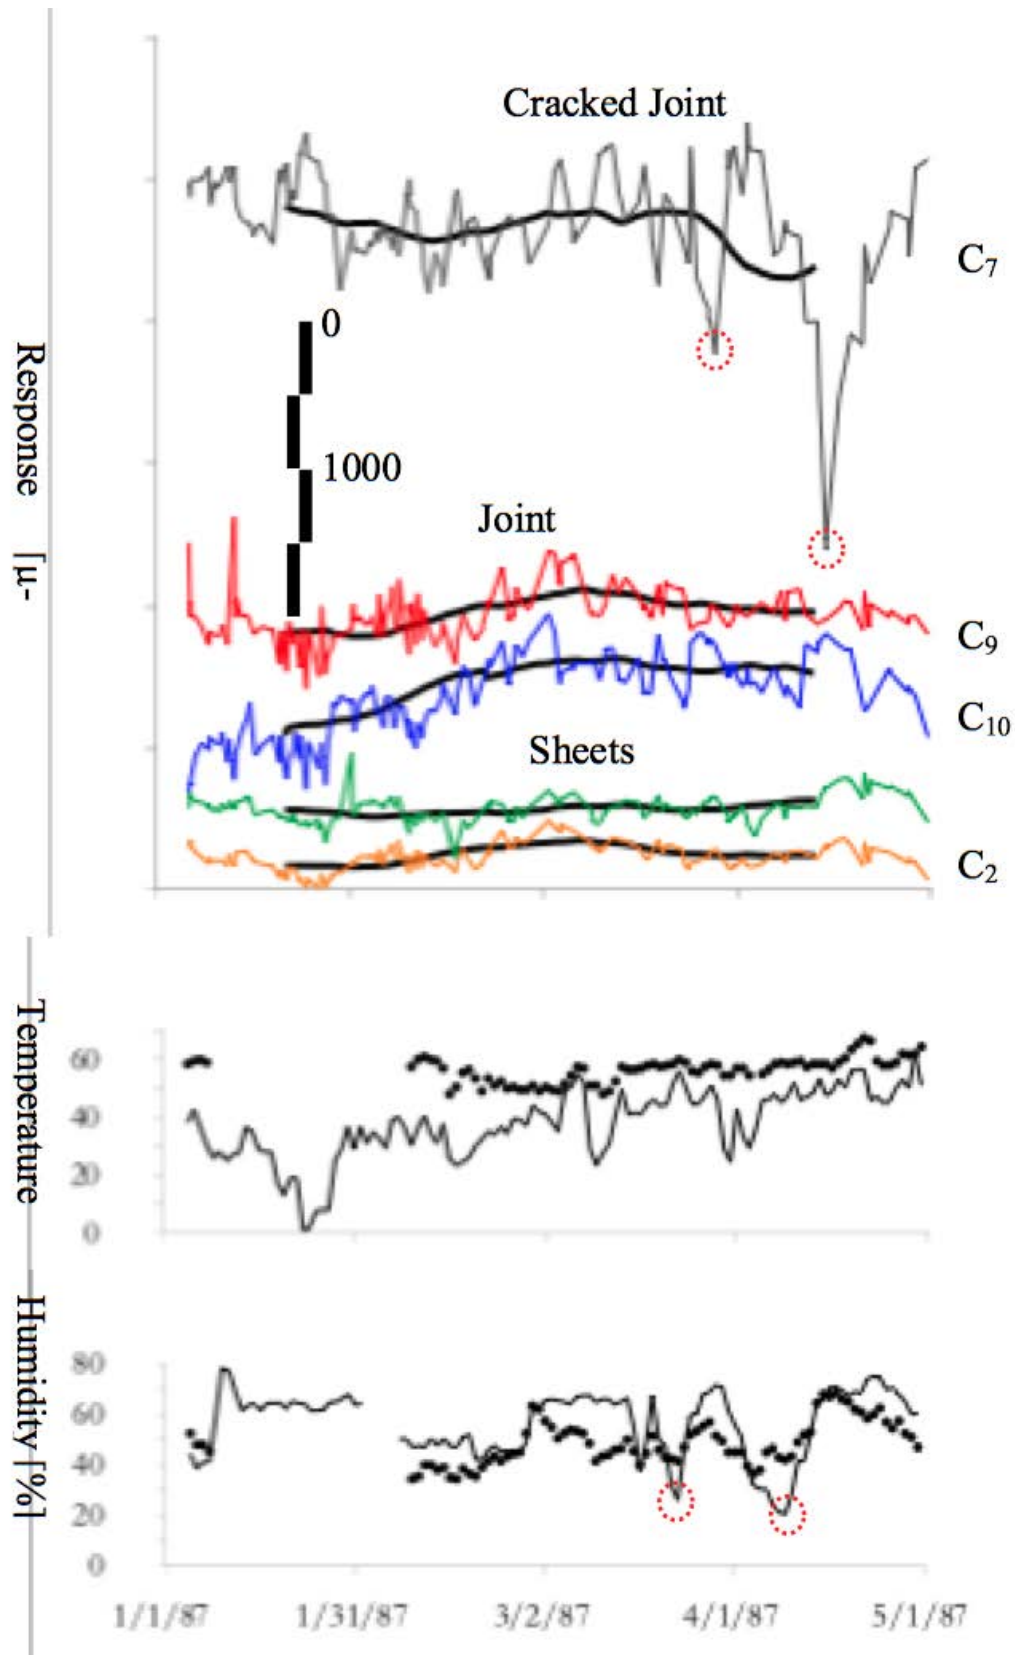
Figure UNII-4 compares four months of responses of the 2 uncracked (C9, C10) and one cracked (C7) drywall joints, and 2 uncracked drywall sheets (C2, C6) to temperature and humidity- induced, climatological effects. Variation in temperature and humidity inside and out is presented on the bottom. Joint, crack and sheet responses are plotted to the same scale at the top for comparison.

These long-term measurements, spanning some four months, show that uncracked weaknesses in wall covering are less responsive to long term, climatological effects than other cracked locations. The same is true for vibratory response.

Figure UNII-4 - Comparison of four months of climatologically induced responses of joints. 30-day central moving average shown with the thick line. Temperature and Humidity are plotted on the bottom (dotted=inside, solid=outside), and joint responses are plotted on the top with common time and response scales for comparison.

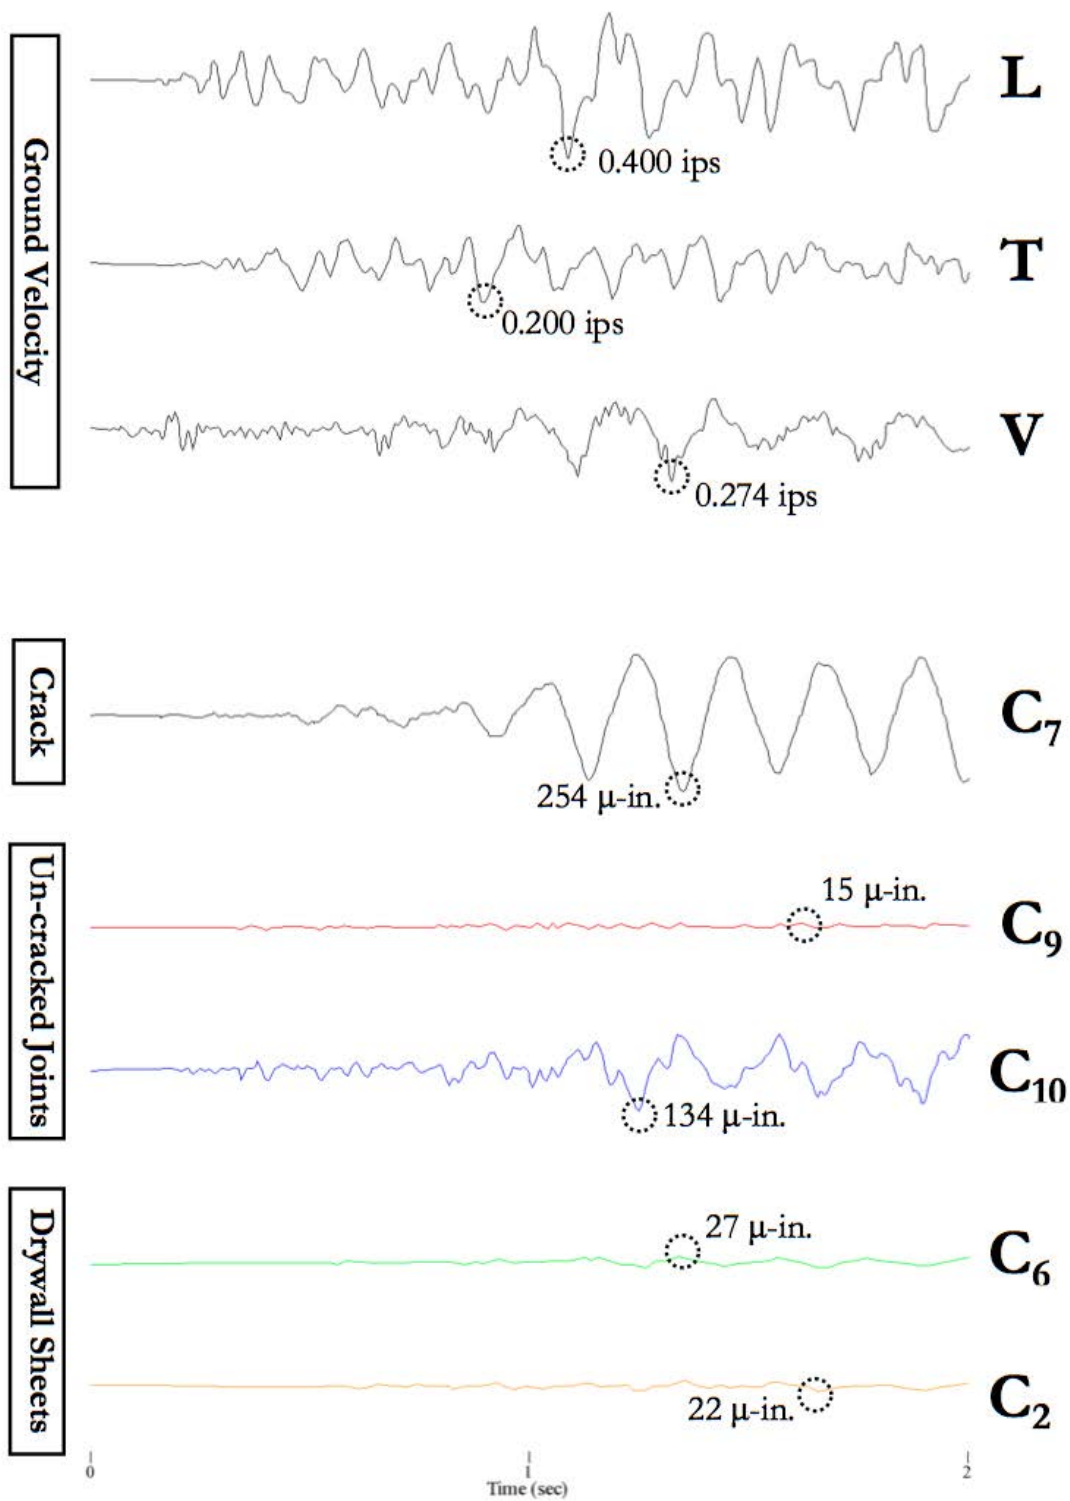
Vibratory response time histories of uncracked and cracked dry wall joints for these two houses are shown in Figure UNII-5. The relationship between vibratory and climatological response for uncracked wall weakness (dry wall joints) is the same as for cracks as shown by the bar chart comparisons in Figure UNII-6. Where climatological response is small, so is vibratory response for both cracked and uncracked joints. Cracking of a joint does not appear to diminish its dynamic response; at least not relative to other uncracked weaknesses such as the joints. Cracked joints are seen to respond more than uncracked joints to both vibratory and climatological drivers. Figure UNII-7 compares the vibration response of C7 and C10 to groundmotions and superstructure (H3, H4) as well as wall response (H3, H4).

Figure UNII-5 - Comparison of ground motions (top) with joint responses (bottom) showing unusually low excitation frequency of the ground motions. (1 ips = 25.4 mm/s, 1 μ-in = 0.025 μm)

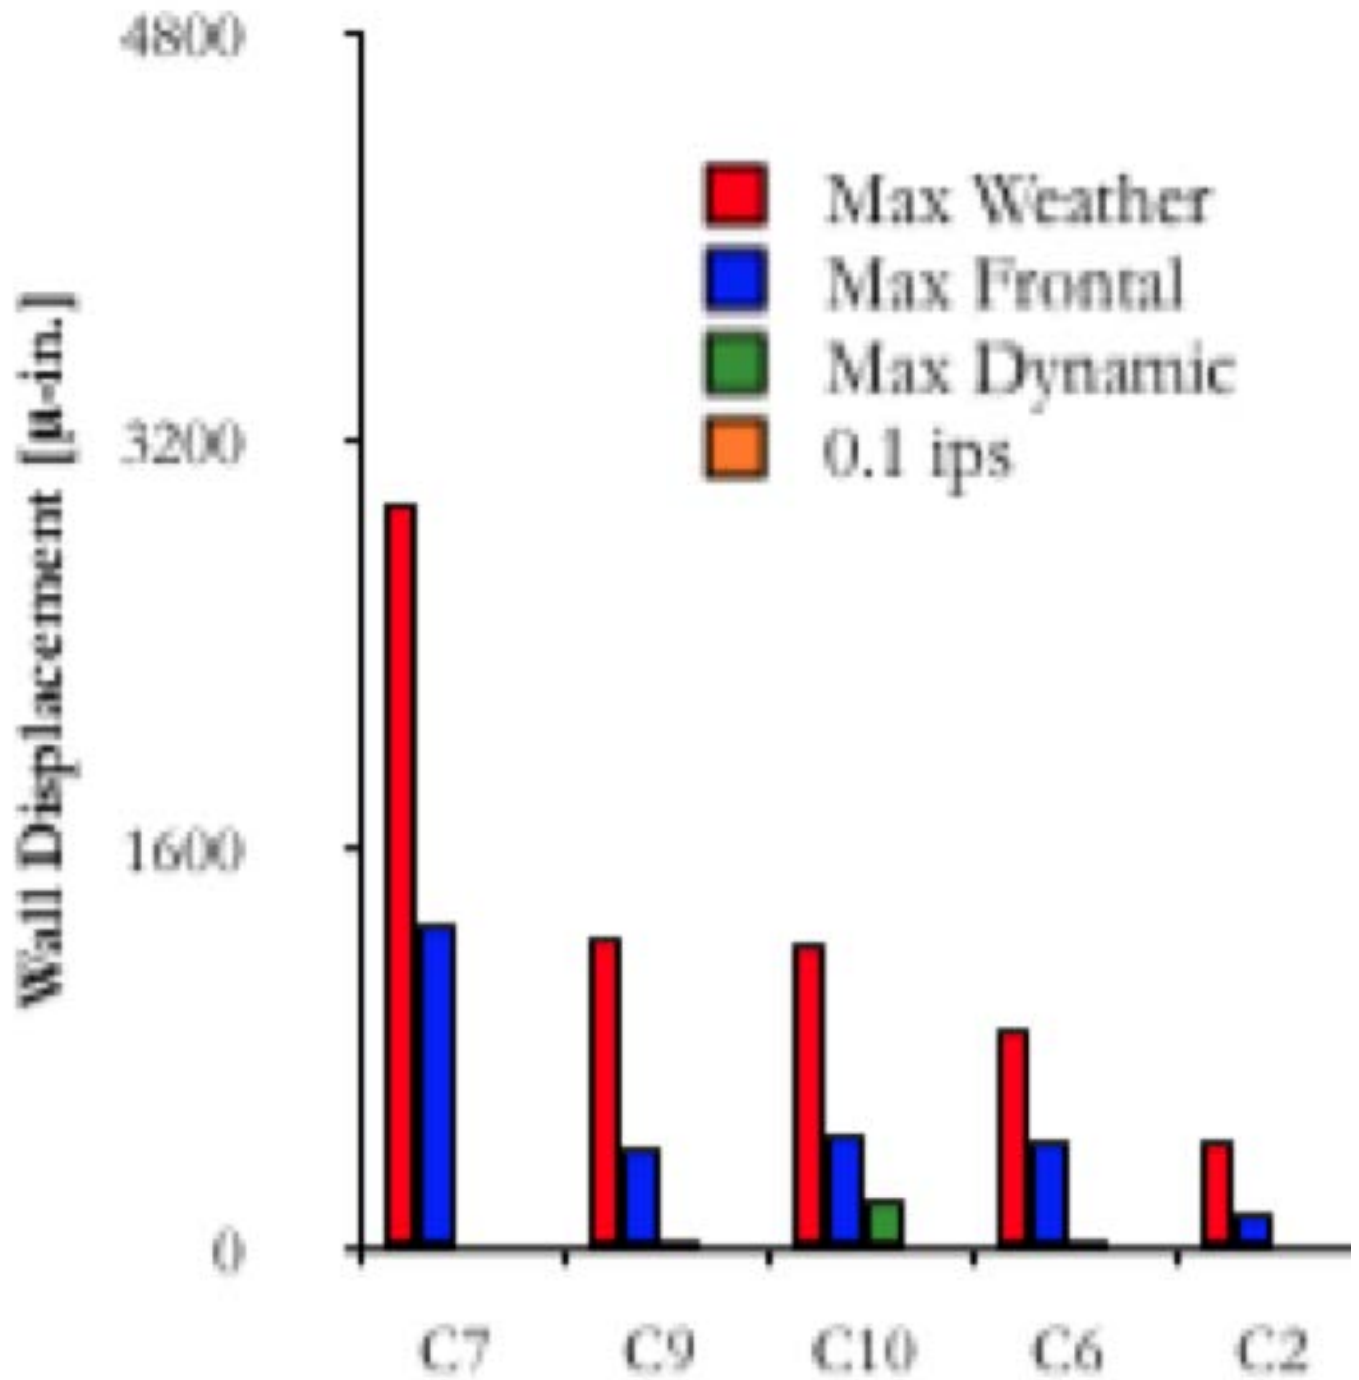
Figure UNII-6 - Bar chart comparison of crack/joint/sheet response induced by weather

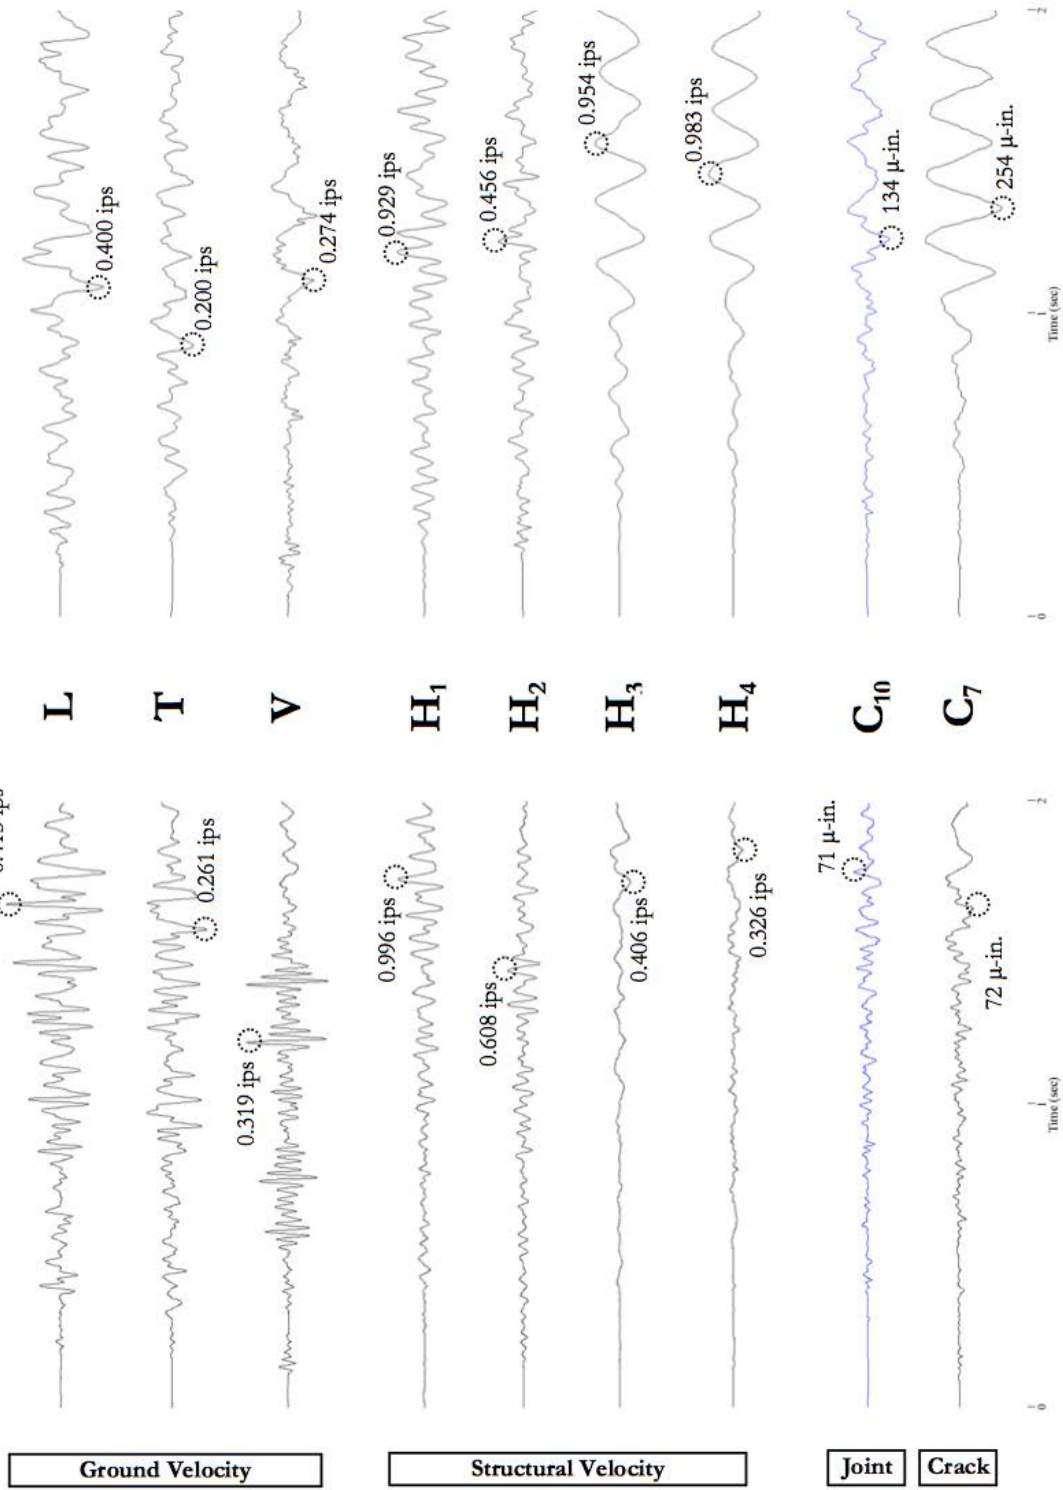
Measurements made in this structure investigated several concerns regarding the usefulness of the observation that cracks respond more to climatological than vibratory effects. Concerns addressed are: 1) sensitivity of uncracked locations and 2) crack response in low excitation frequency - high particle velocity environments. Responses of the weakest of wall components, the paper-thin joints between drywall sheets were measured and shown to be less than that of cracked joints. Specifically, measurements presented herein show that a cracked joint does not respond less than other uncracked weaknesses in the wall covering to either climatological or vibratory effects. Even in high particle velocity and low excitation frequency environments cracks continue to respond more than do uncracked weaknesses.

Figure UNII-7 - Time histories of ground motion, structural response, and cracked (C7) and un-cracked drywall joint response (C10). Low frequency excitation show joint response follows the motion of the upper story. 2/23/87 on the left and 4/2/87 on the right. (1 ips = 25.4 mm/s, 1 μ-in = 0.025 μm)
