**Structure Response
to Blast Vibration**

**C9040
November 2002**

ACARP

**AUTHORS: ADRIAN MOORE, ALAN RICHARDS,
THOMAS LEWANDOWSKI
- TERROCK CONSULTING ENGINEERS**

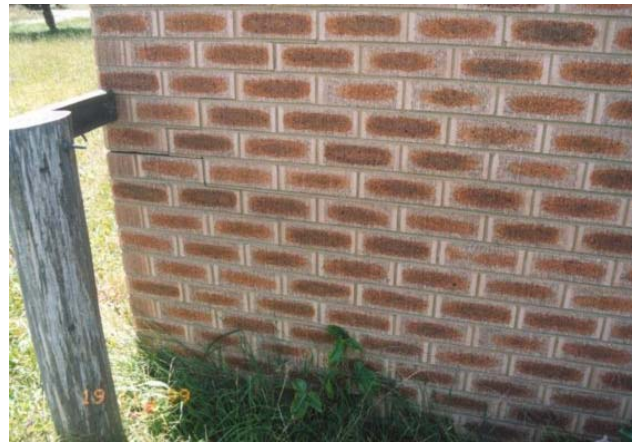
Figure 3a - Stepped brick crack at south-west corner below DPC

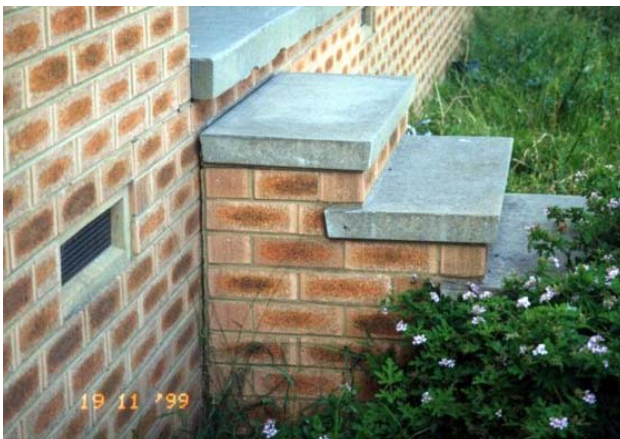
Figure 3b - Stepped brick cracks below DPC at south-west corner

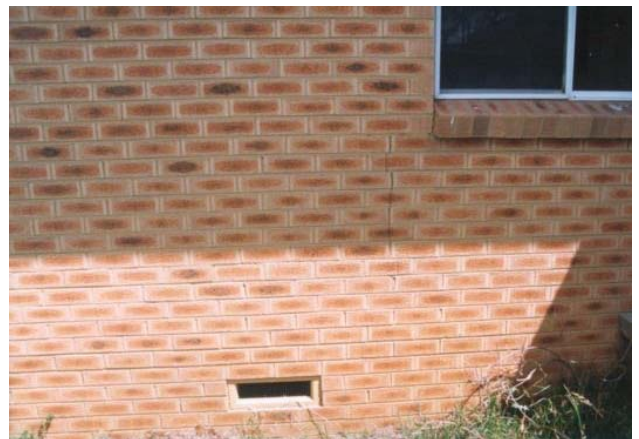
Figure 3c – Horizontal crack at DPC - separation of steps from verandah

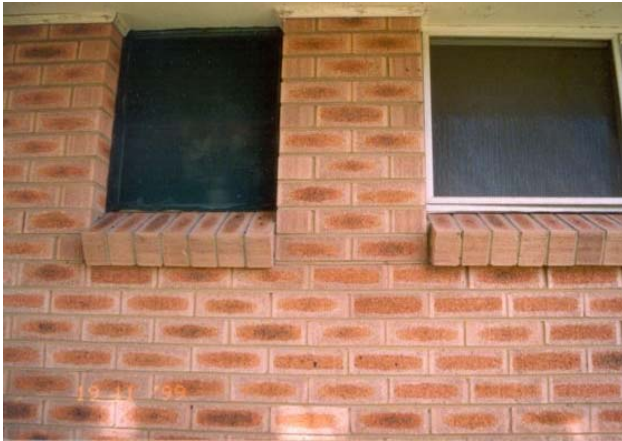
Figure 3d - Cracked brickwork (stepped and vertical) at kitchen window

The external crack showing the most movement was adjacent to where the tank overflow water ponded against the kitchen wall. The extremes of width behaviour of all cracks over the monitoring period shows similar complex movement that is unrelated to blasting but is related to periodic variations in rainfall. Limited width movement of some cracks is related to ground vibration for the 4 blasts in excess of 70 mm/s.

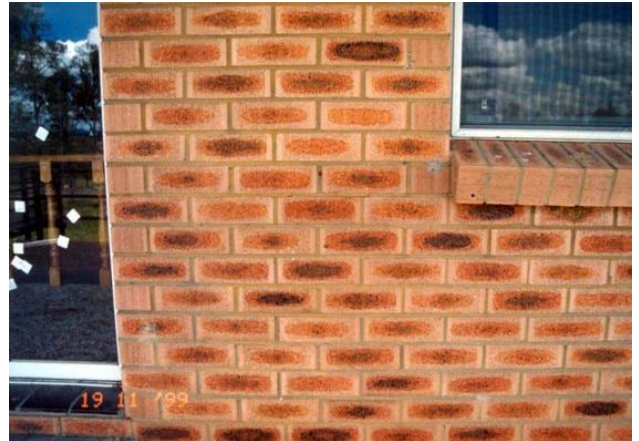
Figure 3e - Horizontal mortar crack between toilet and bathroom windows

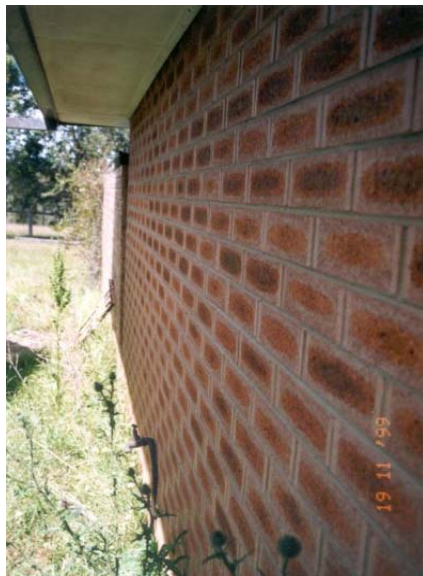
Figure 3f - Horizontal brick crack from dining room window

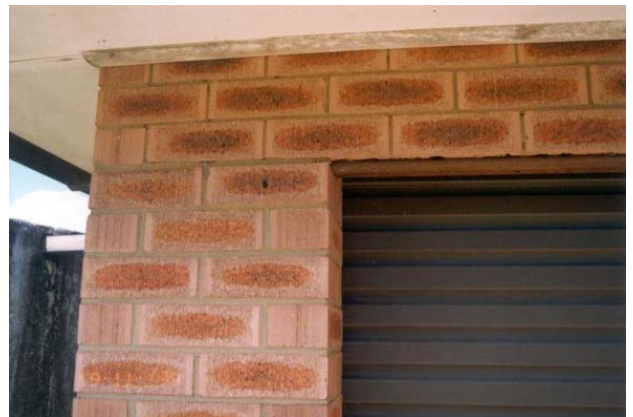
Figure 3g - Freestanding wall moves independently of the garage

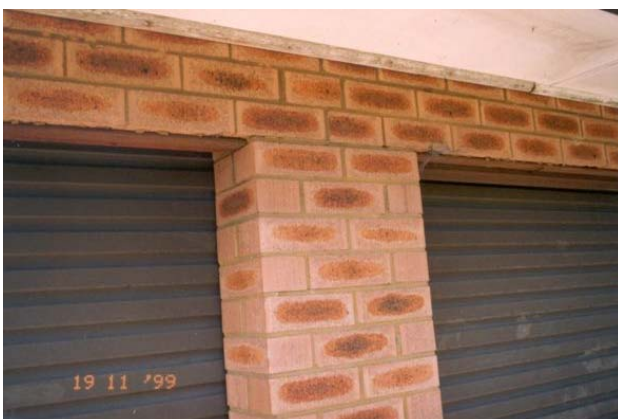
Figure 3h - Horizontal cracked brickwork in garage at end of steel lintel

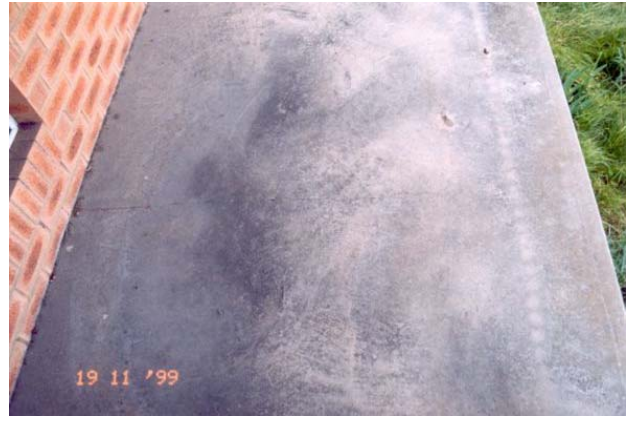
Figure 3k - Separation of path from wall

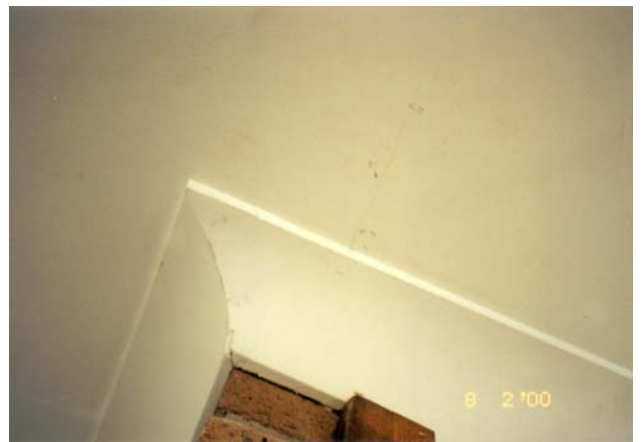
Figure 3m - Inclined plaster crack in kitchen from window to encased beam

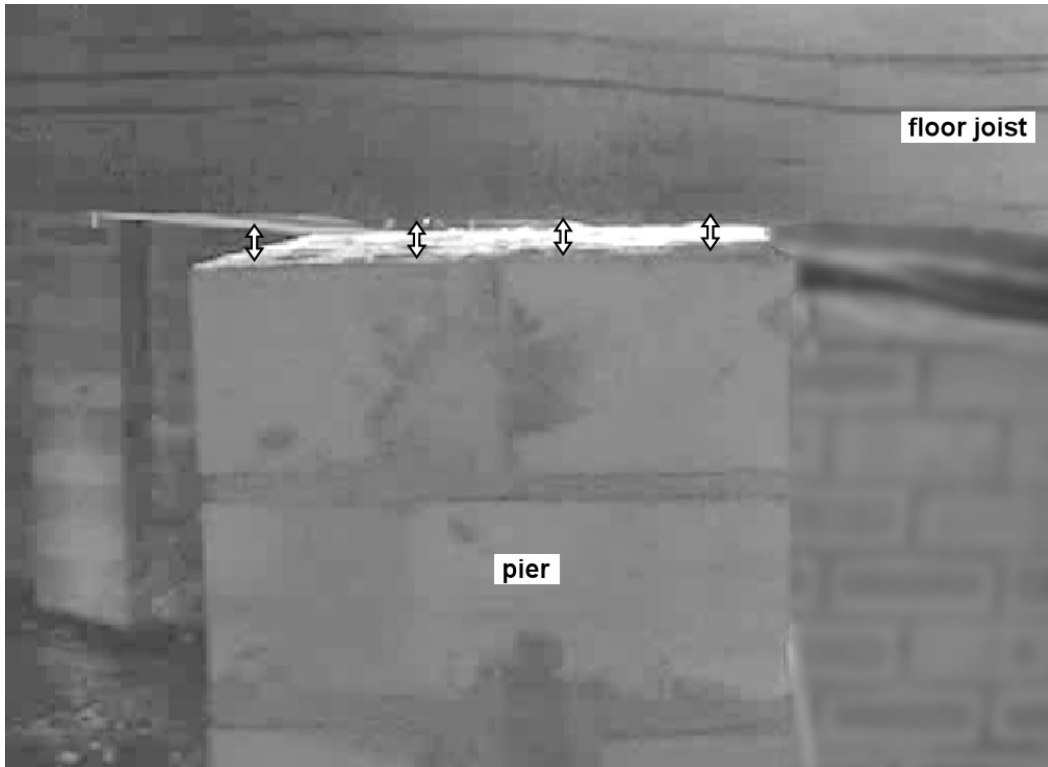
The footings of this house may be regarded as being inadequate to limit damage due to the effects of the reactive soil foundation at this site. It may thus be expected that the performance of this house, in regard to the effects of a reactive soil foundation, may fall outside the bounds considered as satisfactory in Appendix C of AS2870-1966.

Figure 5 - 20 mm gap between brick pier and floor joist

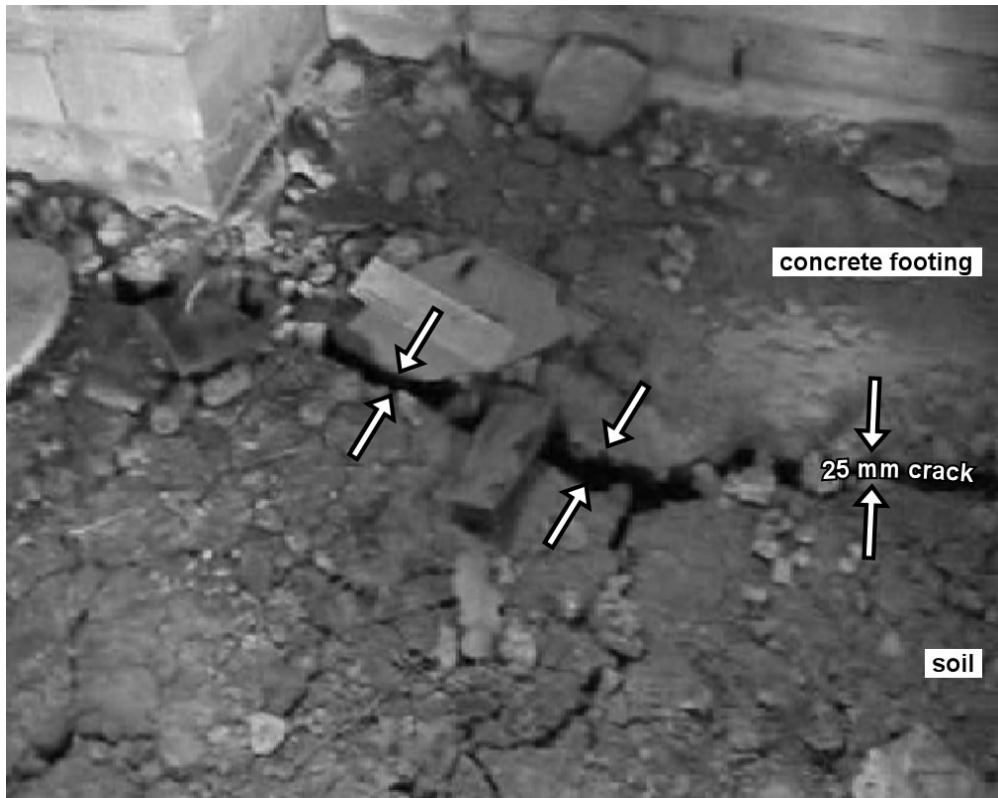
The soil profile ranges from fully saturated to practically dry over a period of time, with considerable lateral variation. When the profile dries out, the soil shrinks considerably, as indicated by the geotechnical testing. **Figure 5** shows a pier which has shrunk away from the floor joist by about 20 mm and **Figure 6** shows 25 mm wide cracks between the soil and the footings.

Figure 6 - 25 mm crack between footing and soil beneath house

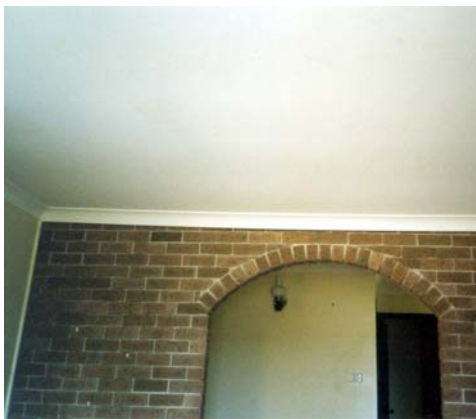
Following Blast No. 23 on 11th August 2000, where the peak ground vibration was 71.2 mm/s, it was noticed that a section of the plaster ceiling in the lounge room had sagged about 30 mm at the hallway end (refer **Figures 15a** and **15b**). Subsequent investigation showed that the plasterer had not used adhesive on the two ceiling joists nearest the western wall and the nails had pulled through the plaster and backing paper. The remainder of the ceilings throughout the house were unaffected. The sagging plaster was re-attached to the joists with plaster adhesive by propping from beneath until the adhesive set. The entire ceiling remained intact for the duration of the investigation.

Figure 15a - Sagging lounge room ceiling after a PPV of 70 mm/s

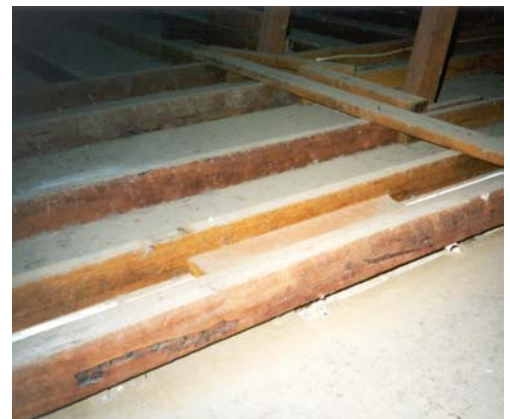
Figure 15b – Lounge room ceiling - nails pulled through plaster and backing paper causing the ceiling to sag

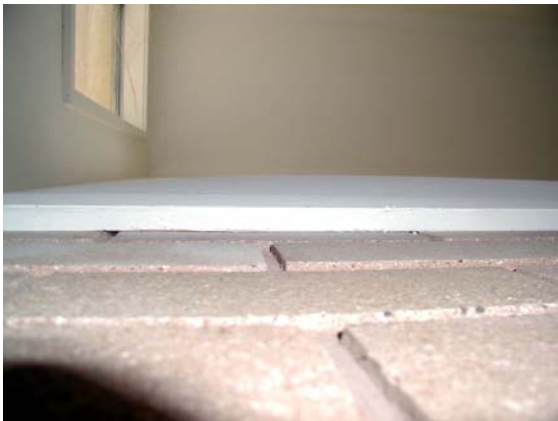
Prior to the commencement of blasting at Bengalla, the house had a number of minor structural defects relating to foundation movement and settlement. Photographs of typical defects are shown in **Figures 21a to 21f**.

Figure 21a- Bulging plaster above the stairs

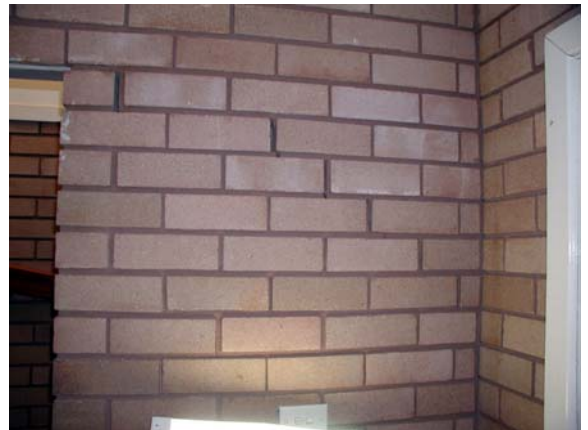
Figure 21b – Tapered stepped crack in brickwork at entrance (up to 8 mm wide)

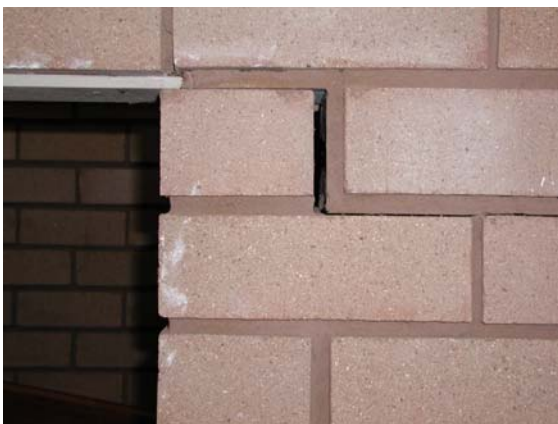
Figure 21c – Close up of Tapered stepped crack in brickwork at entrance (Figure 21b)

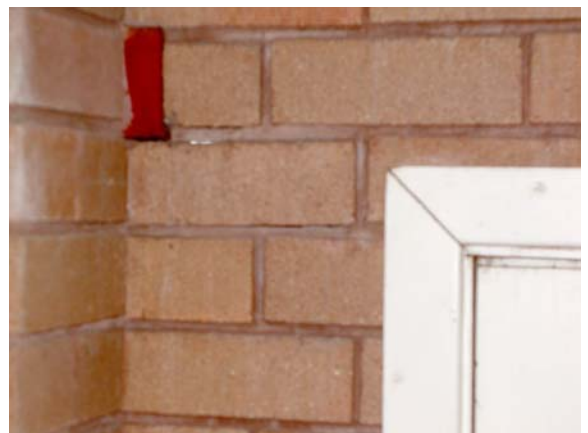
Figure 21d – Cracks in brickwork over door in rumpus room

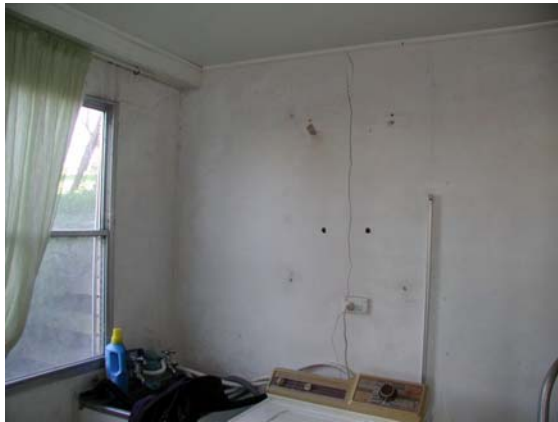
Figure 21e – Cracks in rendered finish in laundry

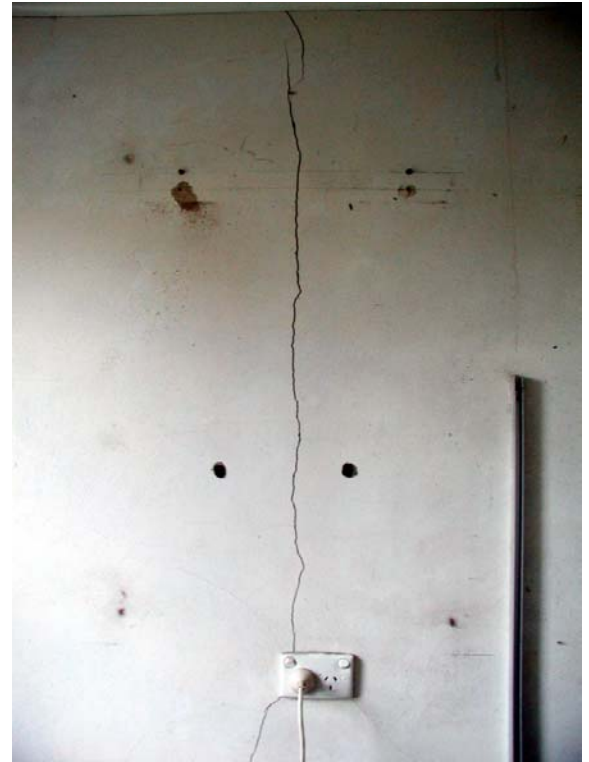
Figure 21f – Close up of vertical crack in rendered finish in laundry (Figure 21e)

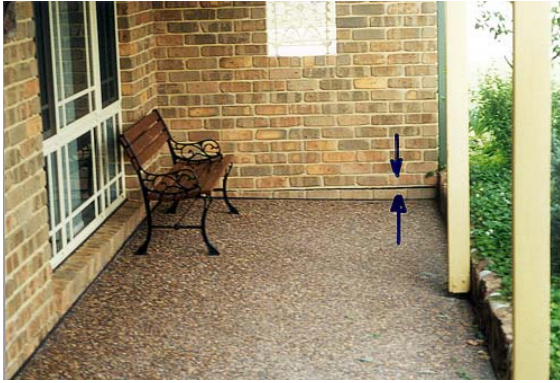
Figure 29a – Reference House R2 (Edgeworth) – bed joint separation

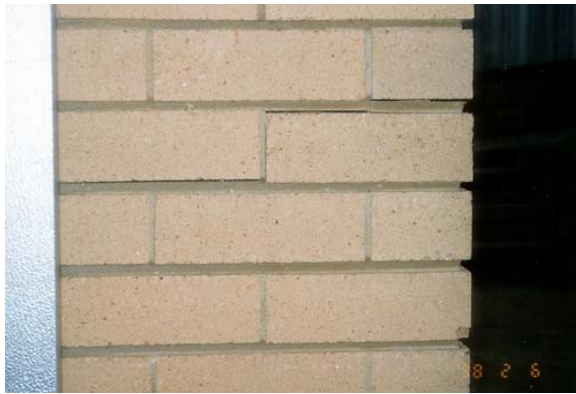
Figure 29c – Reference House R4 (Fennell Bay 2) – brick crack

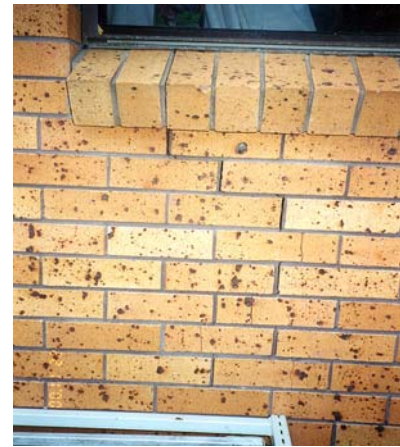
Figure 29d – Reference House R7 (Cessnock) – diagonal brick crack

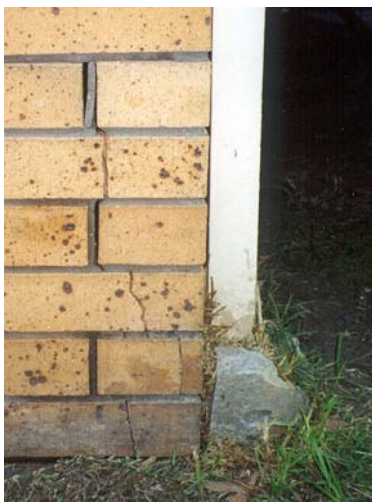
Figure 29e – Reference House R7 (Cessnock) – diagonal brick crack

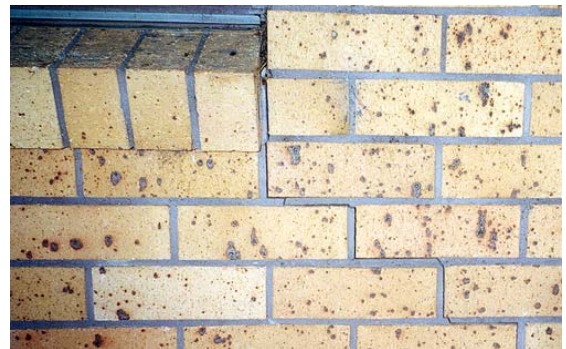
Figure 29f – Reference House R7 (Cessnock) – diagonal brick crack

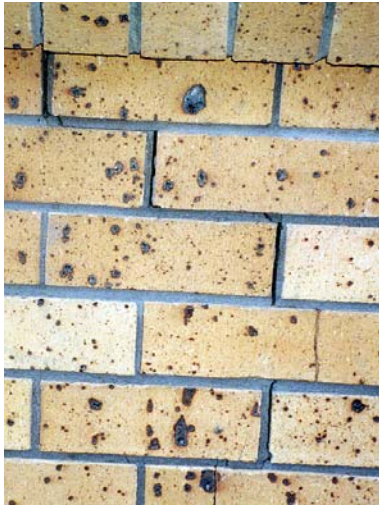
Figure 29g – Reference House R8 (Jewell) – diagonal brick crack

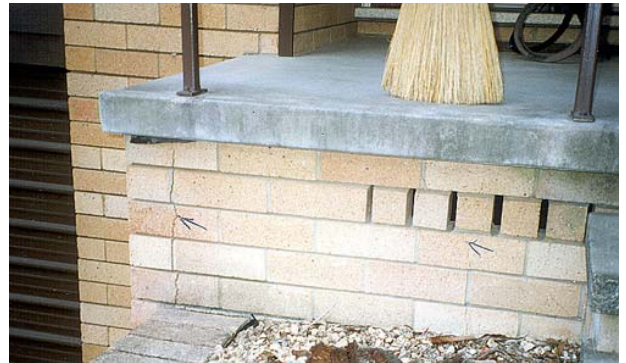
Figure 29h – Reference House R4 (Fennell Bay 2) – foundation brick crack

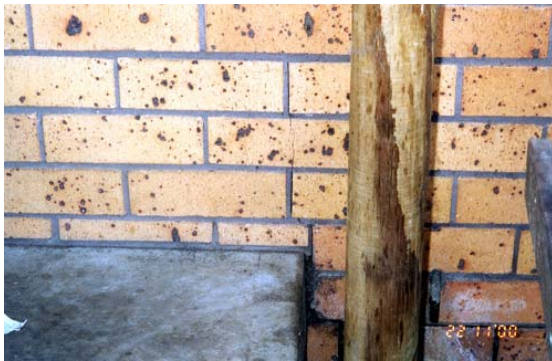
Figure 29i – Reference House R7 (Cessnock) – vertical brick crack

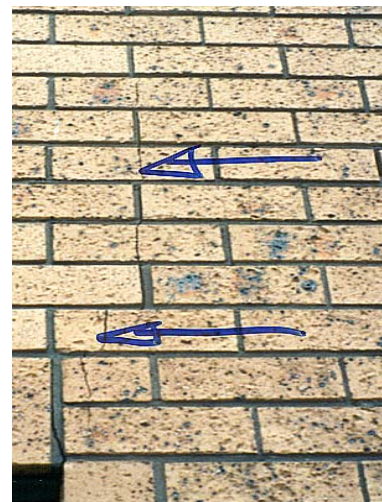
Figure 29j – Reference House R8 (Jewell) – vertical crack brick

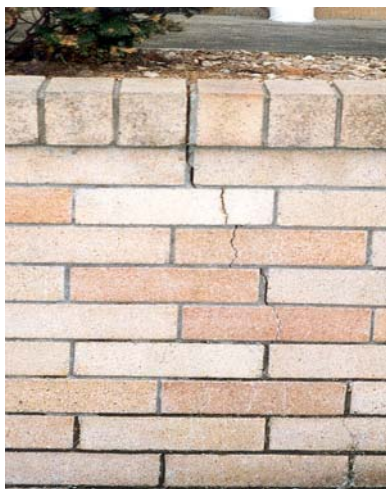
Figure 29k – Reference House R4 (Fennell Bay 2) – vertical crack brick

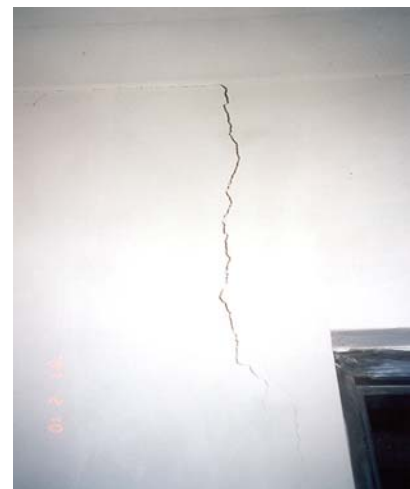
Figure 29l – Reference House R8 (Jewell) – rendered masonry crack

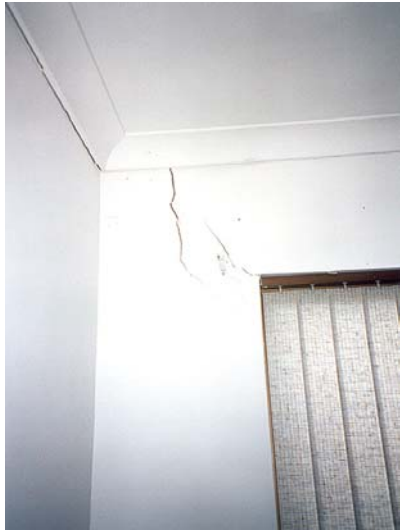
Figure 29m – Reference House R8 (Jewell) – lining and cornice crack

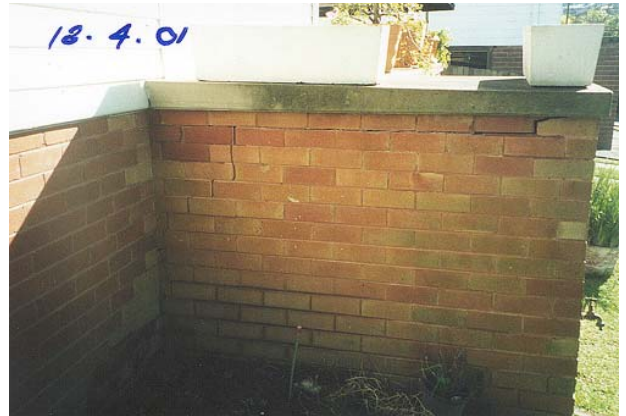
Figure 29n – Reference House R6 (Kotara) – rotated corner

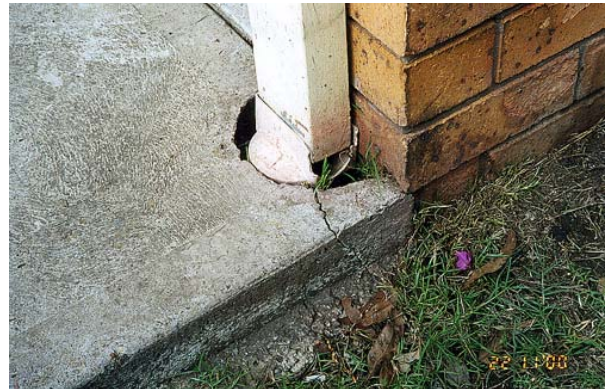
Figure 29p – Reference House R7 (Cessnock) – relative movement and slab crack

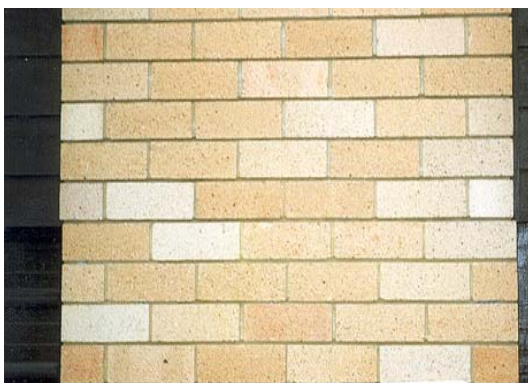
Figure 29q – Reference House R4 (Fennell Bay 2) – shear movement

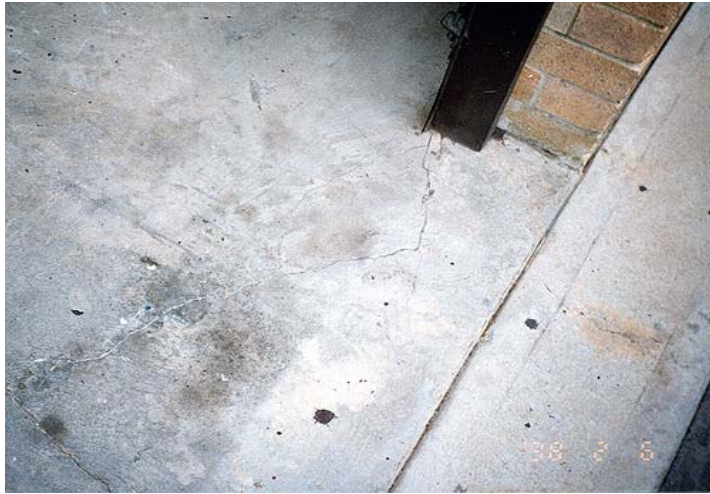
Figure 29s – Reference House R4 (Fennell Bay 2) – slab crack

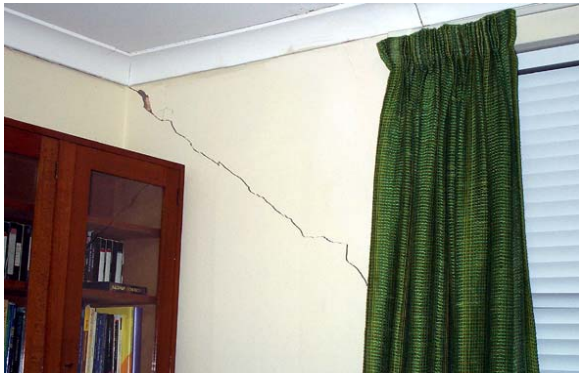
Figure 29t

Figures 29t-v – 25-30 year old solid masonry, single storey house with rendered plaster at New Lampton
