Response of Historic Structure to Long-term Environmental and Construction Vibration Effects

ABSTRACT

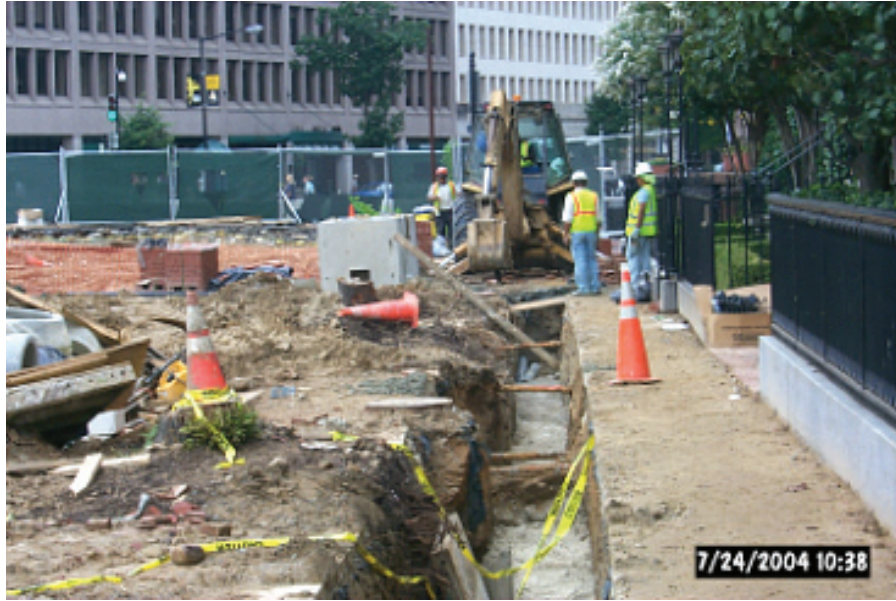
FIG. 1: Construction activities nearest Blair House showing trench excavation within several meters of Blair House. (Alvarez, 2004)

Figure 1 is a photograph that is representative of the closest construction activity during the period of observation. Reconstruction activities during the period of observation included back hoe excavation of a 1-meter wide trench several meters from the south façade on which crack sensors were affixed. The photo shows the small back hoe employed for the excavation of junction boxes in the trench immediately in front of the Blair House. Excavation was followed by vibratory placement of the back fill to prepare the surface for the walkway.

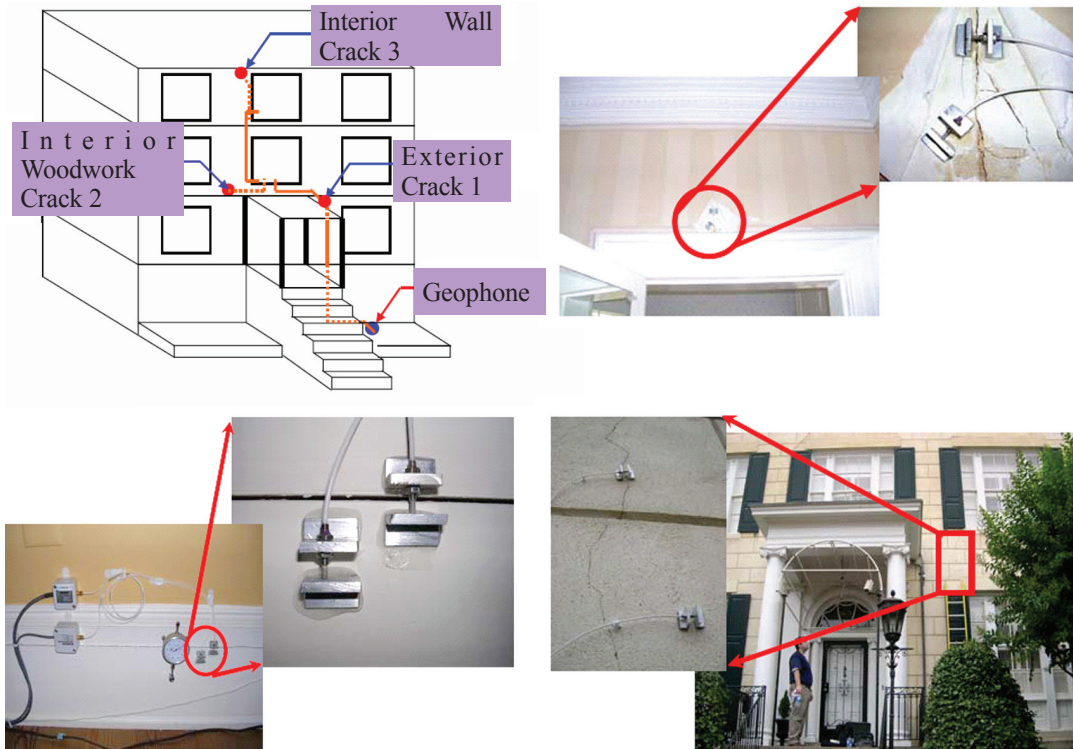
Instrumented cracks shown in Figure 2 were located in three different materials to cover the wide variety of concerns. Two interior cracks were monitored: the joint between two components of the floor molding on the 2nd floor (crack 2) and crack above a door frame on the 3rd floor (crack 3). The second floor floor molding joint is not really a crack, but

FIG. 2: Crack sensors on Blair House. Clockwise from upper left: Location relative to exterior, interior doorway crack (3), exterior stucco crack (1), molding lap joint (2).

was a concern because of the independent movement of the two components, which would normally move together. The third floor crack is in the plaster lath wall behind the wall paper, which was carefully peeled back for mounting. The exterior crack (crack 1) is located just above the portico in the stucco just the façade closest to Pennsylvania Ave., which faces south in the direct sunlight.

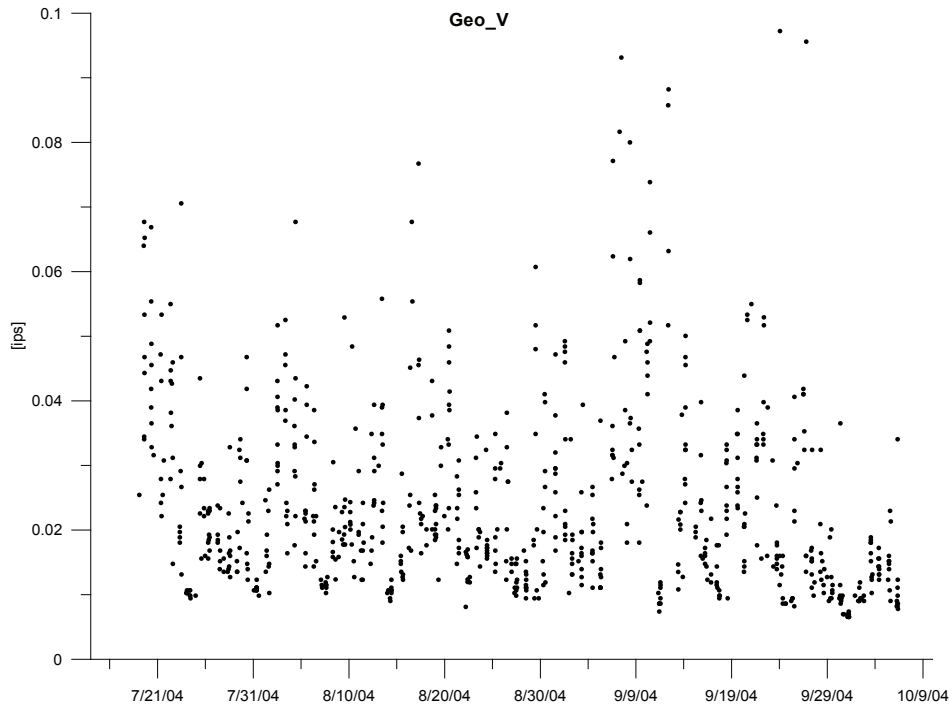
FIG. 3: Vibration environment during the project shown by the plot by date of the highest single axis peak particle velocity (PPV). (1 ips = 1 in. per second = 25.4 mm/s).

The general vibratory environment is shown by the time history of the peaks shown in Figure 3. These peak data were obtained by recording all channels continuously at a 1000 Hz for 60 seconds (60,000 points), but saving only the peak value. Then another minute or 60,000 point recording period begins and so on and so forth. This triggering mode was developed to capture vibratory roller data, but the hand tampers were employed instead and the approach was useful for recording that data instead. Only the peak particle velocities for the ten largest events for each day are reported in Figure 4. Most PPV's fall below 2.54 mm/s (0.1 ips) with only a few larger events. These construction events were separated from noise spikes, which were not reported (Balliot, 2004).

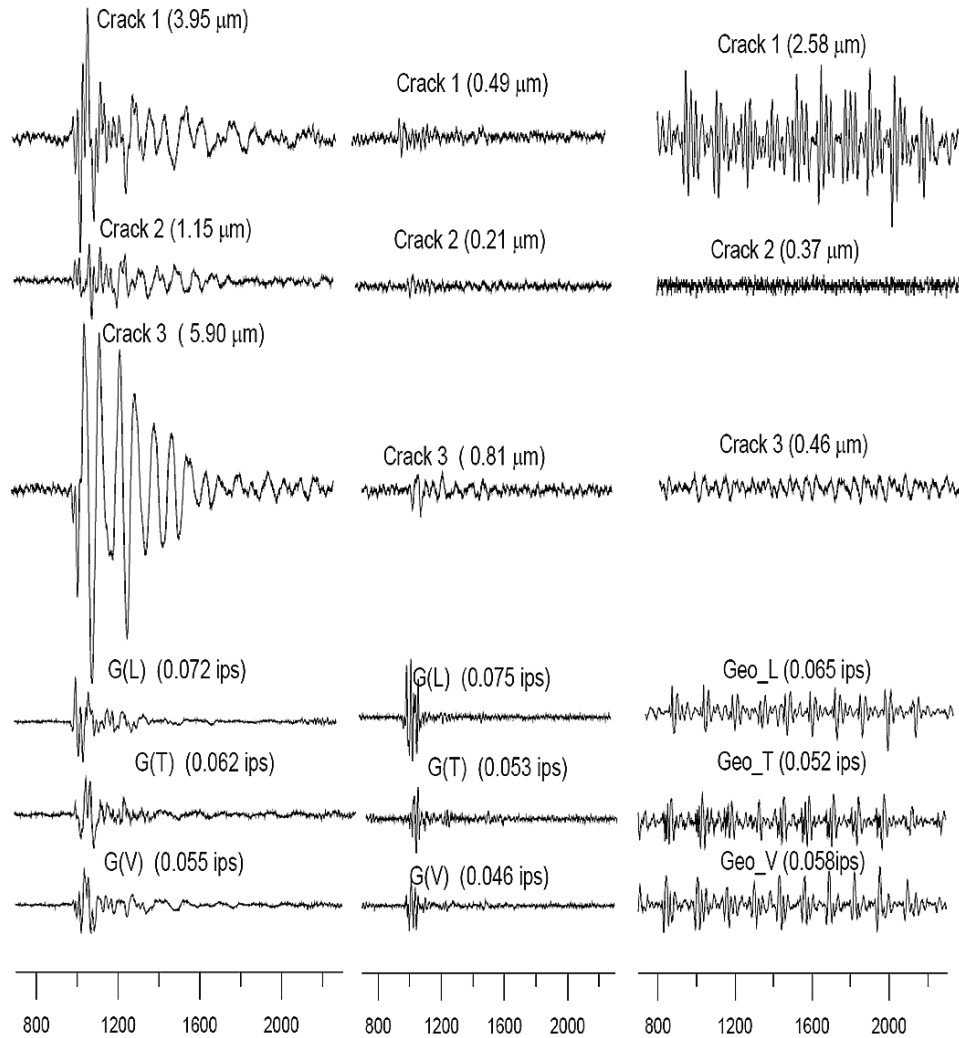
FIG. 4: Time histories of crack responses (upper 3) and ground motion components (lower 3) for three constructions events: 3 and 9 (left) produced by back hoe operation and 22 (right) produced by motorized tamper.

Time histories of ground motions and crack response from three of the 30 vibratory events 3, 9 and 22 are compared in Figure 4. Events 3 and 9 were produced by backhoe

Event 3 produced the largest response of all three cracks. This high response is a result of the lower frequency of the ground motion. Event 9 involved the same PPV, yet produced only 1/8th the response. Response spectra of the longitudinal motions of the two events (Baillot, 2004) show that the dominant excitation frequency of event 3 is 12.5 Hz whereas that for event 9 is some 41 Hz. As discussed by Dowding (1996), motions at the natural frequencies of structural components will produce the greatest response. Many walls and floors have frequencies in the 10 to 20 Hz range. Thus ground motions whose dominant frequency is near 12 Hz (event 3) would be expected to produce greater structural response than ground motions whose dominant frequency exceeds 40 Hz (event 9).

Event 22 was produced by tamping and was one of 99 events recorded that morning. Crack 1's response was the greatest for this event and was consistently the greatest of all three of the cracks for these repetitive motion events. Crack 2's response never exceeded the noise level. Crack 3's response was lower than that typically produced by back hoe activity.

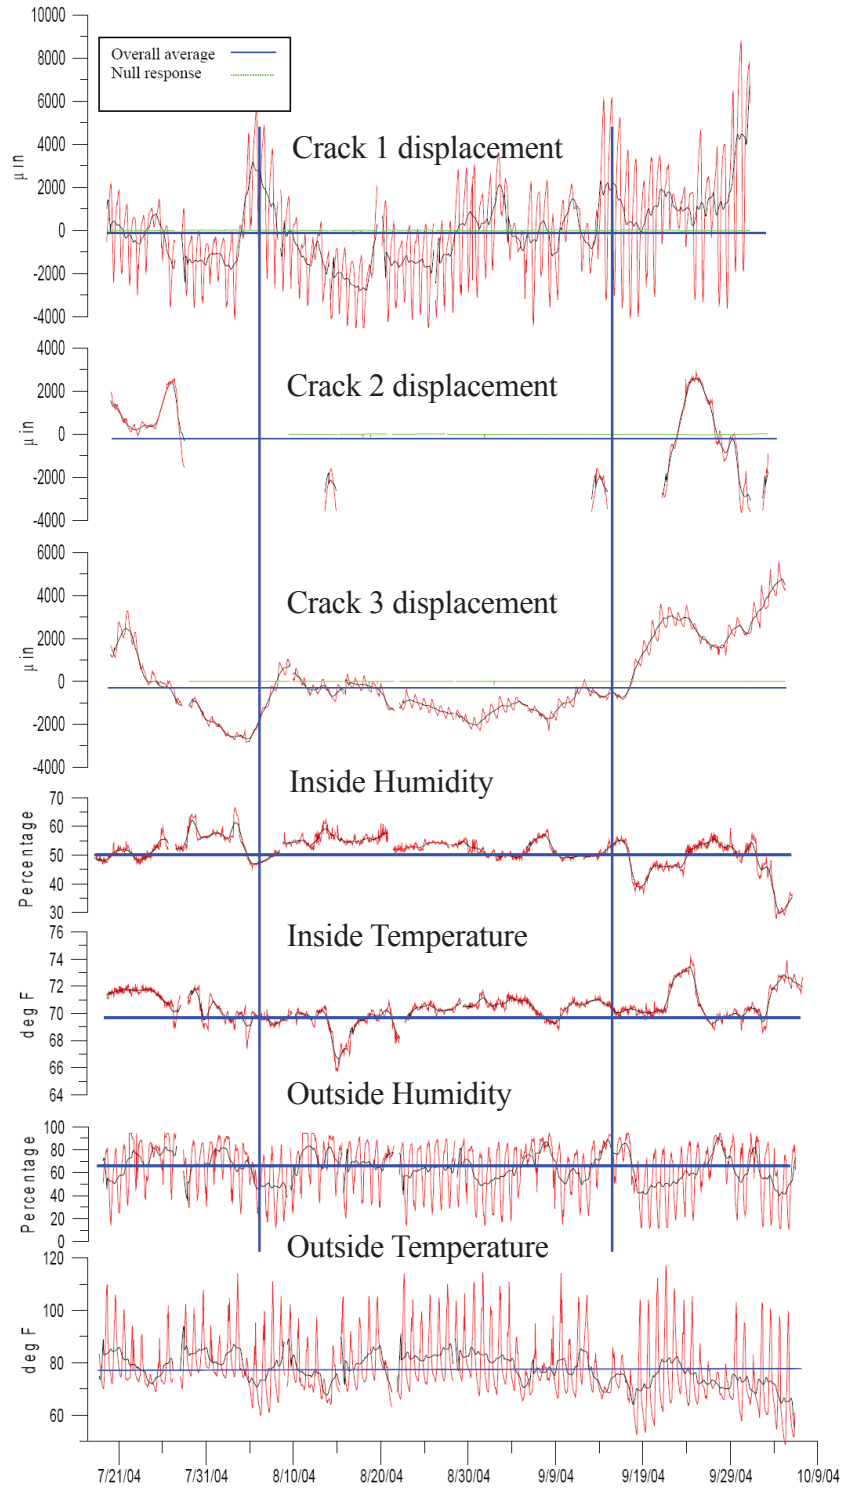
FIG. 5: Comparison of long-term crack responses (upper 3) with inside (middle 2) and outside (lower 2) changes in temperature and humidity showing responsiveness of cracks to climatological effects.

Crack 1 responds the most to daily temperature changes as it is located on the south facing façade, which is heated daily by direct sunlight. Thus there is considerable response to the direct insolation as would be expected. In addition there is a significant long-term response that is probably the result of the façade responding to long term changes in ex-

terior humidity and temperature as seen along the two vertical lines in Figure 5. While looking stone like, the façade is stucco applied over a wooden stud wall, which responds to changes to humidity.

Crack 2 is not really a crack but the joint between two pieces of floor molding. It responded the most to long term changes. In fact so much so that it went out of range. This change, at least $287 \mu \text{m}$ ($11,500 \mu \text{ in.}$) was confirmed by the dial gauge adjacent to the crack sensor. Since this joint was that between two separate pieces of molding, differences in grain orientation and surfaces to which they were affixed could explain this large response.

Crack 3 was located in plaster and lath above a doorway and was probably initiated by differential settlement of the structure, which is founded upon compressible soils. It also responded considerably to long term changes in humidity as shown by the dotted lines in the interior humidity and crack response on Figure 5. The interior humidity and temperature were moderated by air conditioning; however there were times when the system was overwhelmed by exterior conditions, workers opening windows, etc.

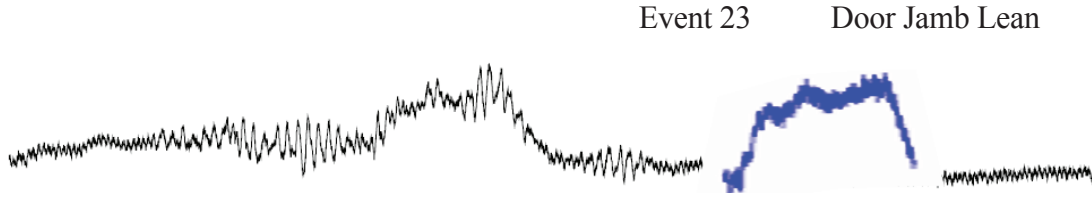
FIG. 6: Comparison of unusual, low frequency hump in the vibratory crack response time history (left) to that produced by leaning on door jamb (right) later determined to be result of workers inside structure.

Crack responses to deliberate occupant activities were recorded at 1000 samples per second in order to identify crack response time histories produced by human activity. The most interesting occupant response was first discovered during crack 3's response to tamping vibration as shown in Figure 6. The large hump also appeared at another time when there was no ground motion. The day this "mysterious" hump occurred coincided with the day repairs were made to the room to which the doorway lead. This discovery lead to the question, "how could repairs in the room itself generate this type of crack response?"

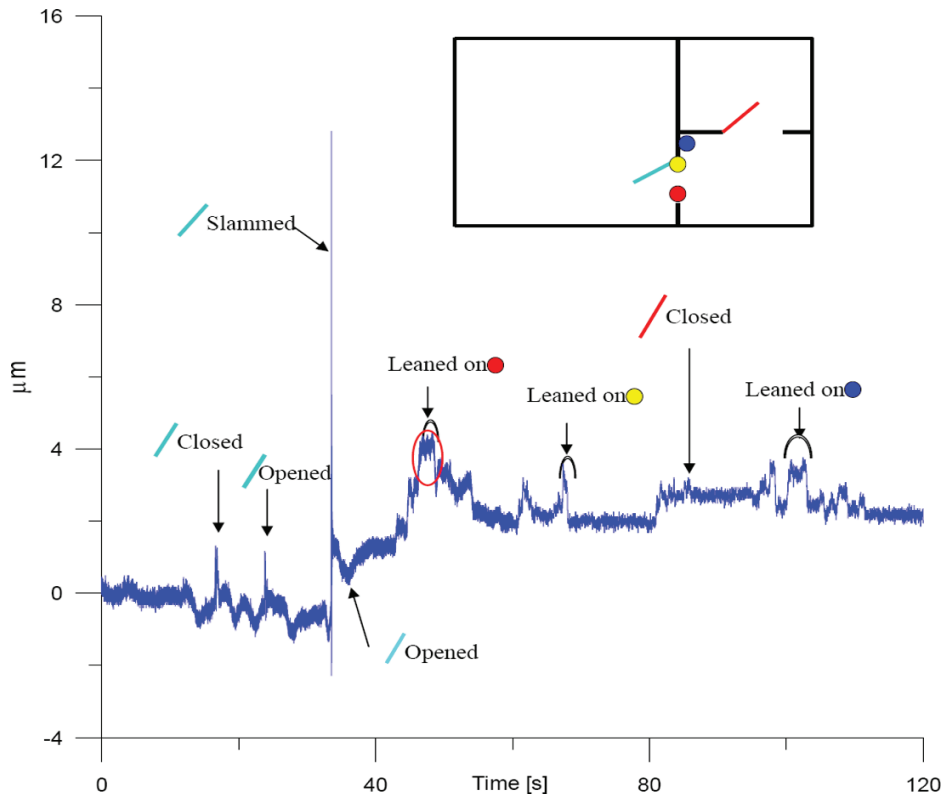
FIG. 7: Response of plaster and lath doorway crack (3) opening and closing, slamming and leaning on door jamb and wall to be compared with ground motion induced response in Fig. 6 ($39 \mu \text{ in.} = 1 \mu \text{m}$).

Results of a deliberate occupant test shown in Figure 7 revealed the mechanism for the hump response. The figure is a time history of crack response to activities involving the doorway, which included (from left to right) opening the door, leaning on the door frame (south then north) closing the door, and finally leaning on the wall. The encircled leaning response (1.2 μm) in Figure 7 is compared in Figure 6 with the mysterious hump (1.9 μm)

recorded with event 23. As can be seen with the similarity of response, the hump is most likely the result of someone leaning on the door frame. As would be expected slamming the door produced the greatest response.

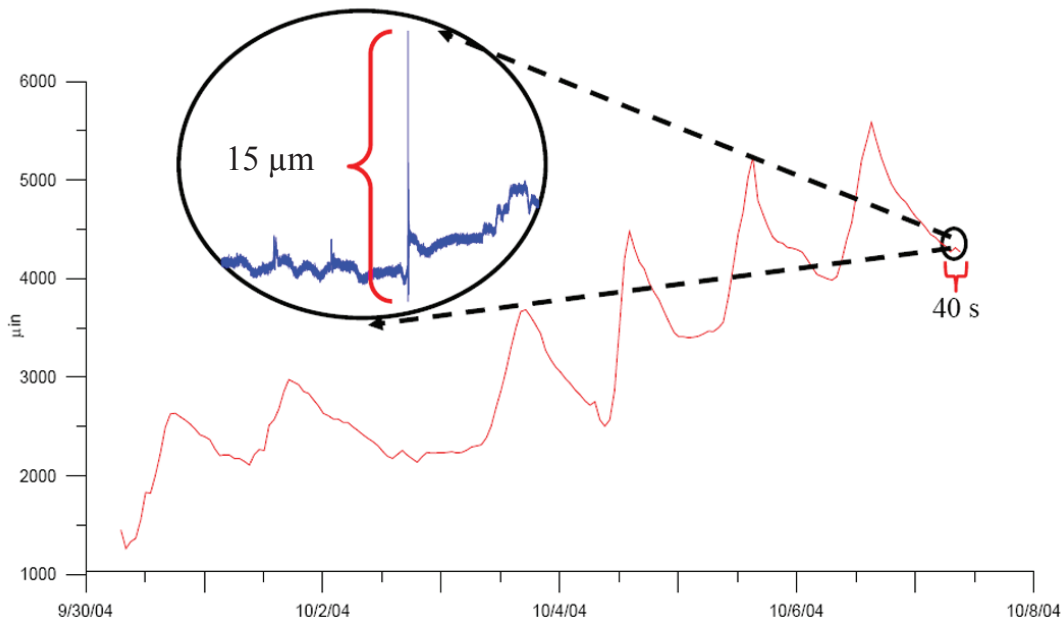
FIG. 8: Comparison of crack 3 response to slamming of door immediately below (in insert) to 8 days of long term climate induced change again showing high responsiveness of cracks to climatological effects (39 $\mu\text{ in.} = 1 \mu\text{m}$).

The enormity of the temperature-humidity responses is best demonstrated by the graphical comparison in Figure 8 of the door slam in the inset with a typical daily temperature induced response of crack 3. Some 8 days of long-term response is easily recognized by the daily cyclic temperature induced response. The inset is that of 40 seconds surrounding the door slam. Over the eight days a combination of temperature and humidity response produced some 100 μ m of response, while every day the trough to peak change was some 50 μ m. Finally, the door slam produced only 15 μ m of trough to peak response.

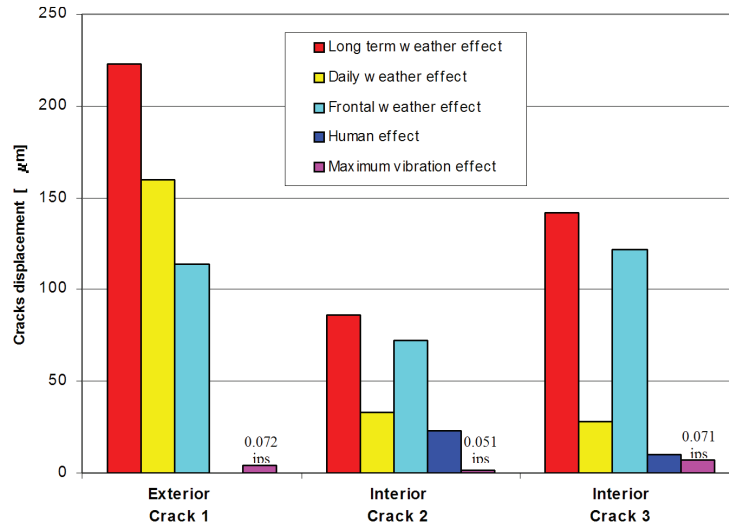
FIG. 9: Comparison of crack response to climatological (daily and long term) occupant (human) and maximum construction vibration induced events (39 μ in. = 1 μ m).

Vibratory, long-term, and occupant induced crack responses of all three cracks are compared as a bar graph in Figure 9. The bars for each crack are the maxima of (from left to right) of the long-term, daily, frontal, human (occupant) and vibration induced crack responses. In all three cases the long-term weather effect produces the greatest response, which is orders of magnitude greater than the vibration effects. The frontal weather effects are also an order of magnitude larger than the construction effect. In this plot the long term effect is the maximum excursion from the horizontal average of the 24 hour rolling average. Daily effect is the maximum excursion from the 24 rolling average curve. Frontal is the maximum excursion of the 24 hour average curve from the average of all the 24 hour averages (the horizontal line). Finally as discussed above, simply leaning on the door jamb produces greater crack response than vibratory motion.

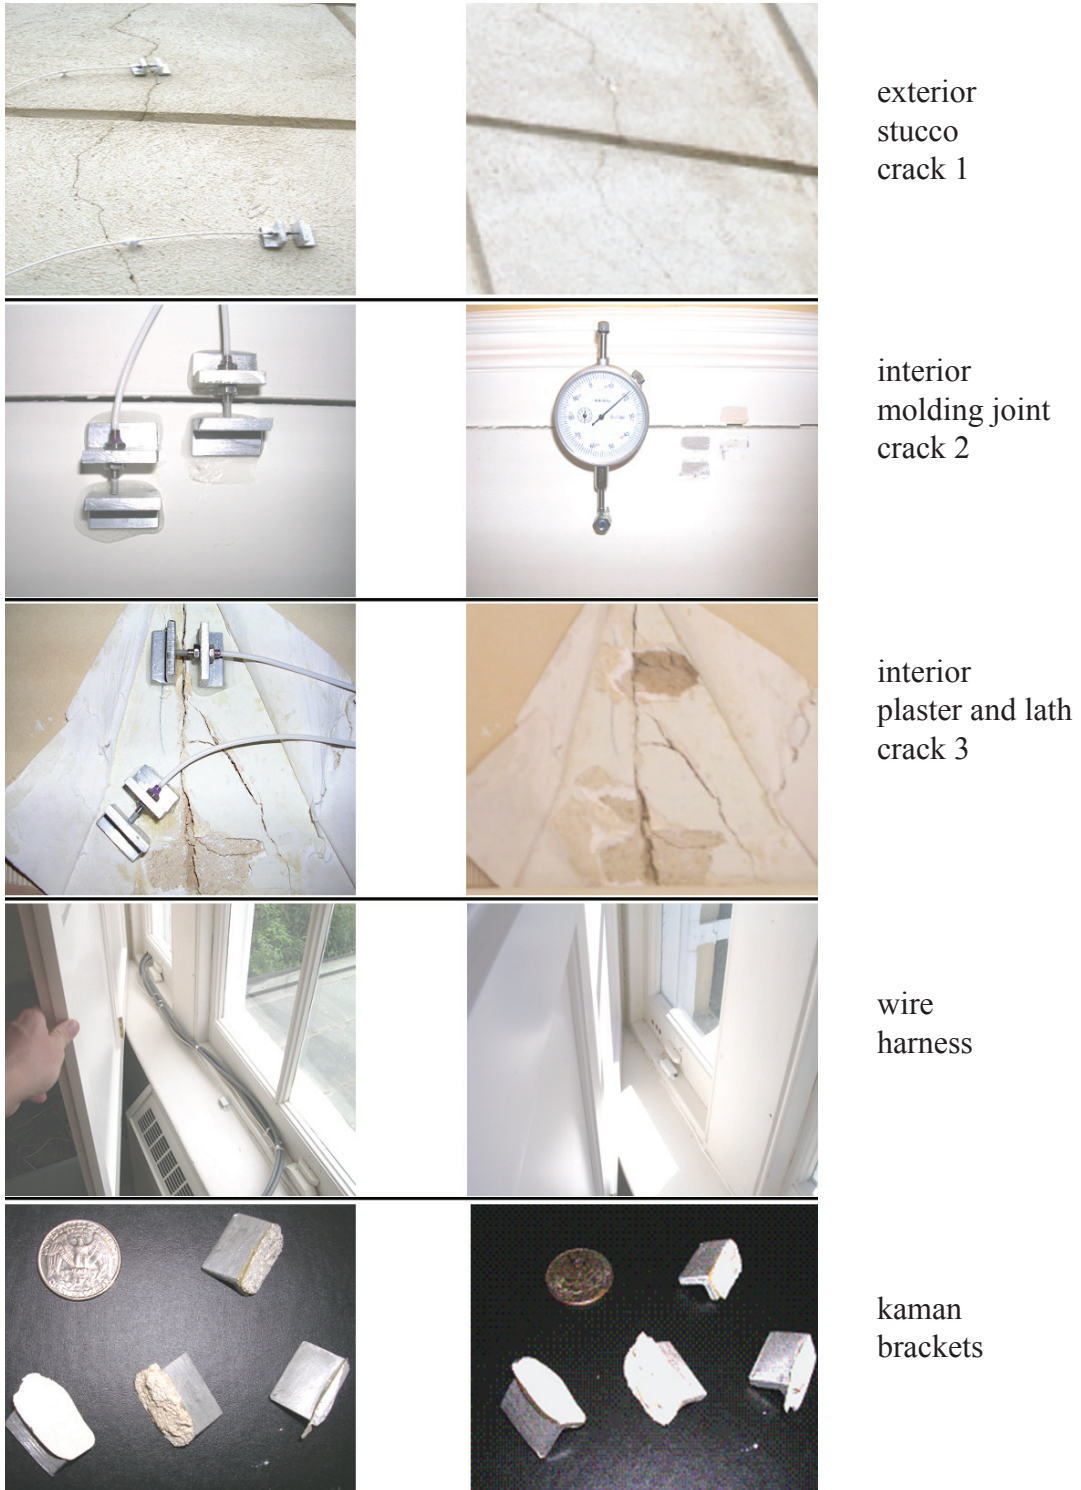
FIG. 10: Photographic comparison of in-place instrumentation (left) and post investigation conditions illustrate the small footprint (bottom) of Kaman micrometer displacement sensors.

To demonstrate the ease of restoring the attachment locations of the sensors, before and after photographs were taken of the sensor attachments. A collage of these comparisons is shown in Figure 9. The small foot print of the brackets minimizes repair. Stucco almost needs no repair. Wood requires only touch up painting. Removal of the epoxied brackets from the plaster left small, shallow divots less than the size of a quarter. Wire runs required only one penetration of a window by drilling holes through the window frame, which can be filled with plastic wood or the equivalent.
