CONST-VIBRATIONS Listserve Newsletter # 2

Details of older, distressed structures whose cosmetic cracking define the lower bound of the Z curve.

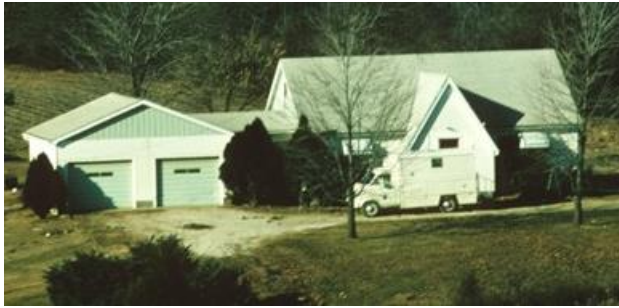
Additional illustrations and photographs of structures not found in USBM RI 8507, whose data points are found on the lower bound of the plaster and lath "Z" curve. From top left proceeding clockwise, Str 20 (drywall, other 3 are plaster and lath), Str 27 (inset showing precarious floor support), Str 21 showing proximity to mining, Str 51's wall cracks visible after stripping wall paper.

Unlike the other three structures, the interior walls of structure 20 (upper left) were covered with gypsum drywall. This house was about 20 years old. At the time of the appearance of the cosmetic crack, there a few other cracks in the drywall, mainly associated with the widows and doorways (Corser,1979)

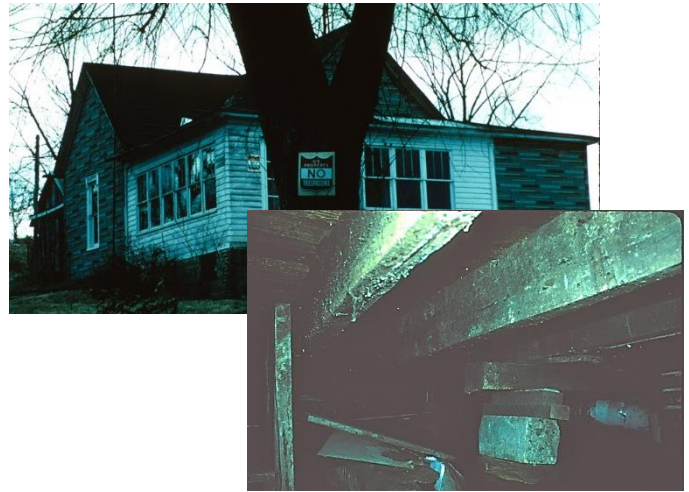
The three plaster and lath structures were old and distressed. Structure 27 (upper right) was approximately 50 years old and in need of moderate to extensive repair. Many of the interior walls were cracked. Improper support of one of the floors by the tilted and poorly founded rock shown in the inset demonstrates the distressed condition of the structure. Structure 21 (bottom right) was some 50 to 60 years old and abandoned. Interior walls were significantly cracked to the point where some of the

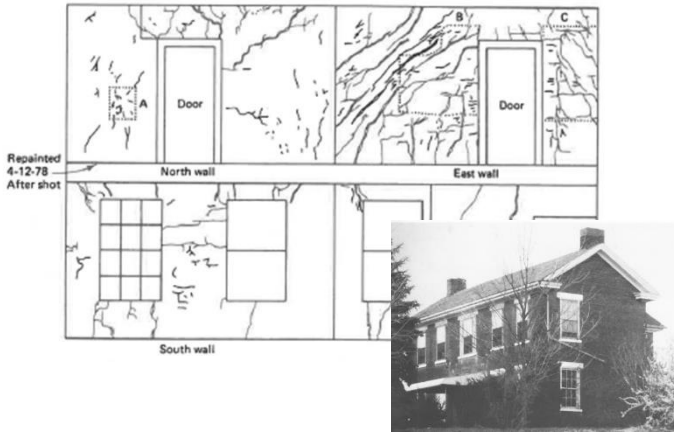
plaster was dislodged. Structure 51 (lower left) was some 150 years old and located above a shallow coal mine at a depth of 250 to 300 feet. Extensive cracking of the walls is illustrated in the figure.

Shots 173, 174, and 175 caused cracking, but 167 did not. Observed walls in the southwest bedroom were stripped of all wall covering and inspected carefully before and after each blast. With respect to the crack pattern in Figure 9-4, inspection after shot 173 showed

Nothing very significant. Test area A's few cracks (in Figure 9-4) are more evident. A few extensions and connections in area B. One new crack in B.

New cracks in area A and preexisting ones more evident. Nothing new in other areas.

"major" cracking in north and south walls—"major" diagonal crack through new paint on north wall, connecting hairline cracks existing previously, and widening considerably. Crack over door is quite wide. Previous condition not known. Very light horizontal crack near door. Nothing significant on east wall. New and wider cracks on south wall near window. Horizontal cracks between windows. Crack below window on west wall. Quite evident crack widths measured. Cement block addition developed a vertical crack through three blocks lower northeast corner east wall through mortar and block.
