# **Instrumental Detection of a Climatologically-Induced Cosmetic Crack in Wall Covering**

**Charles Dowding, Dept. of Civil & Environmental Engineering, Northwestern University  
Justin Lueker, Ebert & Baumann, Washington, DC  
Pierre-Alexandre Abeel, Subsea 7, Houston TX**

## **Abstract**

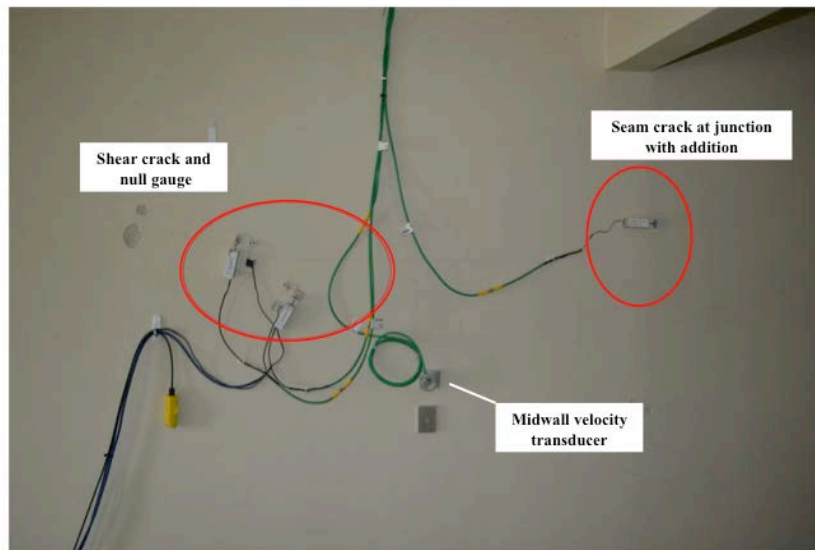
Gauges are shown in context in the photograph of the south wall in Figure 2 and in detail in Figure 3. Two LVDTs (rectangular gauges) were placed across a shear and seam crack and a third was placed on the wall as a null to track wall and gauge response. Also shown are string potentiometers (small square gauges) employed in a wireless system (Dowding, 2011) and the midwall velocity transducer.

**Figure 2. Context of crack observation in south-facing 1<sup>st</sup> floor wall; shear crack gauge and null left, seam crack gauge on right at junction of addition shown by overhead beam.**

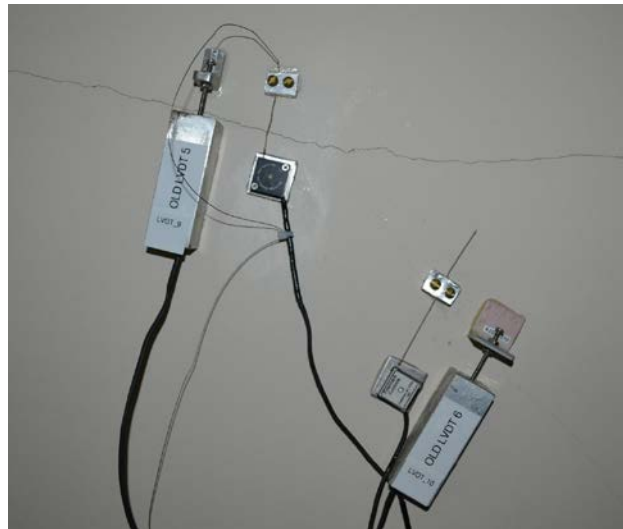
Figure 3 shows the specific area that cracked with the LVDT and potentiometer in position across the shear crack (upper) and on an uncracked section (lower) to serve as null gauges. At the time of the crack the potentiometer was not in service. The LVDT and potentiometer across the ceiling crack are shown in Figure 4.

**Figure 3. Details of the shear crack and crack gauges (LVDT and potentiometer) and null gauge before appearance of the crack.**

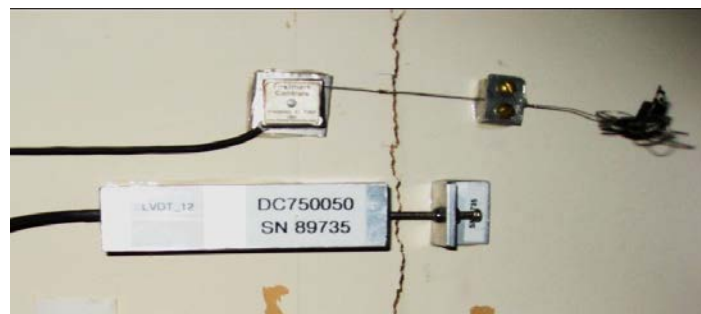
**Figure 4. Details of the ceiling crack and crack gauges (LVDT and potentiometer).**

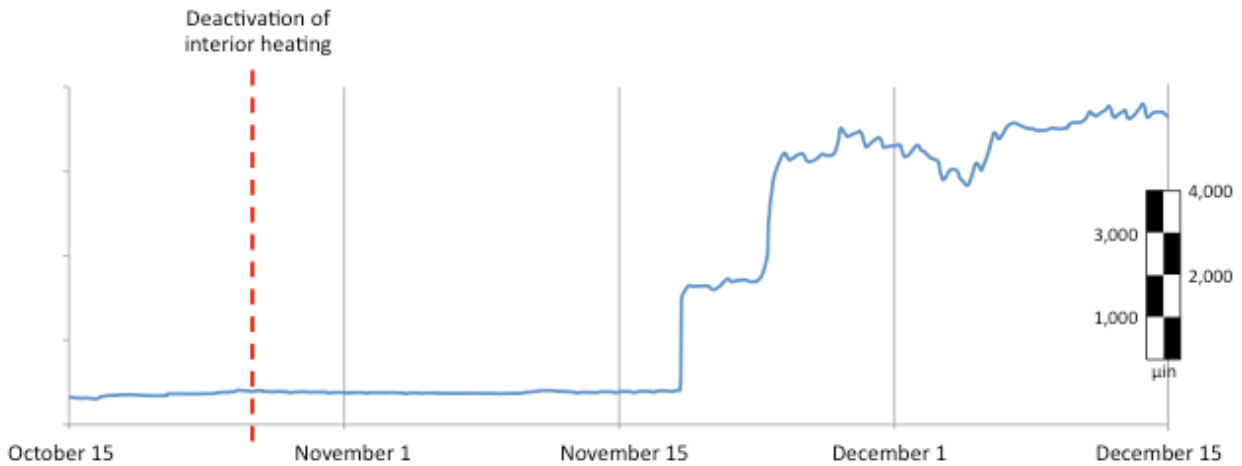
After more than two years of no response, a large step was detected by the null gauge between November 19<sup>th</sup>-20<sup>th</sup>, 2012. The data that were gathered indicated that it might have spanned a crack, as shown in Figure 6. Proof of the existence of a new crack was found during decommissioning of the equipment at the test site, as shown in Figure 7. This was the first detectable activity occurring in the null gauge since installation more than two years prior.

**Figure 6. Null gauge response between November 15<sup>th</sup>-December 15<sup>th</sup>, 2012. Deactivation of interior heating sometime around October 25<sup>th</sup> indicated by a dotted line, and subsequent response in null gauge between November 19<sup>th</sup>-20<sup>th</sup> is shown in blue.**

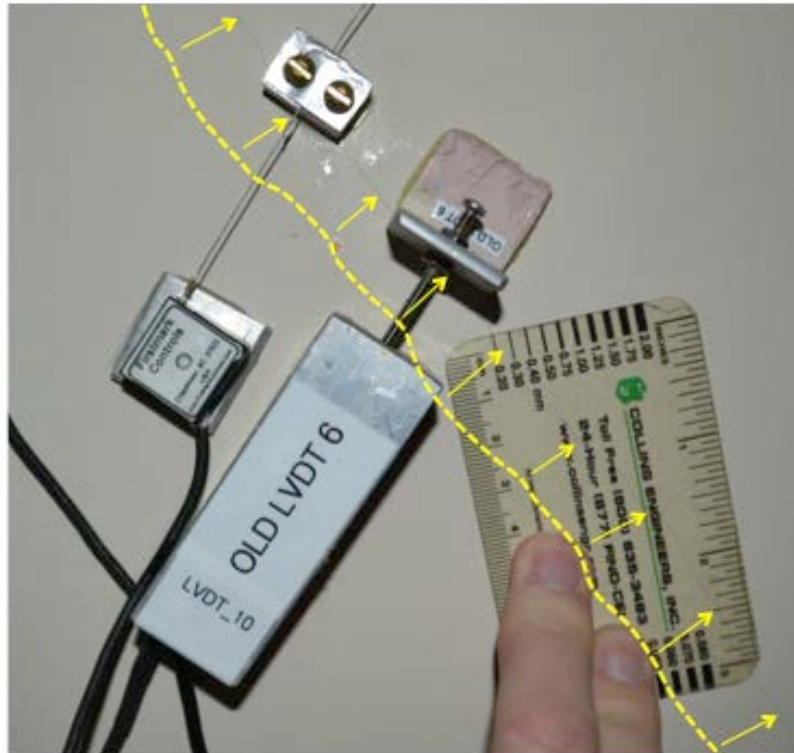
**Figure 7: Null gauge with arrows pointing to the visible crack and an offset dotted line indicating the crack contour. The crack gauge shows an approximate crack width of 0.20 mm.**

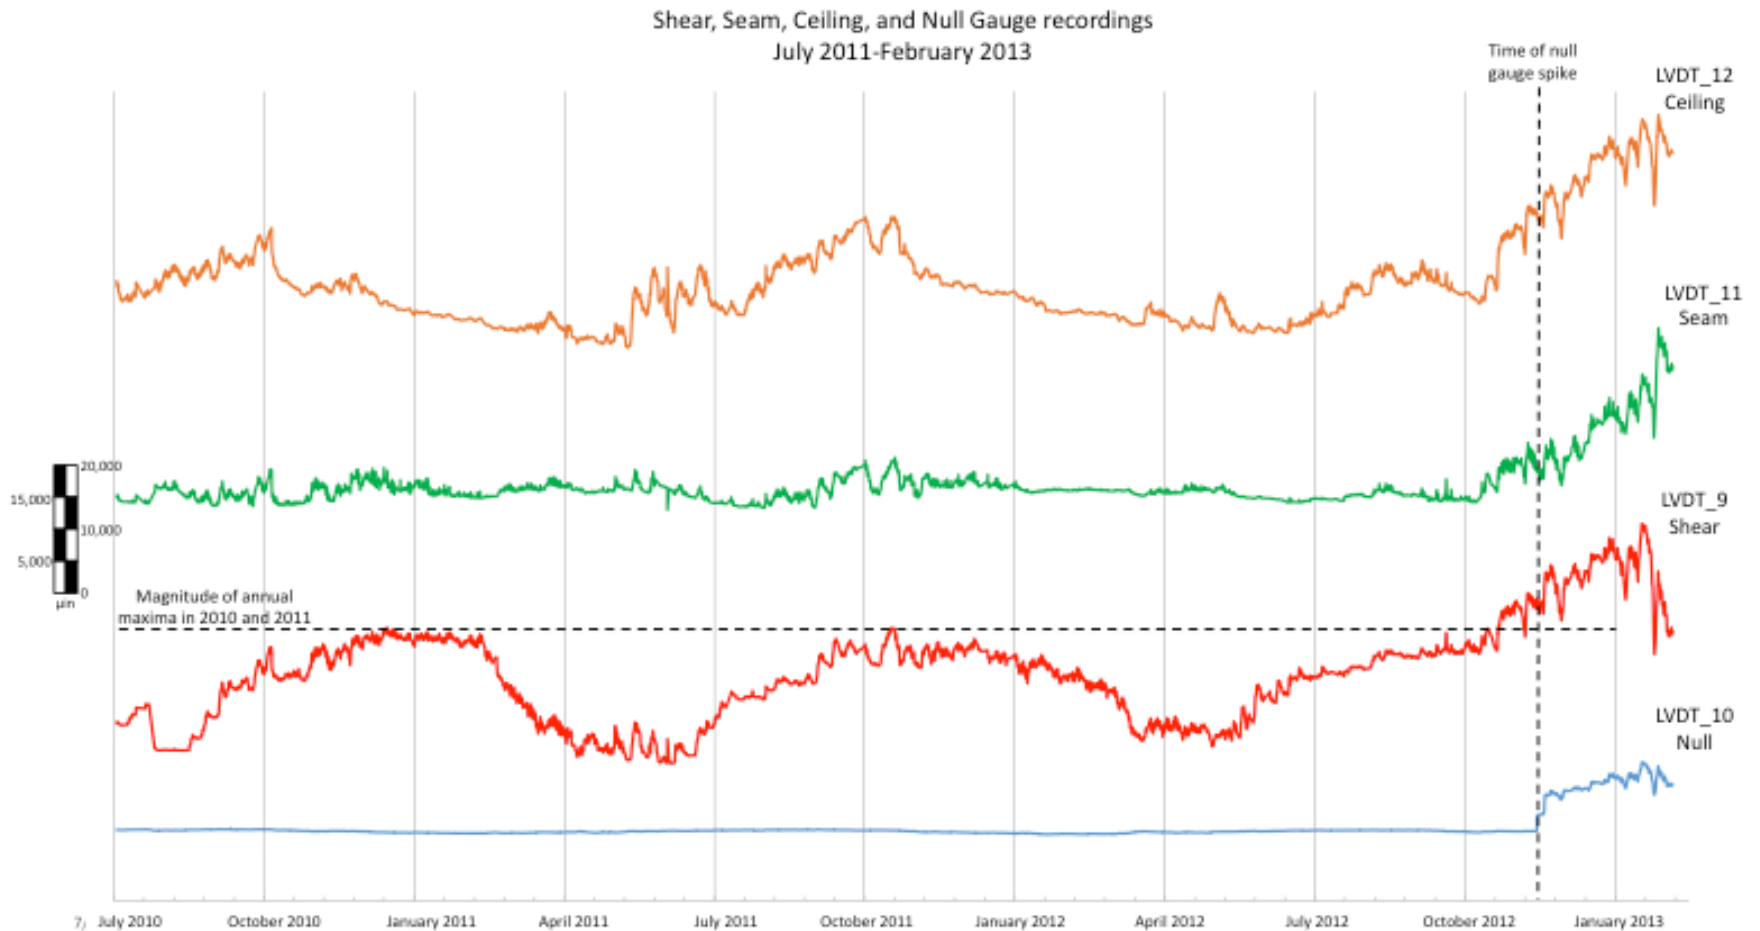
Figure 8 compares the response of the null gauge with long-term response of shear, seam, and ceiling cracks, respectively. Between July 2010-July 2012 there appears to be an annual cycle of crack response magnitude. This cyclic pattern is especially pronounced in the shear crack, which is nearest to the new crack on the instrumented wall and whose time history is documented in Figure 8.

After October of 2012, there is a large aberration from the previous cyclic responses of all three cracks as well as the null gauge. The responses of these three cracks exceed those recorded over the previous two years around the same time that the null gauge detected activity. This can be seen near the intersection of the dotted lines in Figure 8. This exceedance was not small; as shown by comparison with the past annual peaks (indicated by the horizontal line), the exceedance was some 20% to 30% larger, or 4000  $\mu\text{in}$ -6000  $\mu\text{in}$ .

**Figure 8. Timing of crack formation through uncracked wall beneath null gauge. Precise instant of null gauge activity is marked by a vertical dotted line. Previous cyclic maxima from 2010 and 2011 is marked by a horizontal dotted line.**

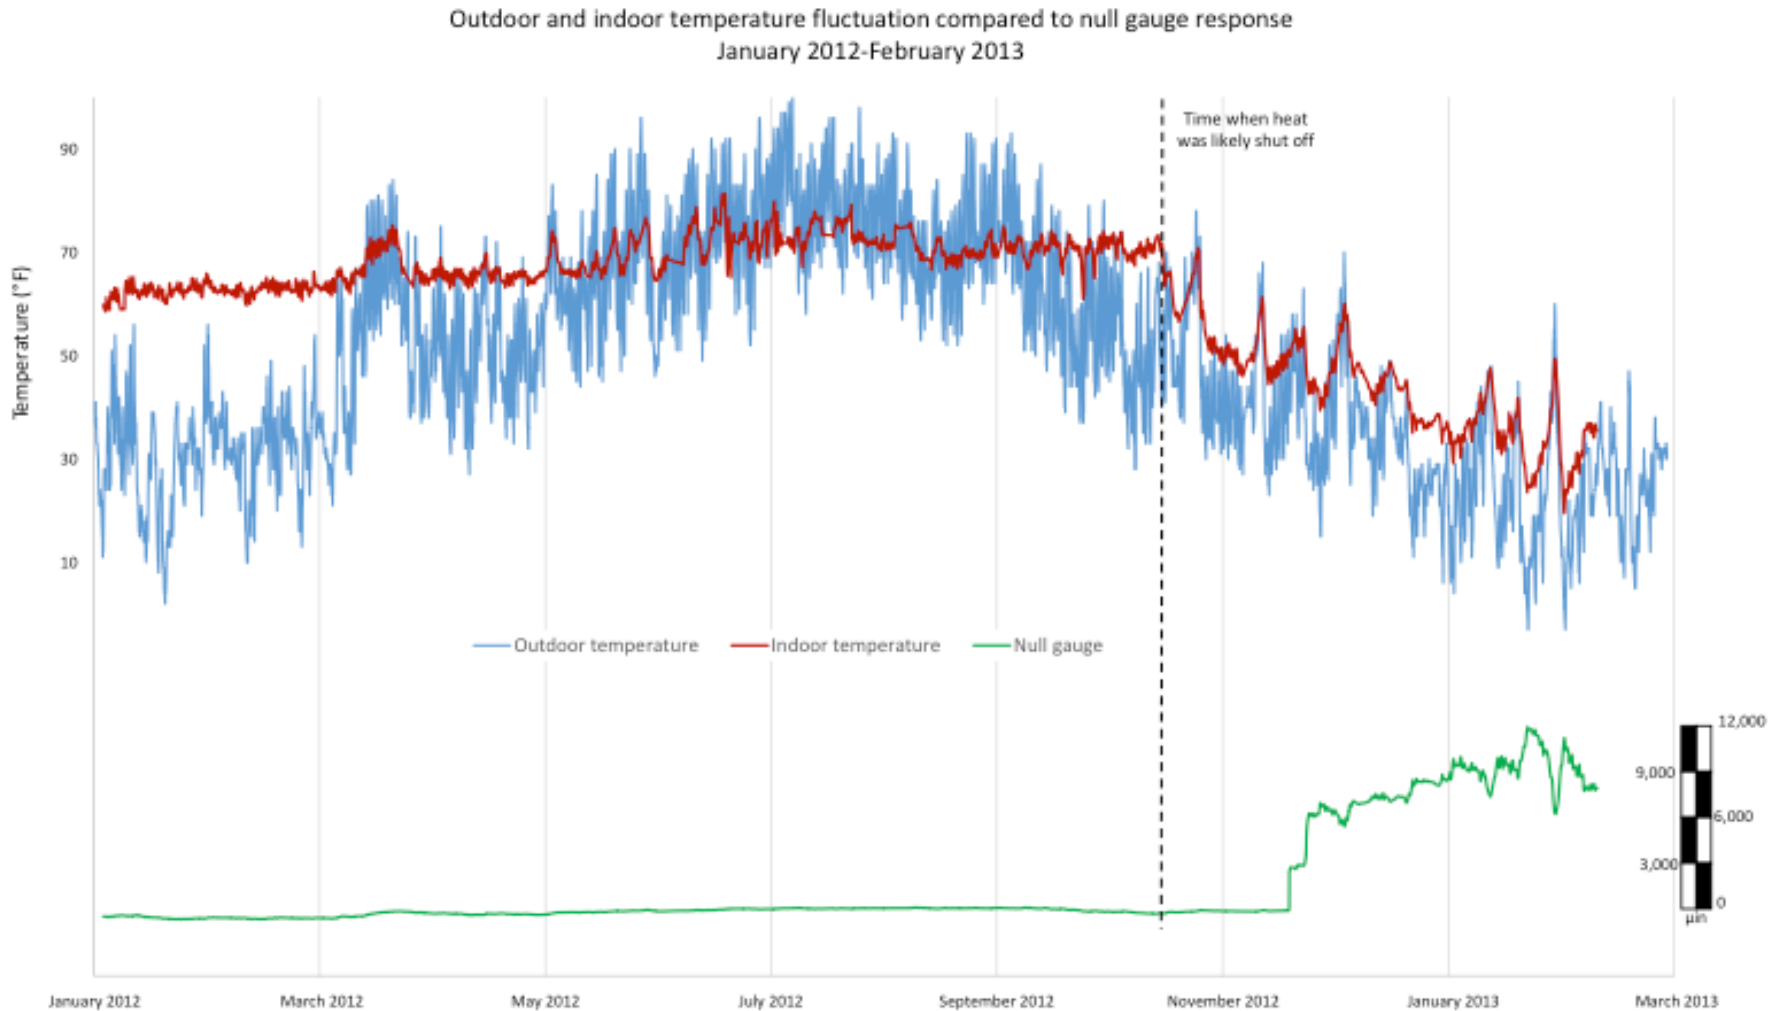
The interior temperature data in Figure 9 show that sometime in October of 2012, there was a dramatic drop in temperature inside the house. The drop resulted from the deactivation of the heating system in the house to make way for its demolition to allow for the quarry's southerly expansion. The relatively constant temperature observed in the house between January-October 2012 was replaced with temperature that equaled outdoor temperature and matched its daily fluctuations. Not long thereafter, the aforementioned aberration from previous cyclic responses occurred and the sudden response in the null gauge was detected. This timing points to the likely relationship between interior temperature and the formation of the null gauge crack.

As shown in Figure 9, some time passed between the deactivation of interior heating and the crack response across the null gauge. This time lag is consistent with the notion that the interior walls (and accordingly, the pre-existing cracks being tested) must undergo some level of temperature-induced distortion before a new crack can form.

**Figure 9. Comparison of outdoor and indoor temperature fluctuation and null gauge response between January 2012-February 2013. The instant of interior heat deactivation is shown with a dotted line. Outdoor temperature data comes from climate records at the Dekalb Municipal Airport, roughly 8 miles (13 km) to the south.**
