APPENDIX NF

Naples, Florida (2007-2008) Quarry Blasting

Kosnik 2008

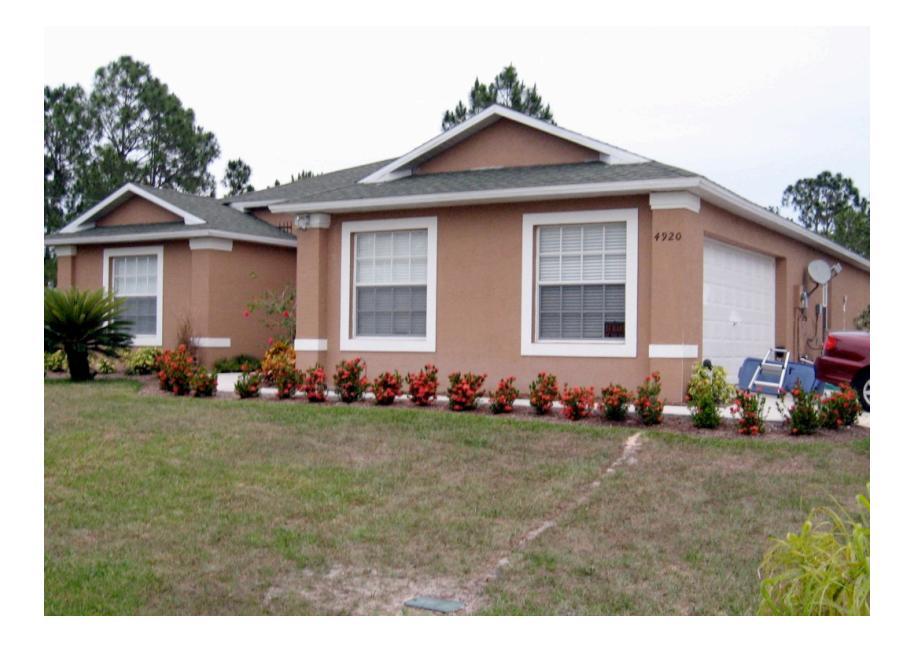
Figure NF-1 - Photograph of the one-story house with 3 instrumented cracks

The exterior wall of the slab on grade CMU one-story house was covered with stucco as shown in Figure NF-1. Two exterior cracks were monitored on the south side of the house (stucco), and one was monitored inside the garage (drywall). The locations of these sensors are shown in Figures NF-2 and NF-3. Figure NF-4 shows vibratory time histories of crack displacements in all three cracks compared with longitudinal, vertical, transverse ground motions from an

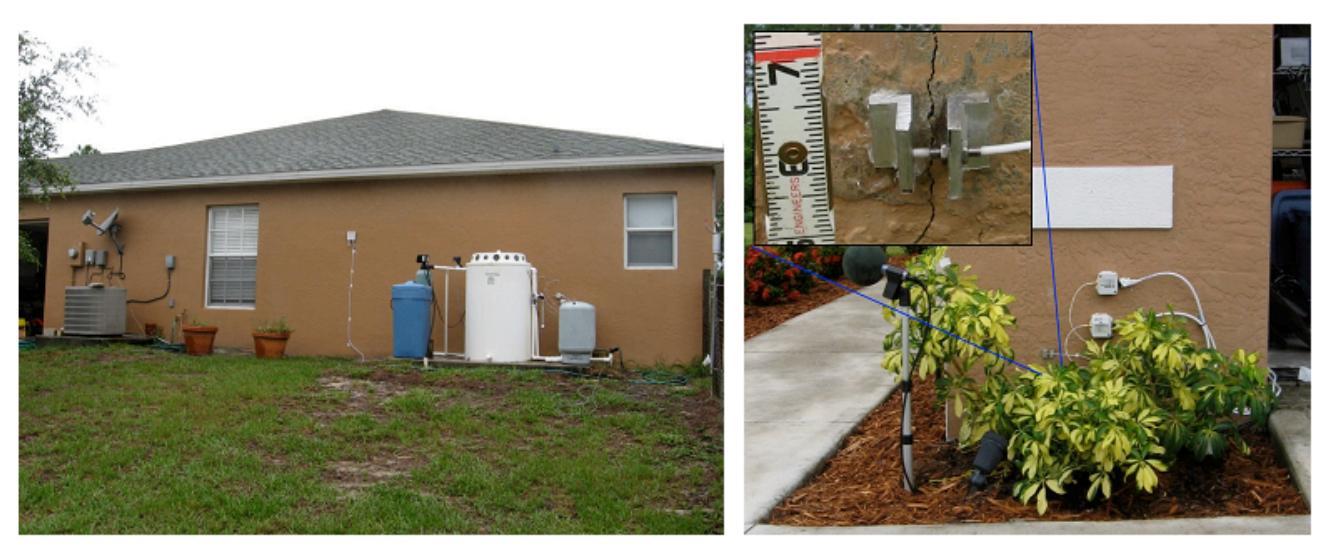
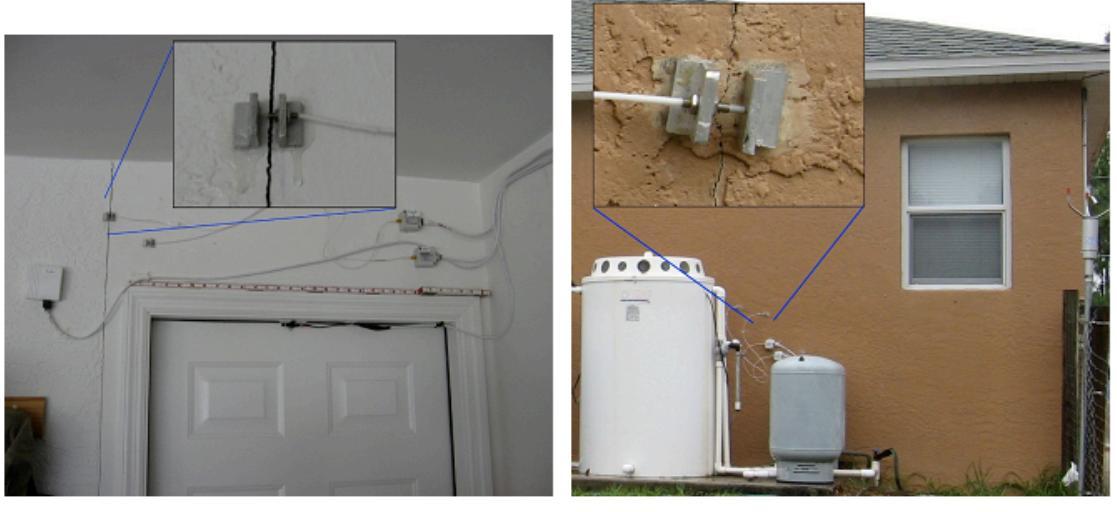
(a) South face of house

(b) Crack 5

(c) Crack 7

(d) Crack 9

Figure NF-3 - General locations of crack displacement transducers with insets showing details of cracks and sensors

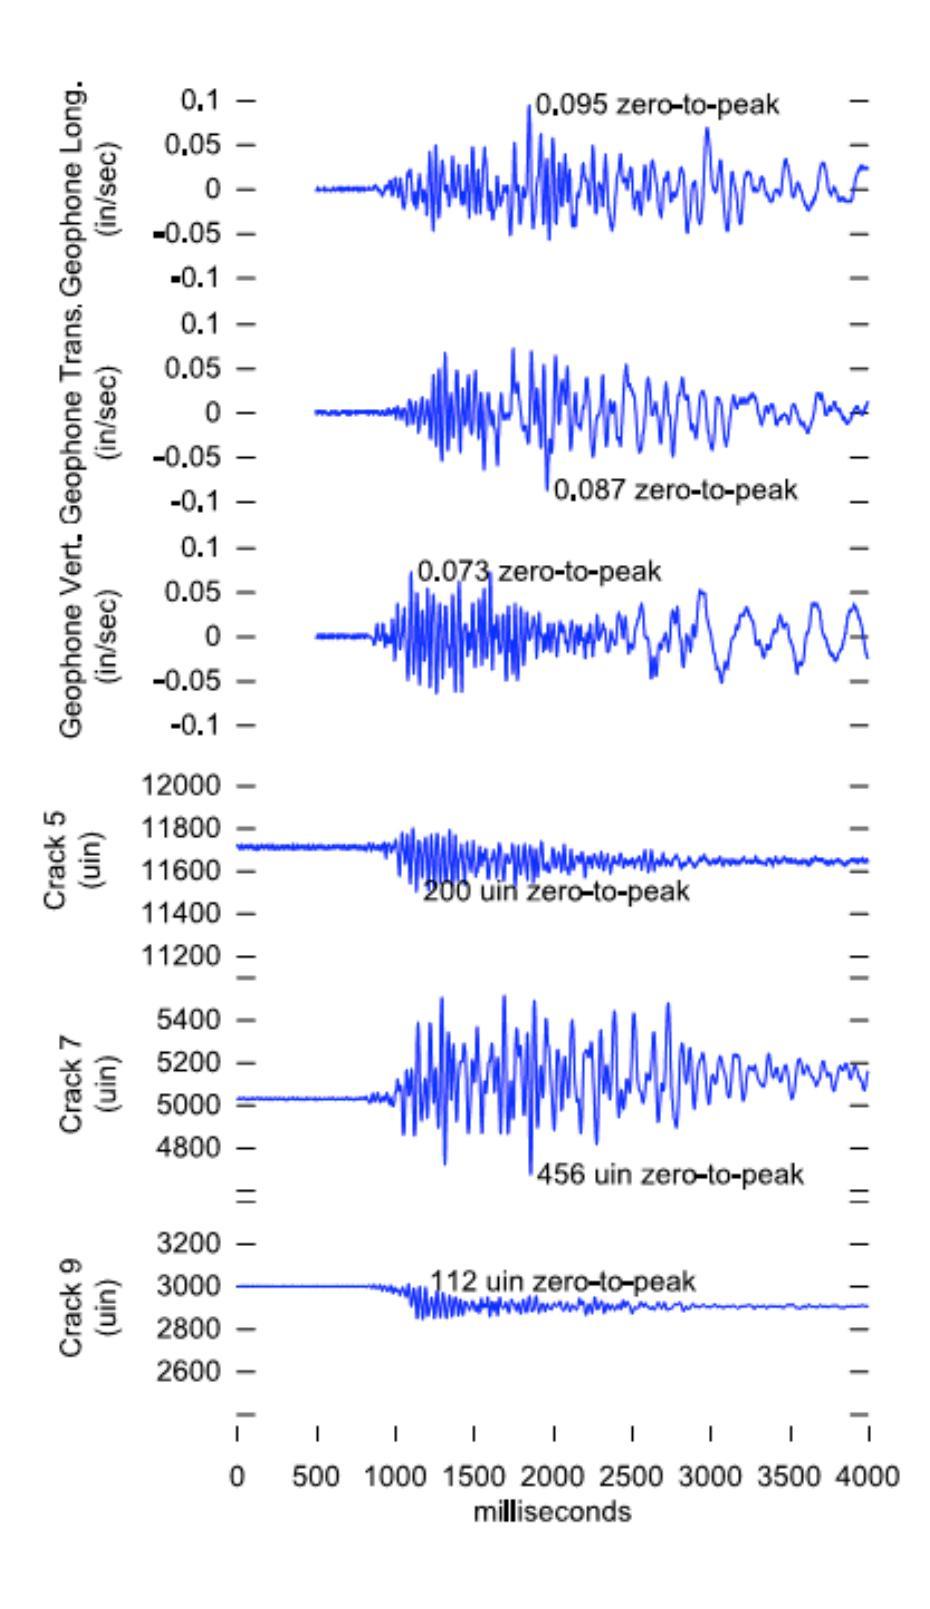
8/21 blast. The ground motions from this blast produced the largest crack response of the study period. The interior drywall crack displaced 11.6μ m (456 μ -in).

Figure NF-4 - Comparative Time History Plots for 8/21 blast

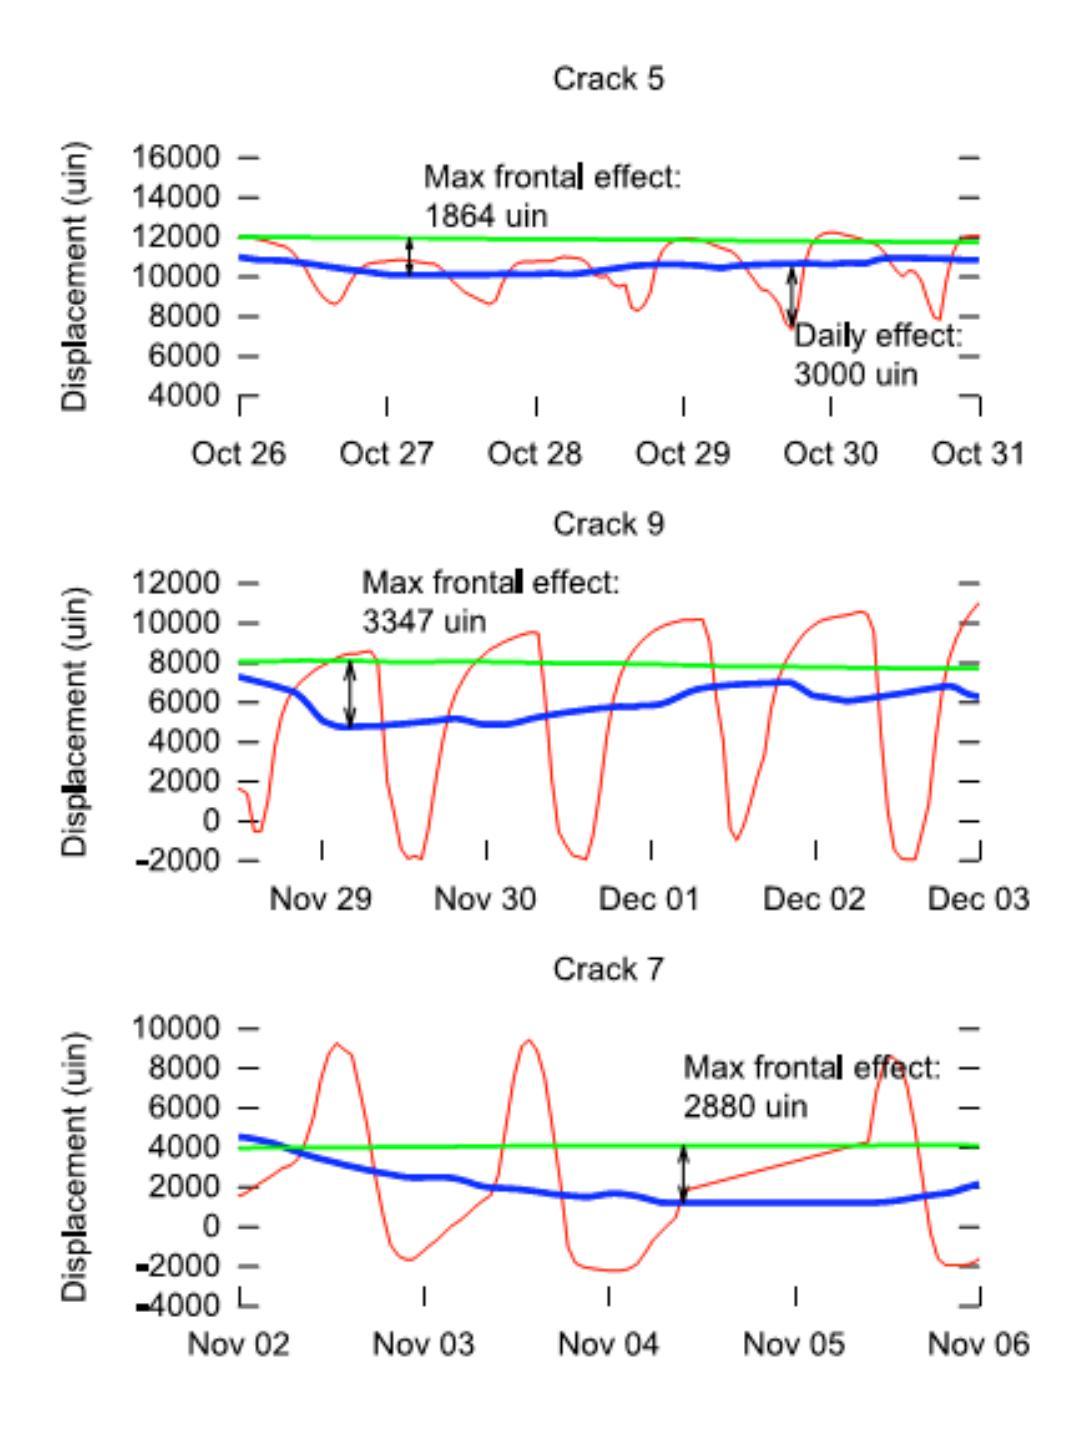
Figure NF-5 shows the maximum response to frontal effects of all three cracks. Hourly readings are shown in orange, 24-hour central-moving-average in blue, and 30-day central-movin-average in green. The difference between the blue and green is the frontal effect caused by changes in humidity and temperature. Figure NF-6 then compares the magnitude dynamic crack responses from blasting to the climatological responses before and after the day of the vibratory excitation. Figures NF 7 and 8 show the long term seasonal responses for the entire six months of observation. Figure NF 9 compares in bar chart form the magnitudes of the crack responses to maximal climatological and vibratory effects. The max response of crack 7 at the transition of CMU to door frame to blasting (11.6 μ m) is only 5.6 % of the max crack responses from climatological effects (200.0 μ m). Thus climatological crack responses can be seen to be more than an order of magnitude greater than dynamic crack responses from blasting.

Figure NF-5 - Daily and frontal (max) weather effects on cracks 5, 7,

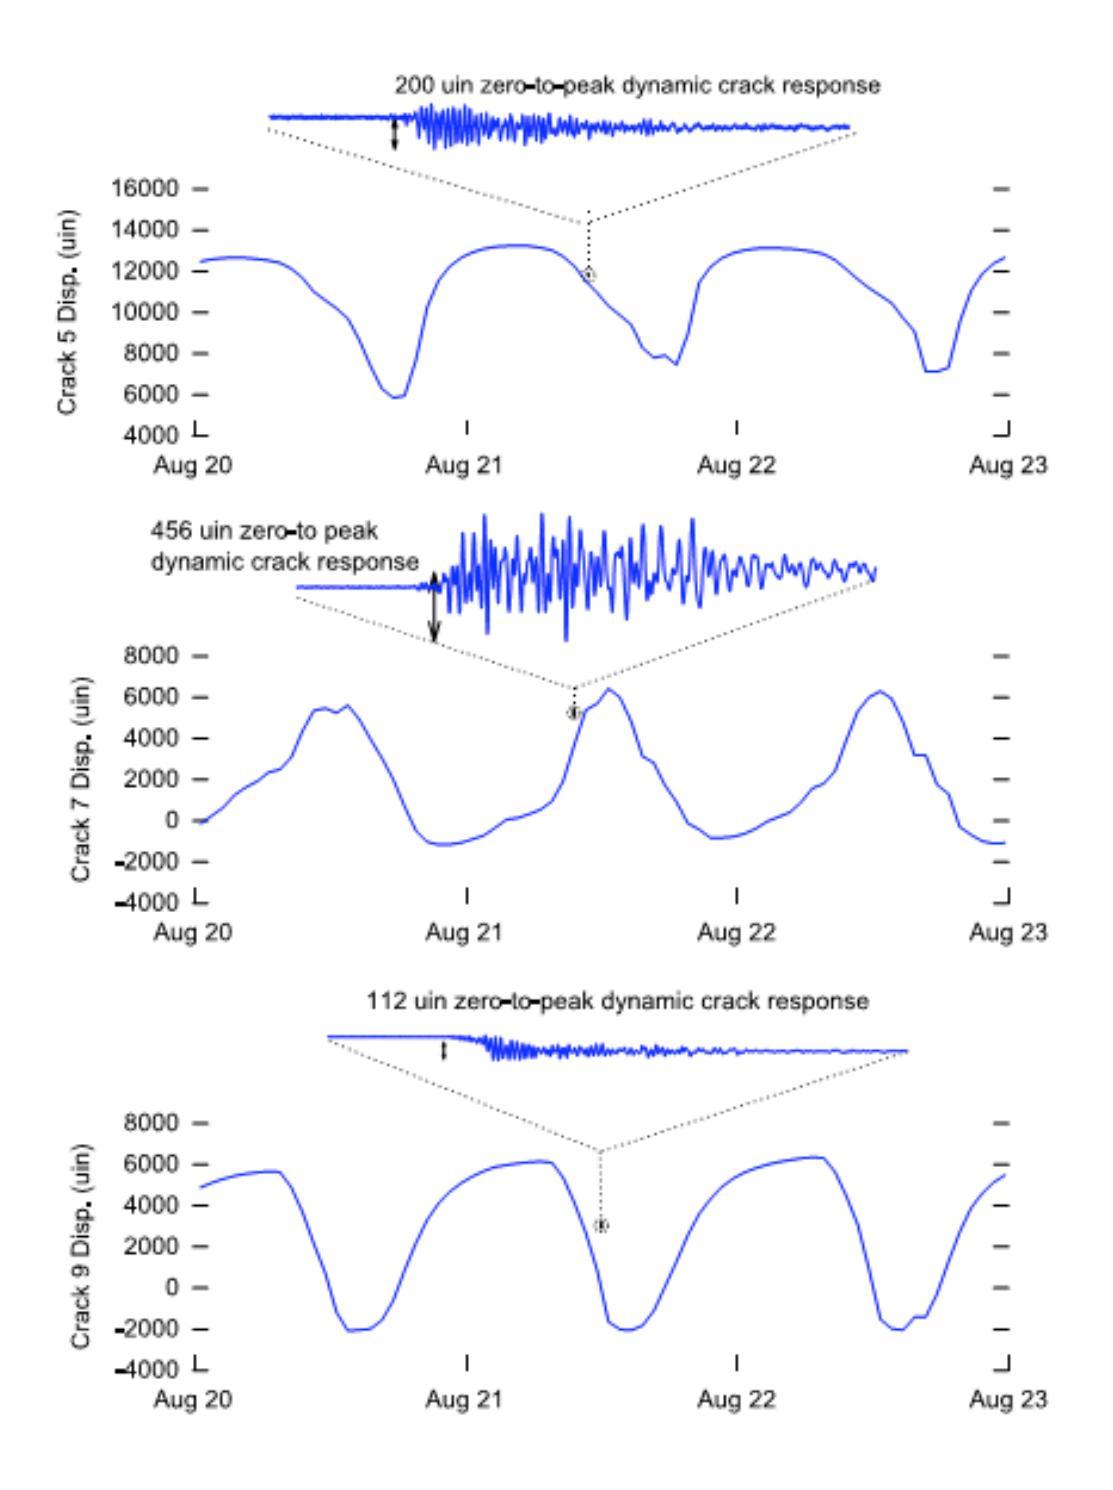
Figure NF-6 - Comparison of static changes in crack width from weather and blastinduced dynamic crack motion for the blast on 8/21

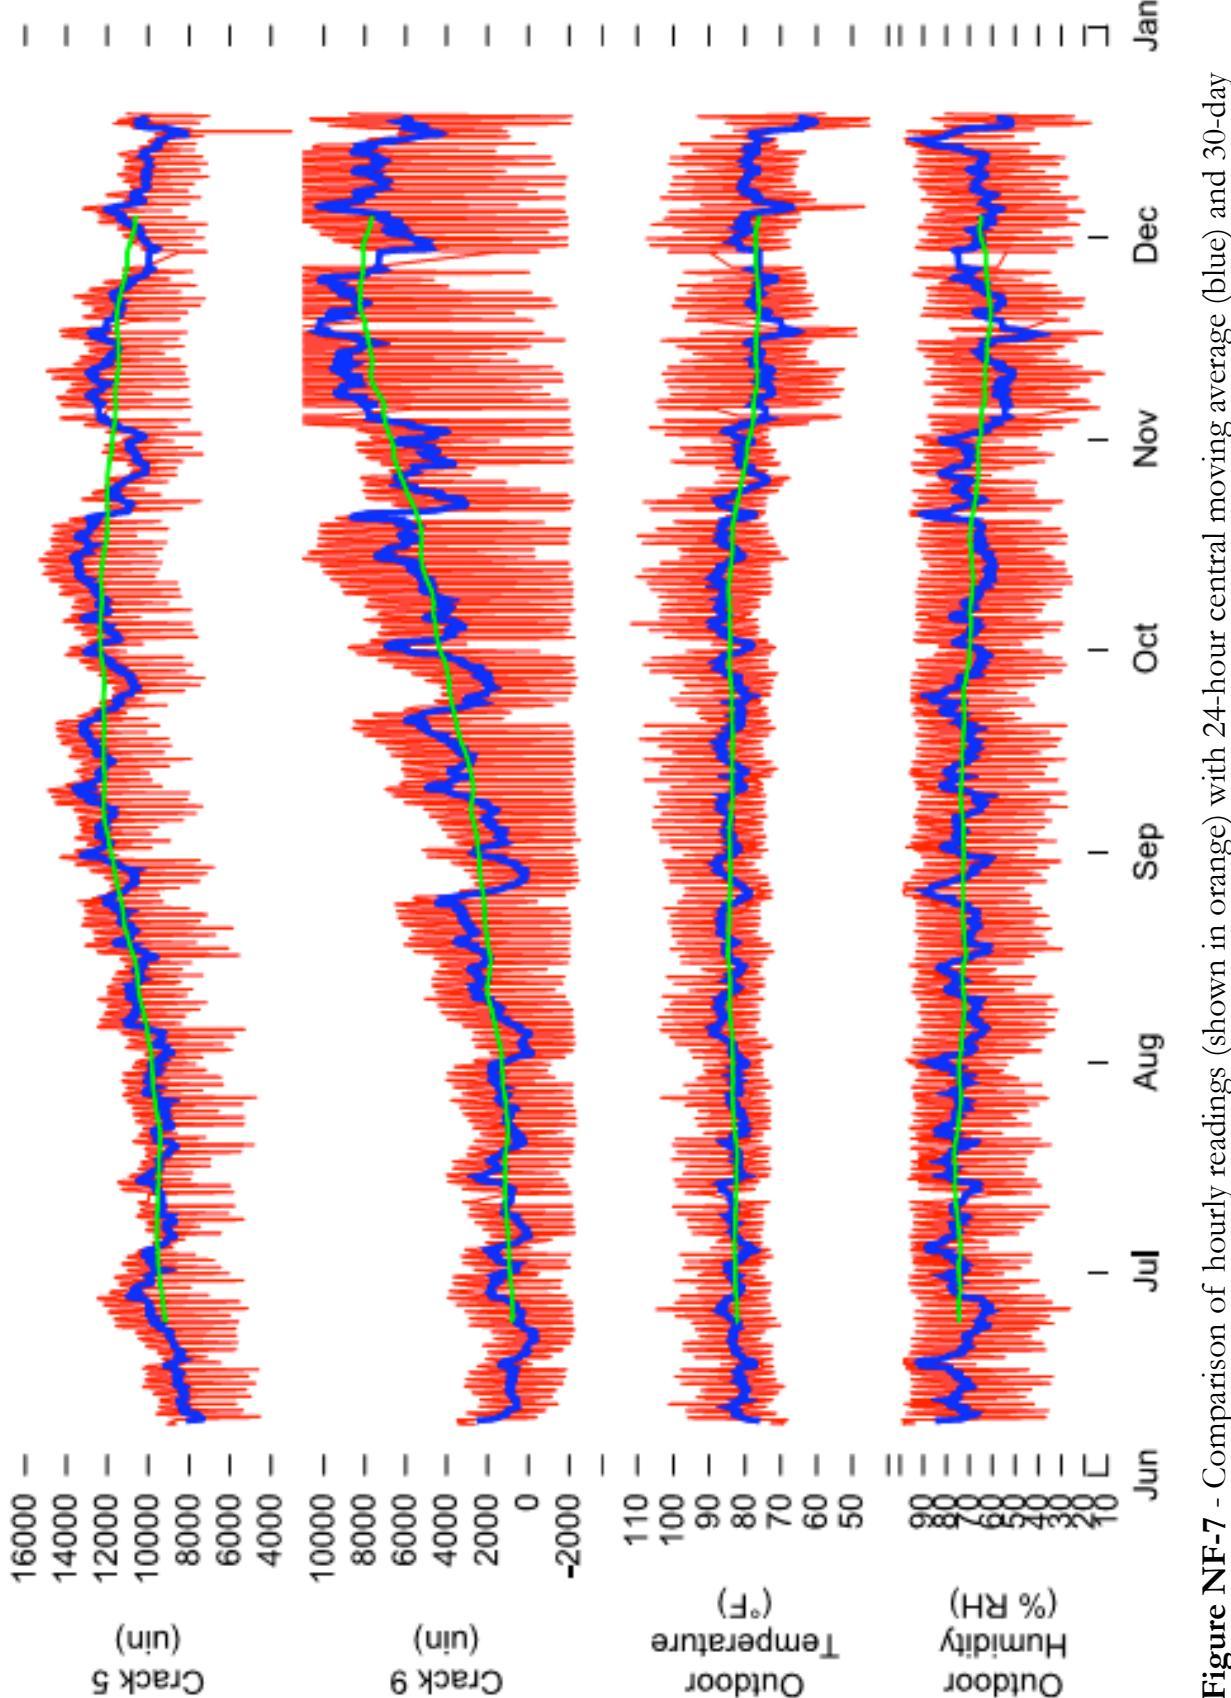
Figure NF-7 - Comparison of hourly readings (shown in orange) with 24-hour central moving average (blue) and 30-day central moving average (green) for exterior cracks and environmental conditions

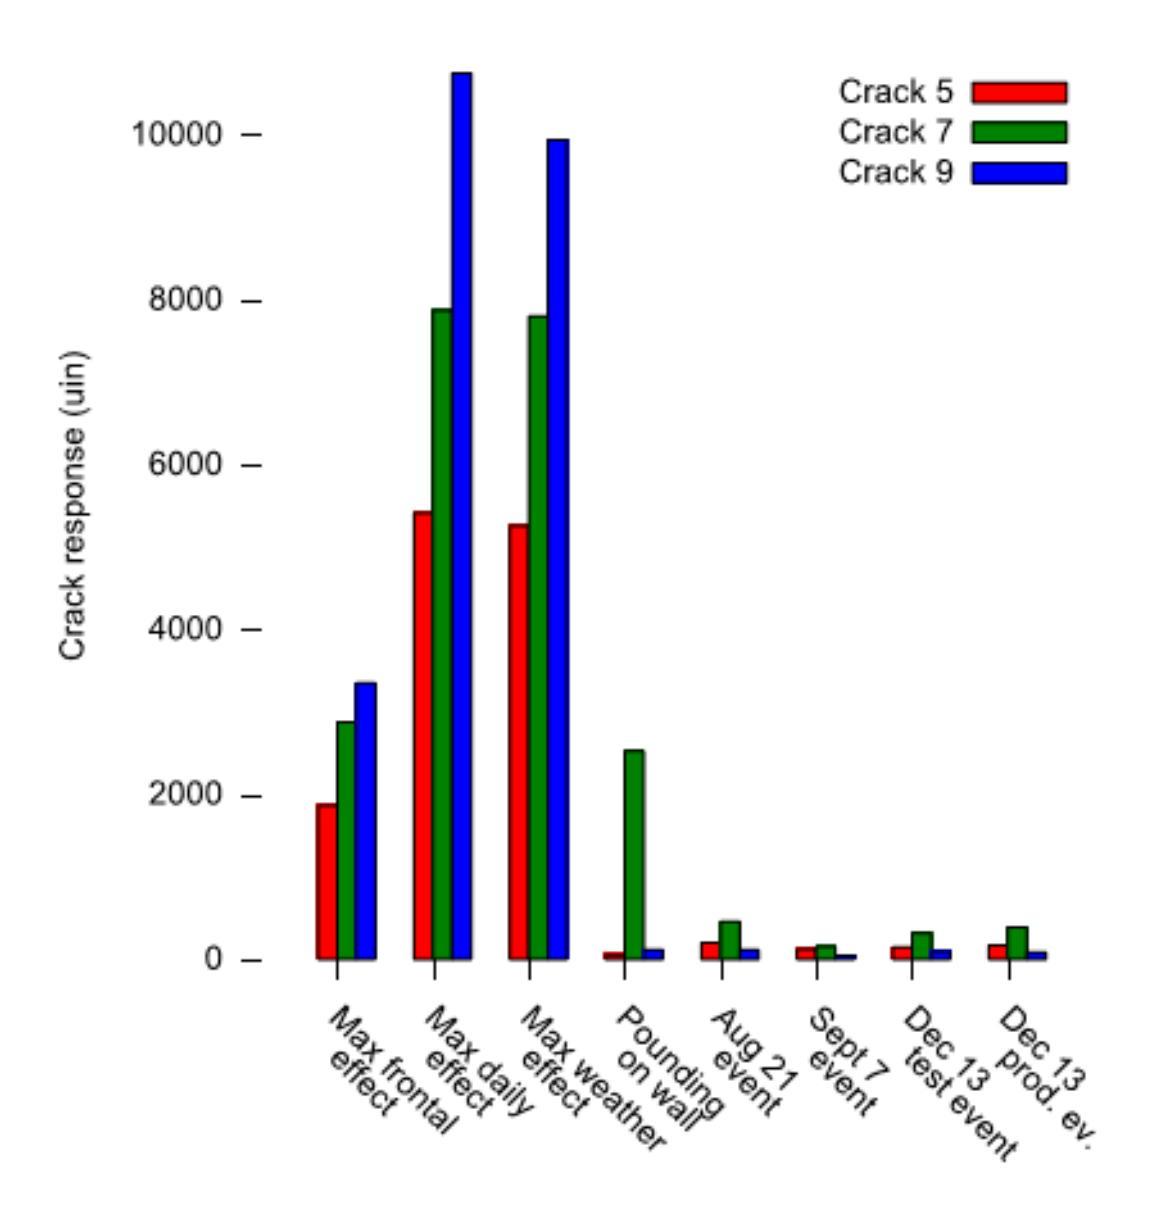
Figure NF-9 - Comparison of crack response to environmental effects, occupant activity, and blast-induced ground motion
