APPENDIX PN

Pineville, North Carolina (2006-2007)

Quarry Blasting

Aimone-Martin 2007

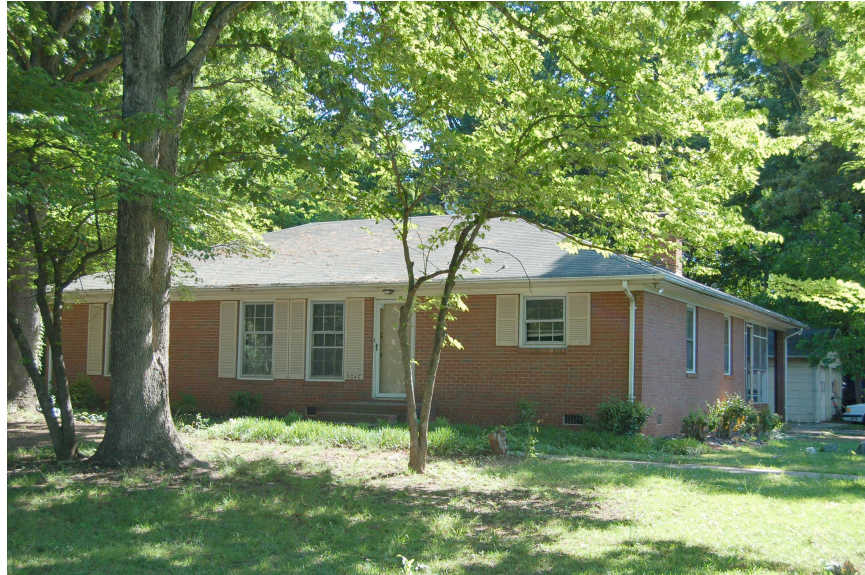
Figure PN-1 - Photograph of the one-story house with instrumented interior drywall crack

The house shown in Figure PN-1 was monitored with the hybrid combination of the ITI ACM system and LARCOR standard vibration monitoring seismograph (AMA et al, 2002). This combination allows recording of vibratory response time histories of both crack and structural response to either ground motions or air over-pressures as well as well as long-term, climatological crack response. See App. KI for a detailed description of the hybrid ACM-seismograph system used in these studies. Figures in this appendix were copied directly from Aimone-Martin and Rosenhaim (2007).

The exterior wall of the slab on grade wood-frame one-story house was covered with brick as shown in Figure PN-1. The exterior façade and interior walls were monitored along with an interior gypsum drywall crack. The locations of these sensors are shown in Figures PN-2 through PN-5.

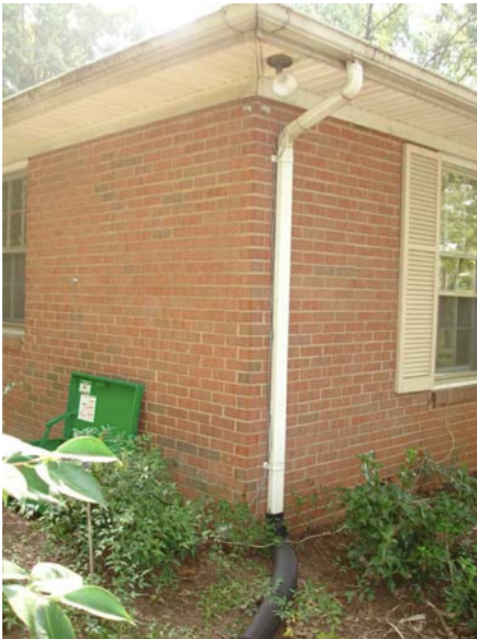
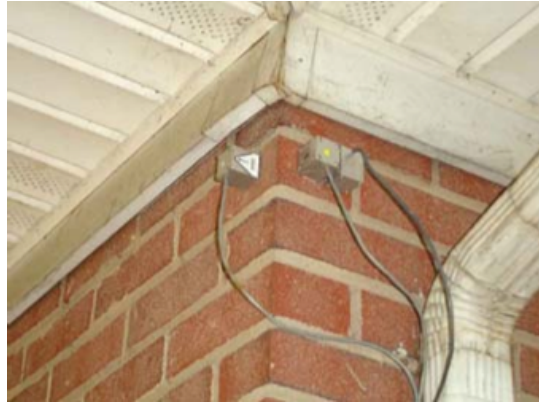
Figure PN-3 - Photographs of Exterior Sensors

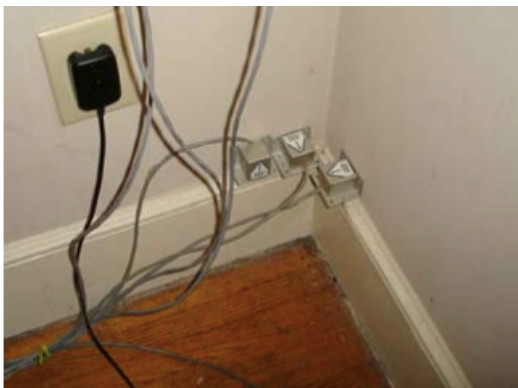
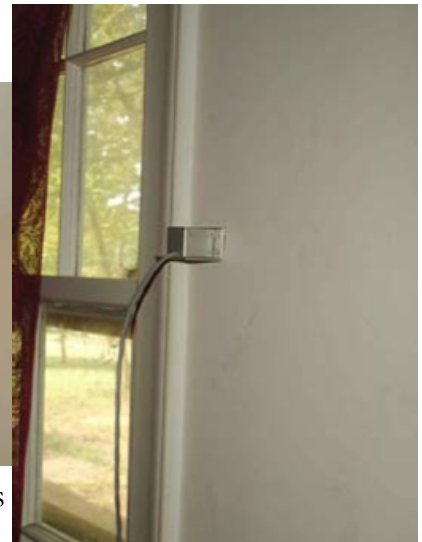
Figure PN-4 - Photographs of Interior Sensors

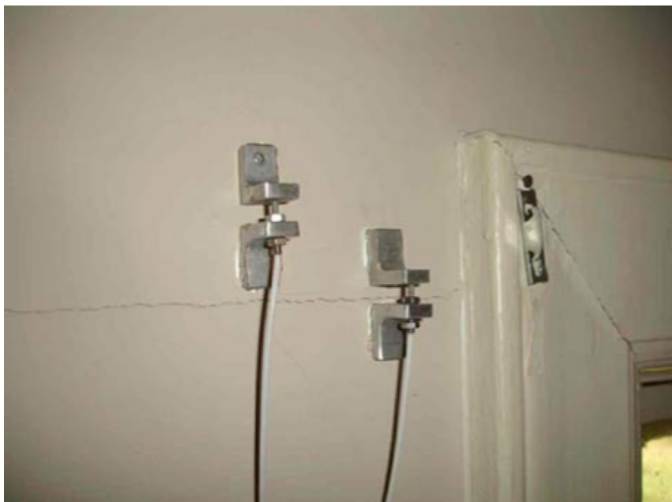
Figure PN-5 - Photograph of interior drywall crack and sensors.

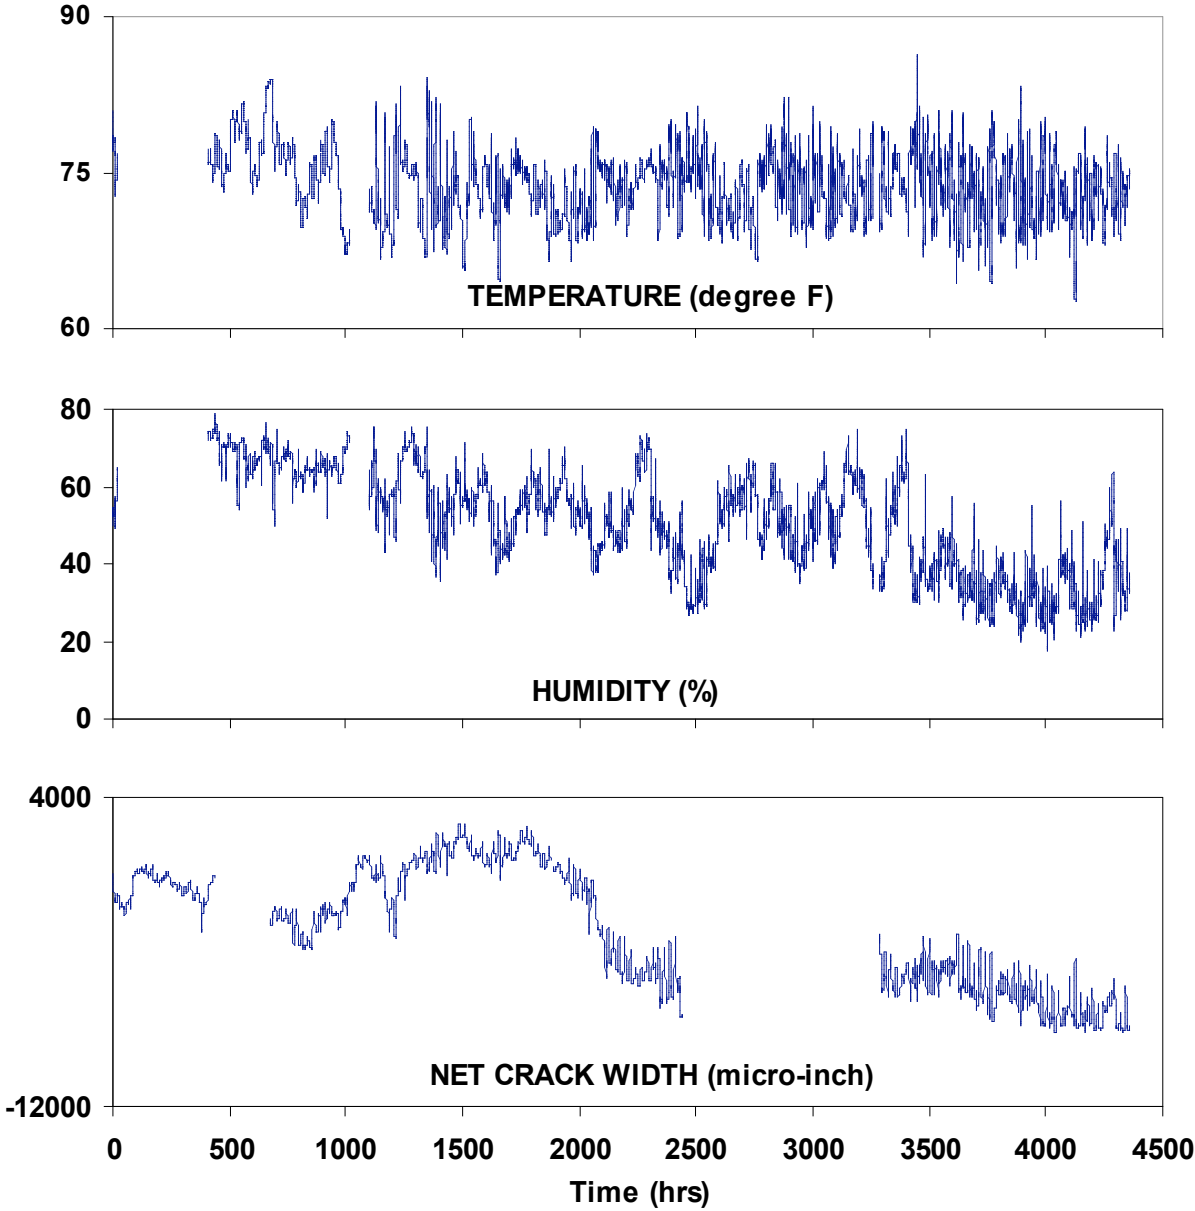
Figure PN-8 - Variations in ambient temperature, humidity and corresponding crack displacement for entire study period

Response of the crack to climatological effects for the full study is compared to the time histories of temperature and humidity in Figure PN-8. Humidity was high between the 1000 and 2000 hour marks of the study. The crack had a large response during this time as the wood frame absorbed moisture which contributed to the opening of the crack. Figure PN-9 then compares the long-term, climatological response for a few days surrounding the 2/05 blast with vibratory crack response time histories.

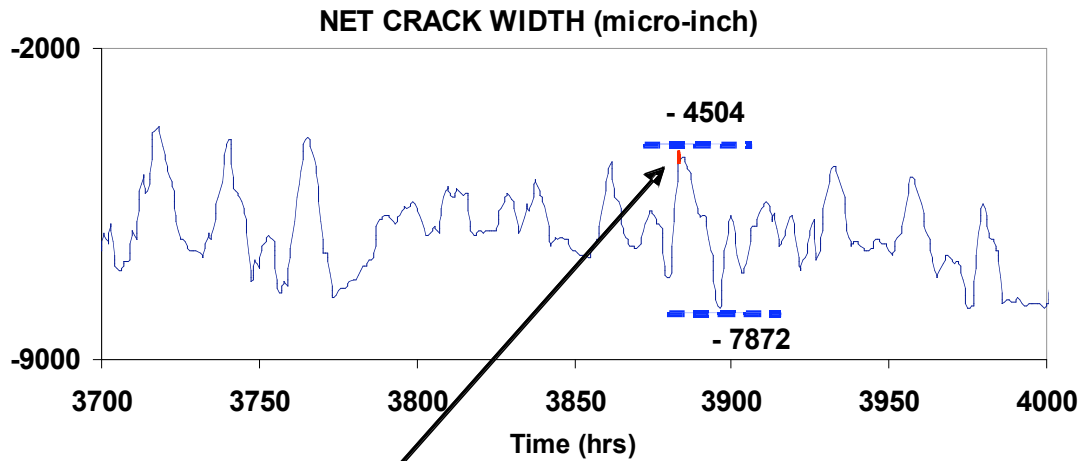
02/05/07 blast

PPV - 0.105 in/s airblast - 112 dB

141.55 micro-inch maximum zero-to-peak crack displacement

Figure PN-9 - Comparison of static changes in crack width from weather and blast-induced dynamic crack motion for the blast on 02/05/07 (blast-induced crack time history is enlarged below)

Quarry blasting some 760 m (2500 ft) away produced a maximum PPV of 2.667 mm/s (0.105 ips) (average 0.044 ips) and a maximum airblast of 125 dB (average 116 dB) on 2/05. This maximum ground motion produced a zero-peak crack response 3.6 μ m (141.55 μ -in). This is 0.014 (1.4%) of the maximum weather response (peak-peak) during the study.

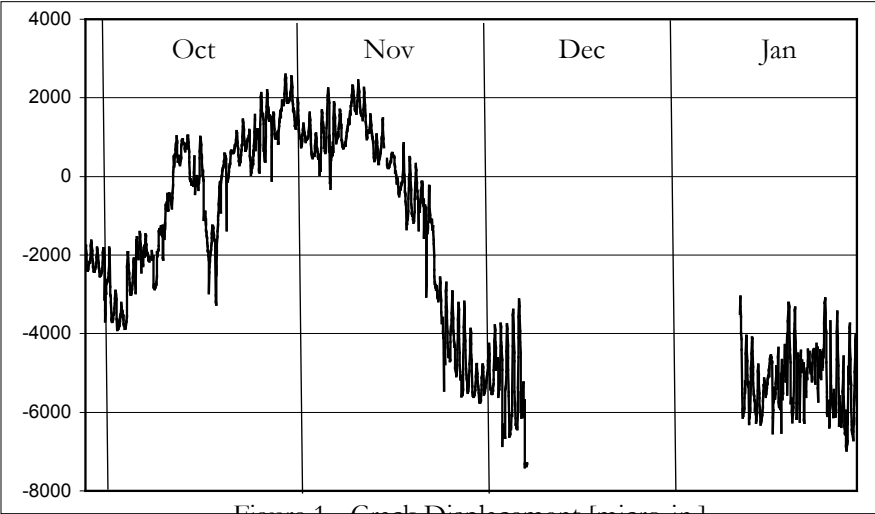
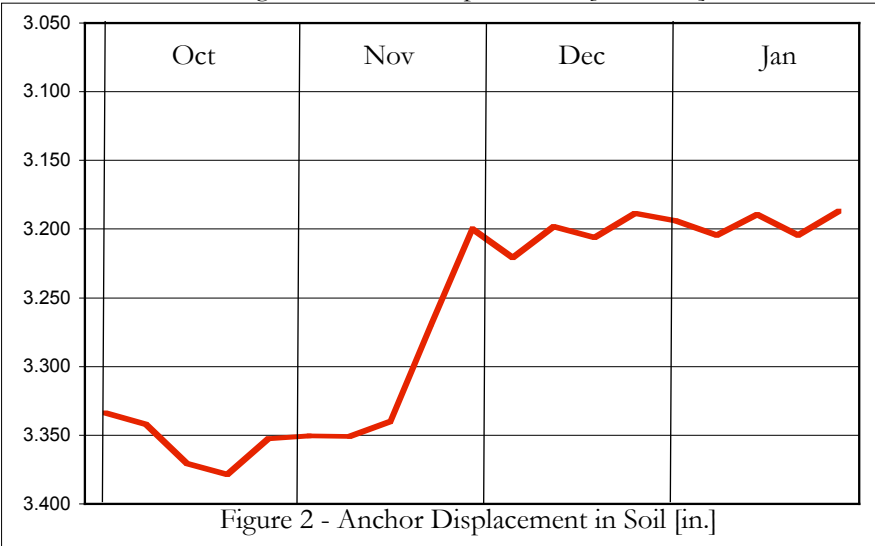
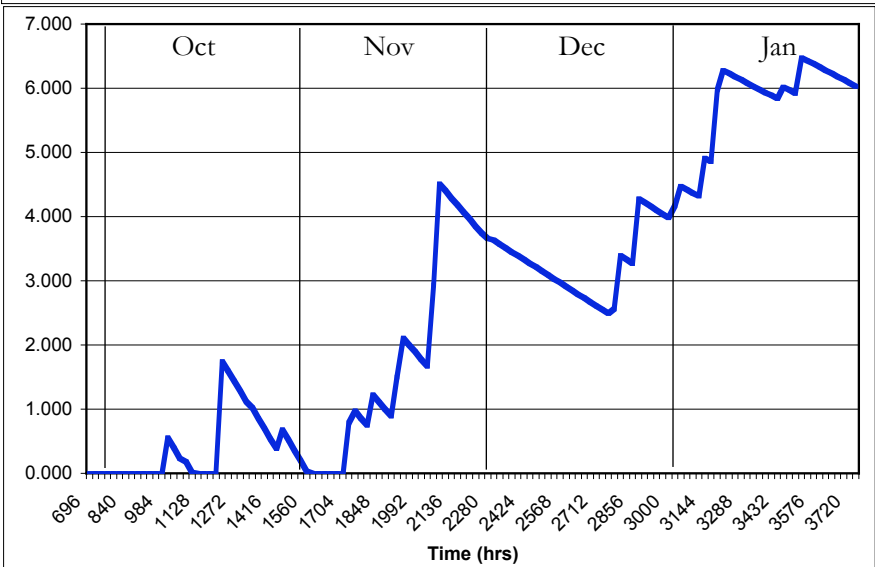
Figure 1 - Crack Displacement [micro-in.]

Figure 2 - Anchor Displacement in Soil [in.]

Figure PN-10 - Comparison of precipitation that causes ground swelling and induced crack development

In addition to the crack's response to ground motion from blast vibrations, it also responded to ground swelling and settlement during a frontal rainfall period in November. This effect is illustrated in Figure PN-10. As a soil anchor point swelled 0.015 in., the structure responded and caused the crack width to decrease by 8000 μ -in.
