*Comparative Field Qualification of ACM and ACSM
Systems at Sycamore, IL*

Introduction

The purpose of this comparative field qualification is to demonstrate the new Kelunji EchoPro hybrid ACSM system and its performance relative to the eDAQ and eko Motes systems. These three systems are installed at a test site in Sycamore, IL, adjacent to an active quarry. Data for this report was collected during a period between March 7, 2011 and May 13, 2011. The analysis includes a comparison of the long-term results for all three systems and a comparison of the dynamic results and noise levels for the eDAQ and the Kelunji EchoPro systems.

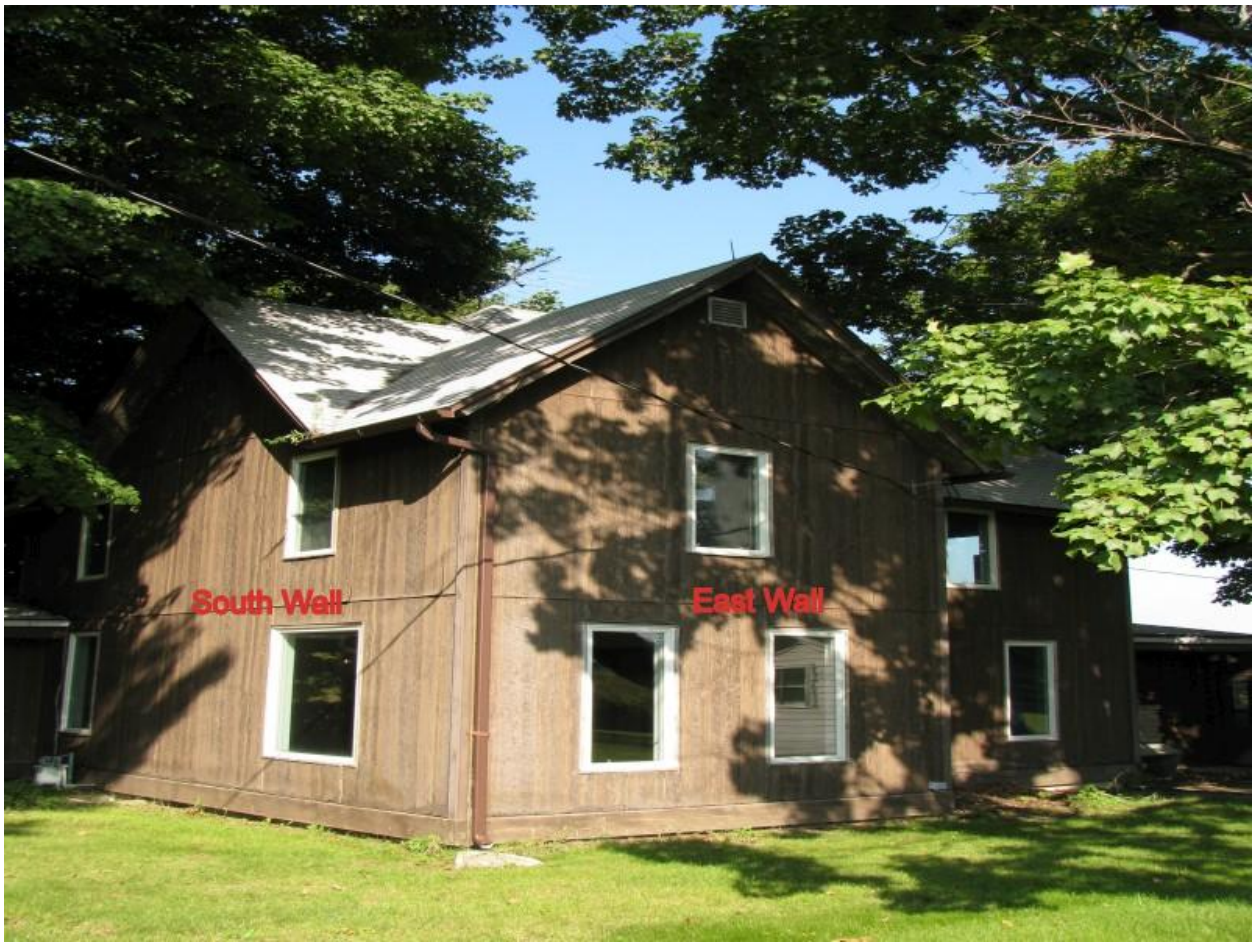
Figure 2: Exterior View of Flint House with Annotations

Figure 1 is an aerial view of the site, and Figure 2 is a view of the exterior of the house with the exterior walls annotated. These photographs, along with the floor plan in Figure 6, will give a basic understanding of the site and test house layout. Figure 3 through Figure 5 illustrate the sensor locations throughout the house. The comparable sensors include the three crack sensors on the first floor shear crack and the second floor ceiling crack and the two crack sensors on the first floor seam crack. Also, dynamic data from the internal and exterior geophones will be compared.

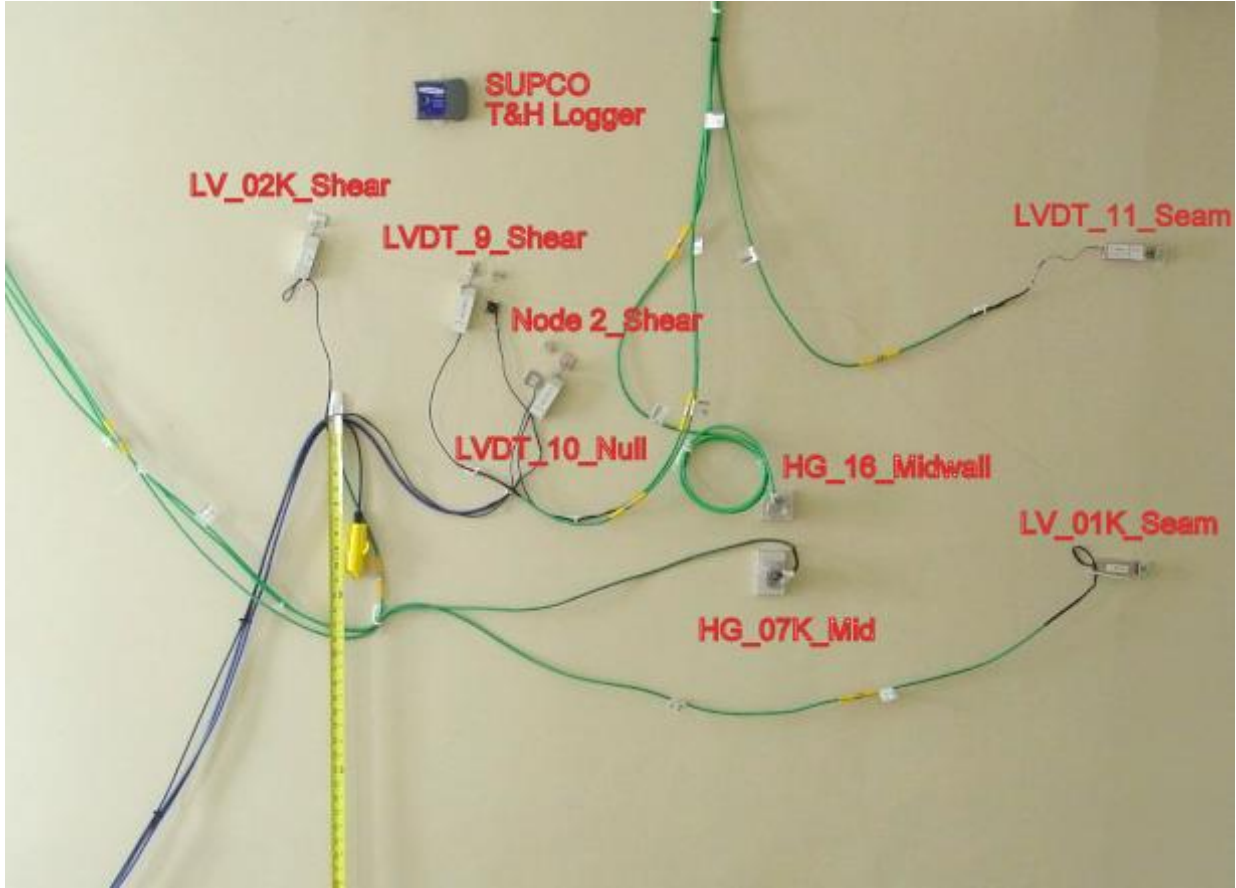
Figure 3: South Exterior Wall with Sensors

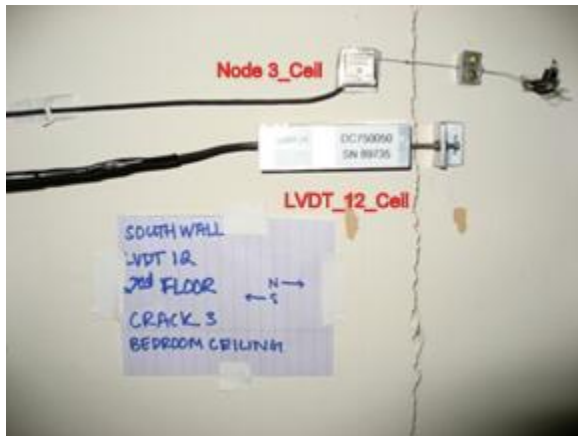
Figure 4: Ceiling Crack Bedroom with Sensors

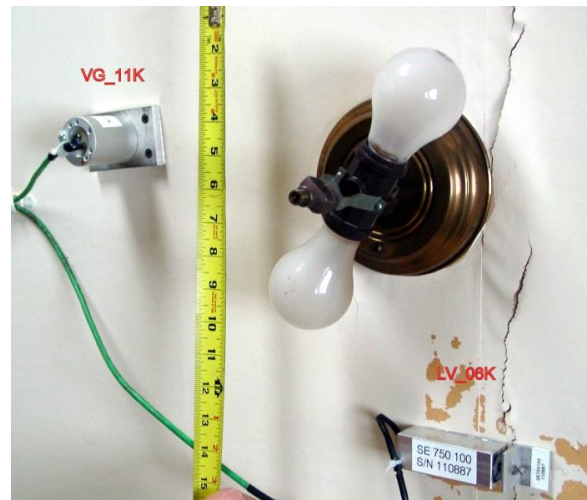
Figure 5: Ceiling Crack Bedroom with KEP sensors

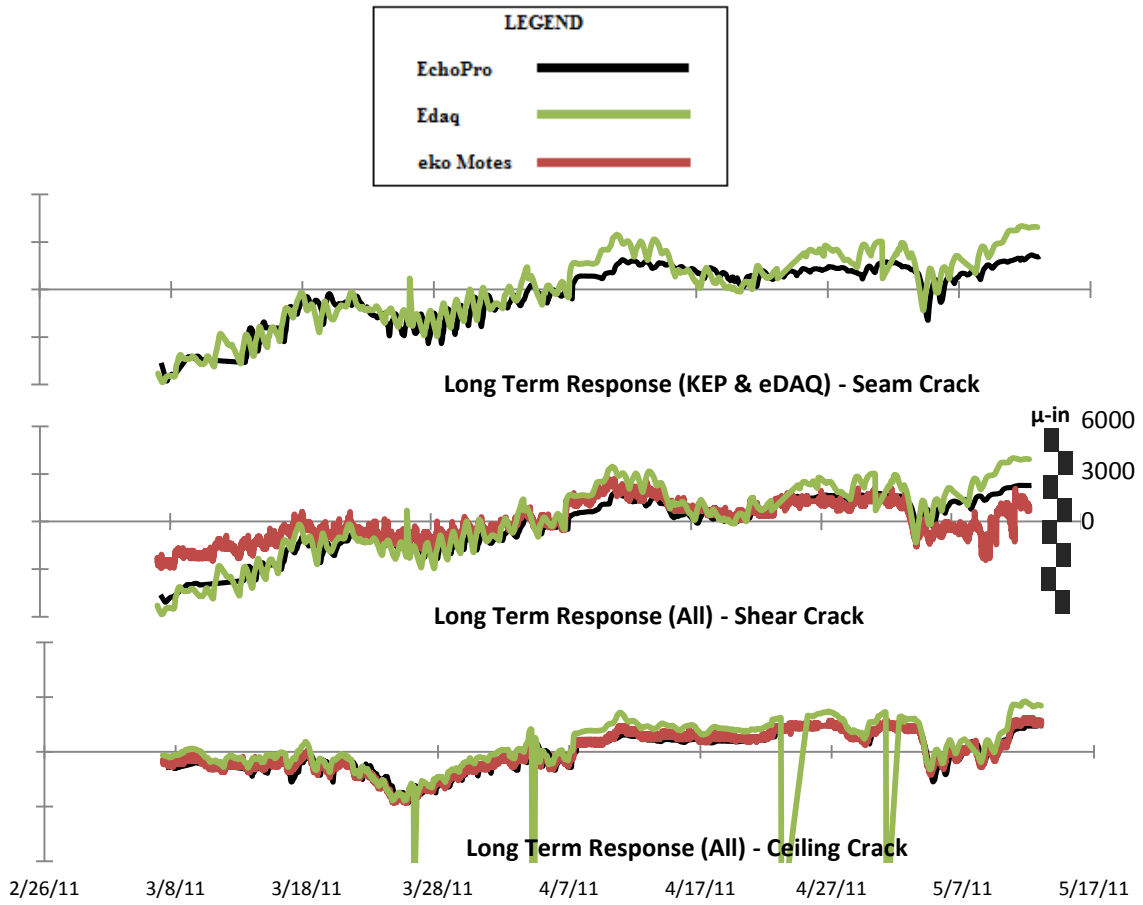
Figure 10: Long Term Crack Response for Multiple Systems to Highlight Differences in Response Patterns

For the most part, the crack sensors measure very similar responses and show peaks and troughs at the same points in time. However, there are observable deviations between the sensors at the beginning and end of the shear crack time history and the end of the seam crack time history. There are several possible explanations for these differences. First, human error in installation and sensor error in responding to crack movements can be the different magnitudes.

Second, the crack gauges monitor different locations on the crack. Therefore, the long term environmental factors could create strain localizations that vary the impacts at the various positions of the sensors. Further study could involve multiple LVDT's on a single system and crack to help determine what factors influence differences in long term crack response between sensor locations.

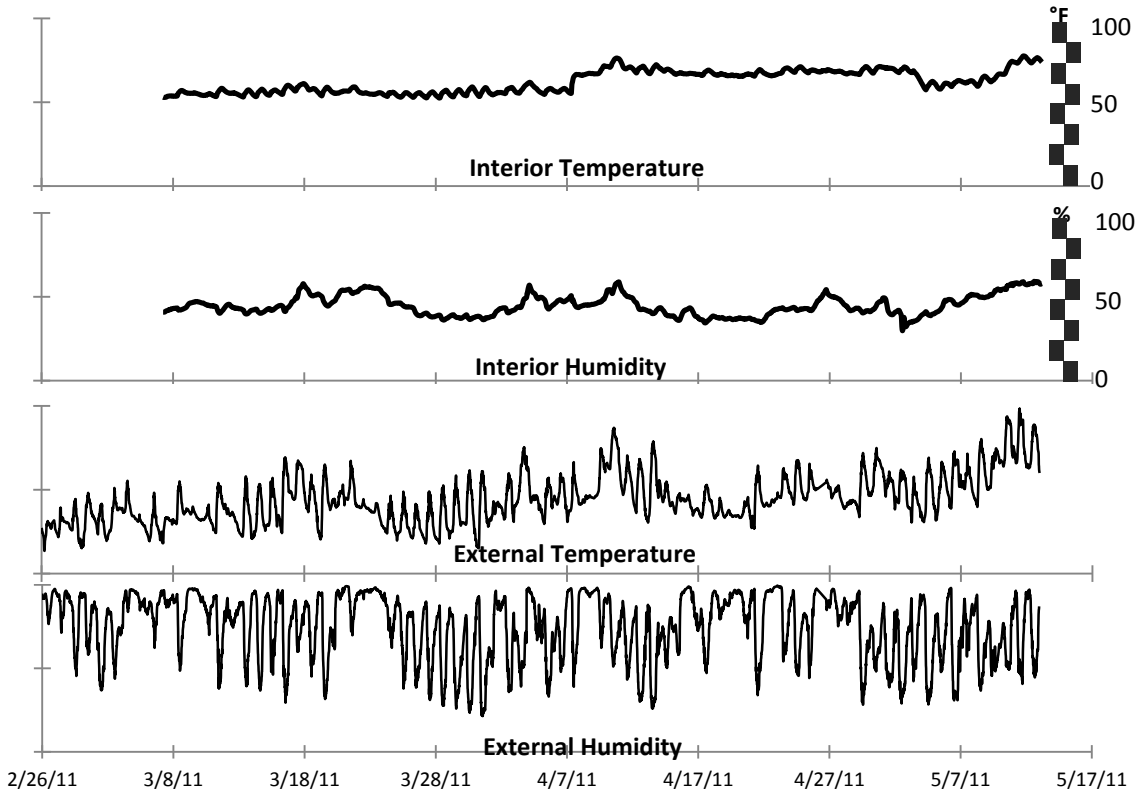
Figure 11: Interior and Exterior Temperature and Humidity Fluctuations

The trend that can be extracted from the figures is that as the average temperature increases, the cracks decrease in size. This makes sense as thermal expansion of the wall material with increased temperature would serve to reduce the size of the cracks. However, it is important to note that humidity fluctuations also have a large impact on crack response, though it is difficult to discern a trend from the figures due to the rapid variation of the exterior humidity response.

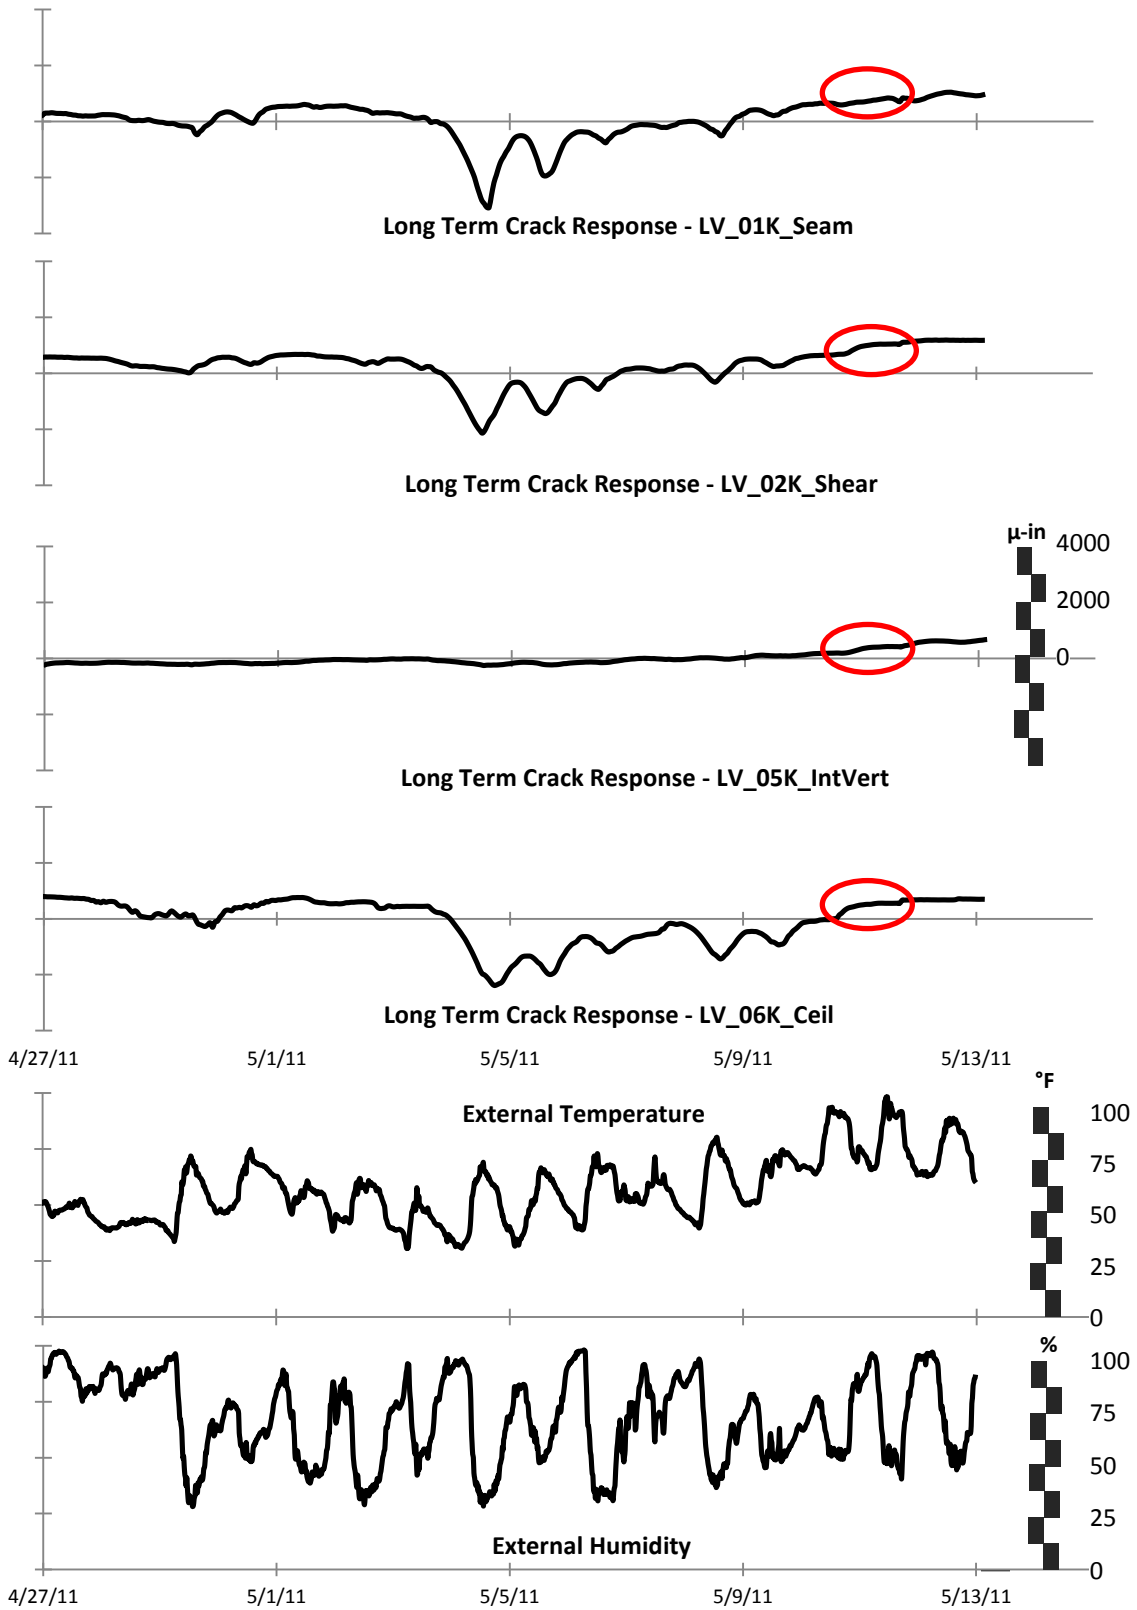
Figure 14: April 27 – May 13th EchoPro Response with Dynamic Event Data Circled

Figure 14 and Figure 15 shows the long term crack response of the EchoPro and eDAQ systems respectively with the dynamic event period circled in red. These figures show that there is no large change in the long term trend of the crack movement during this period. In order to further demonstrate this, Figure 13 and Figure 14 enlarge the long term response for the three comparable cracks (exterior seam, exterior shear, bedroom ceiling). Also included in these figures is a representation of the dynamic response of these cracks during the May 11, 2011 blast event. These dynamic responses are displayed below the x-axis near the corresponding date and are scaled to about twice their real response magnitude for viewing purposes

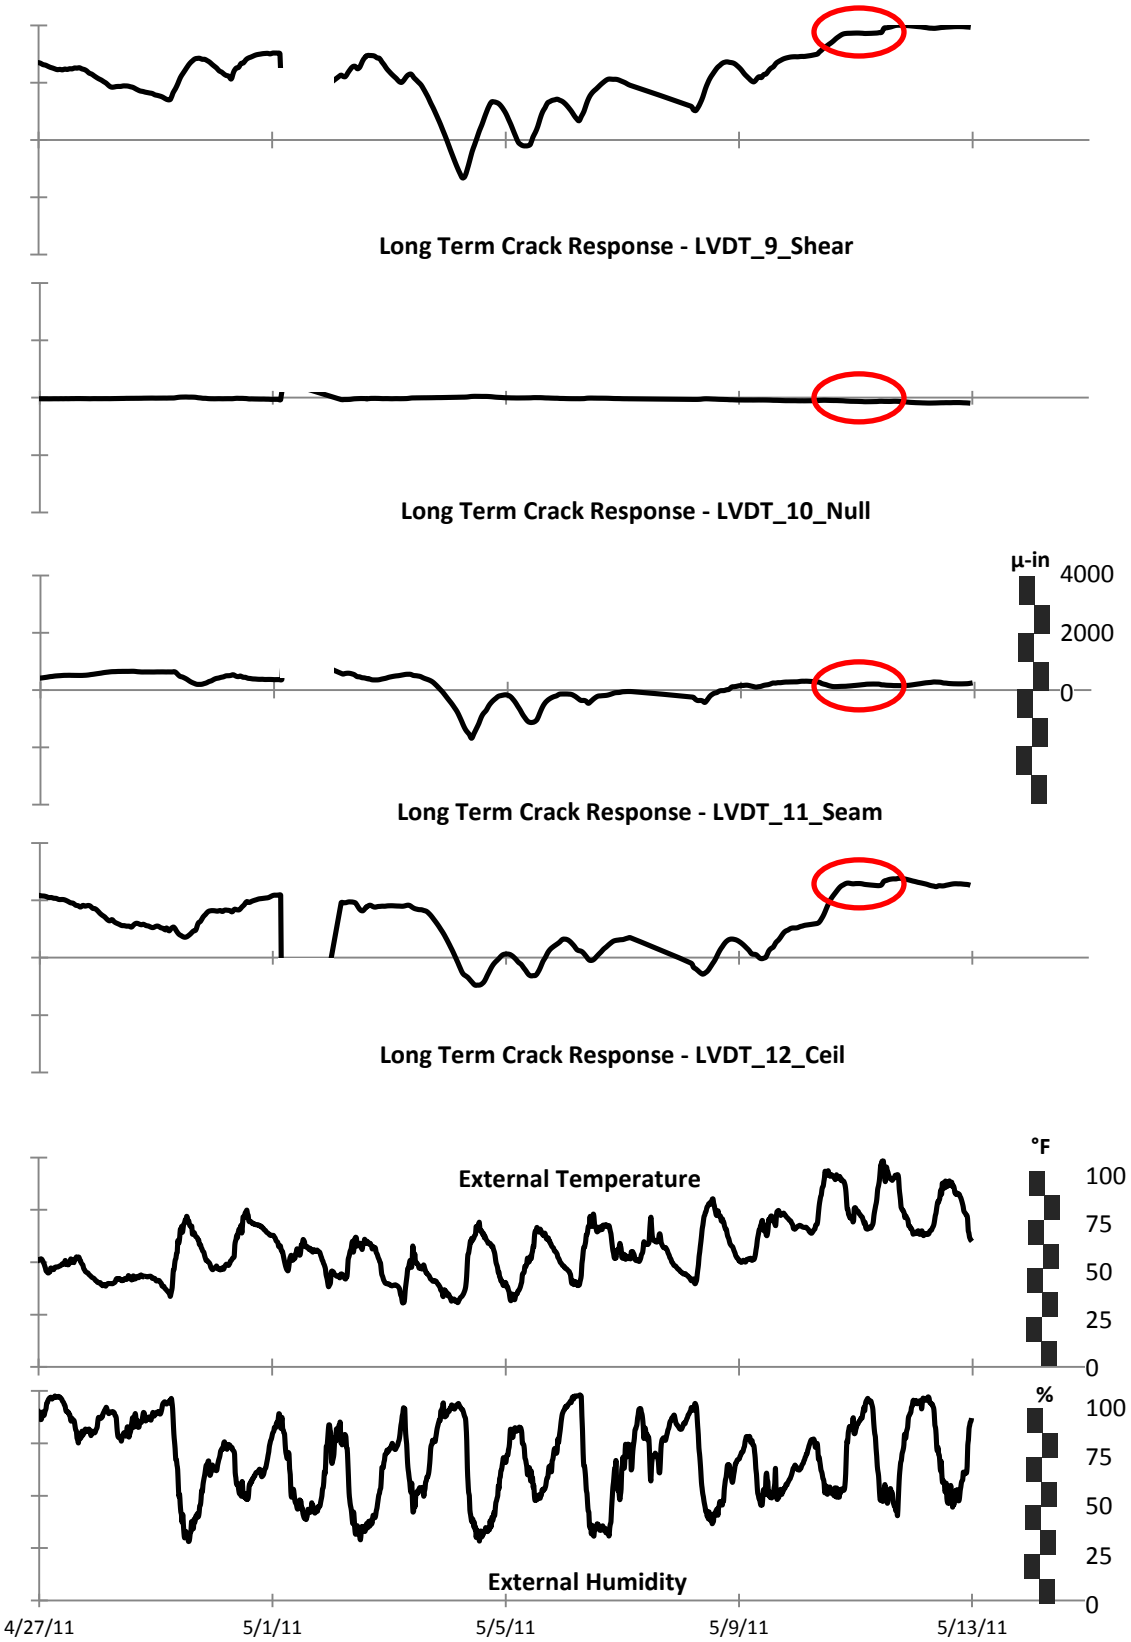
Figure 15: April 27 - May 13th eDAQ Response with Dynamic Event Data Circled:

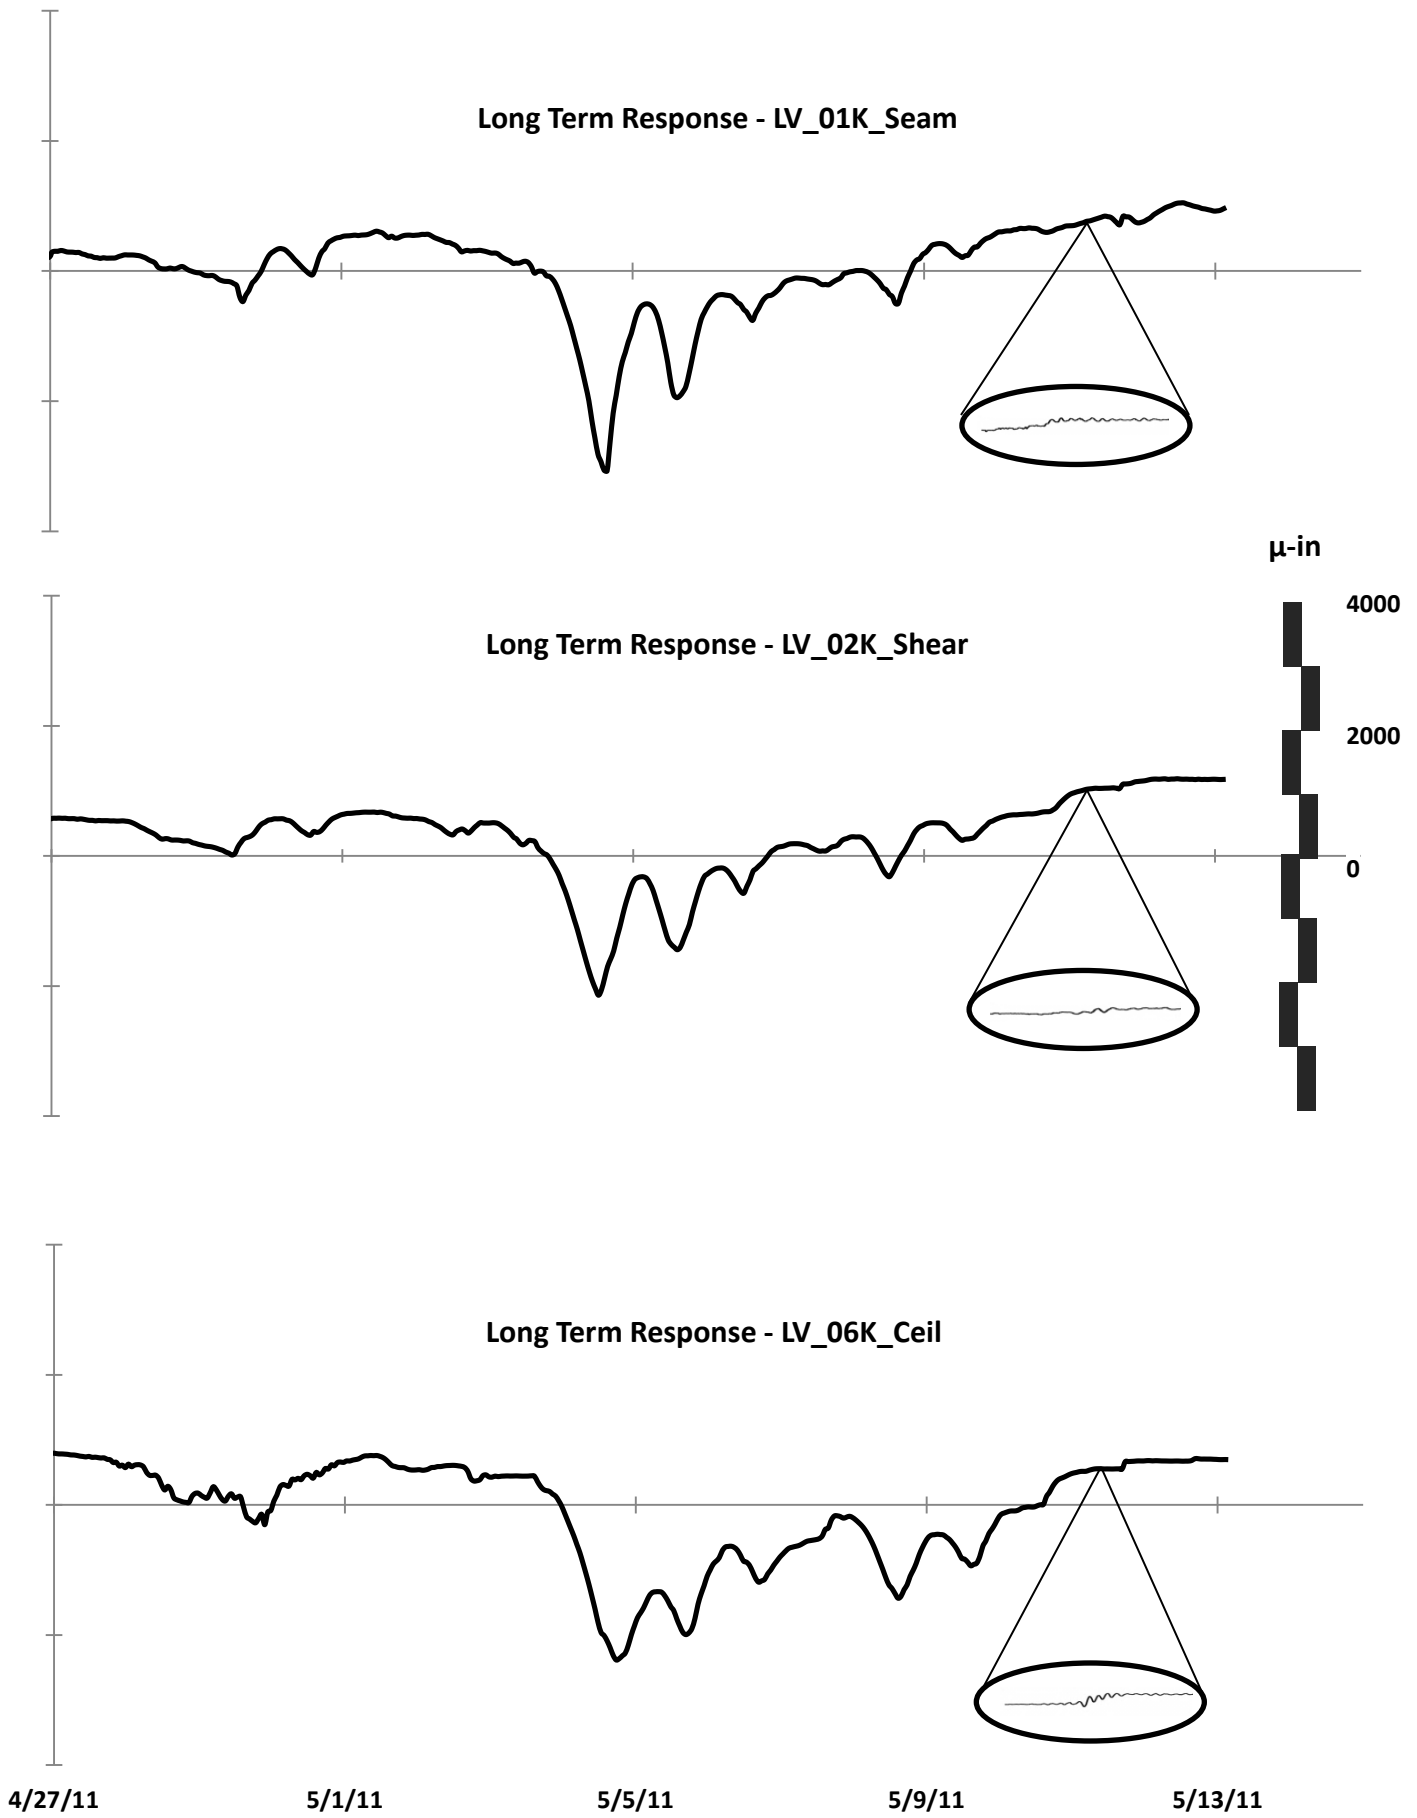
Figure 16: Visual Comparison of Long Term and Dynamic Crack Movements on EchoPro

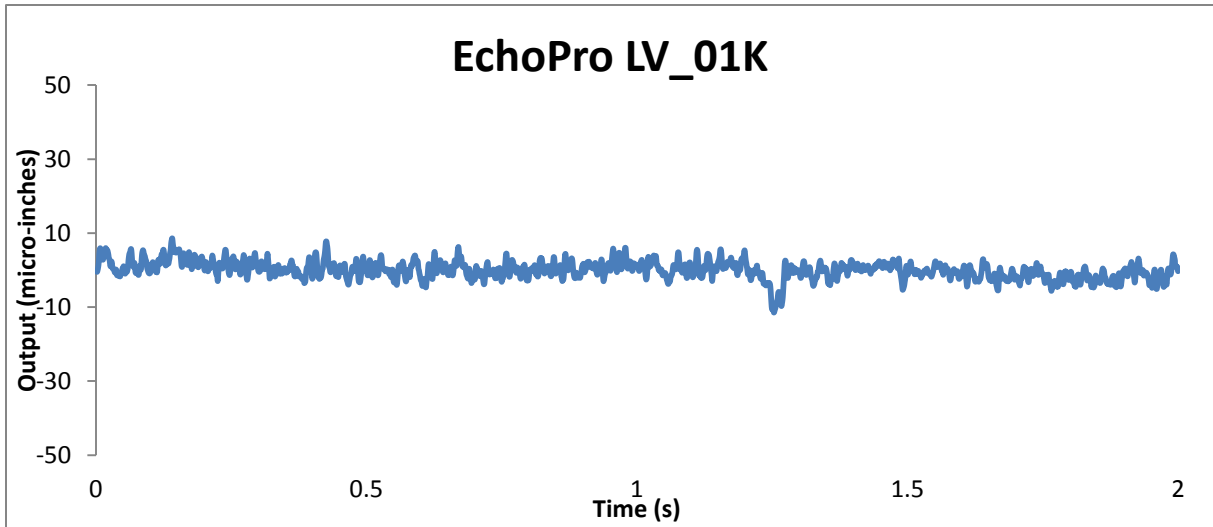
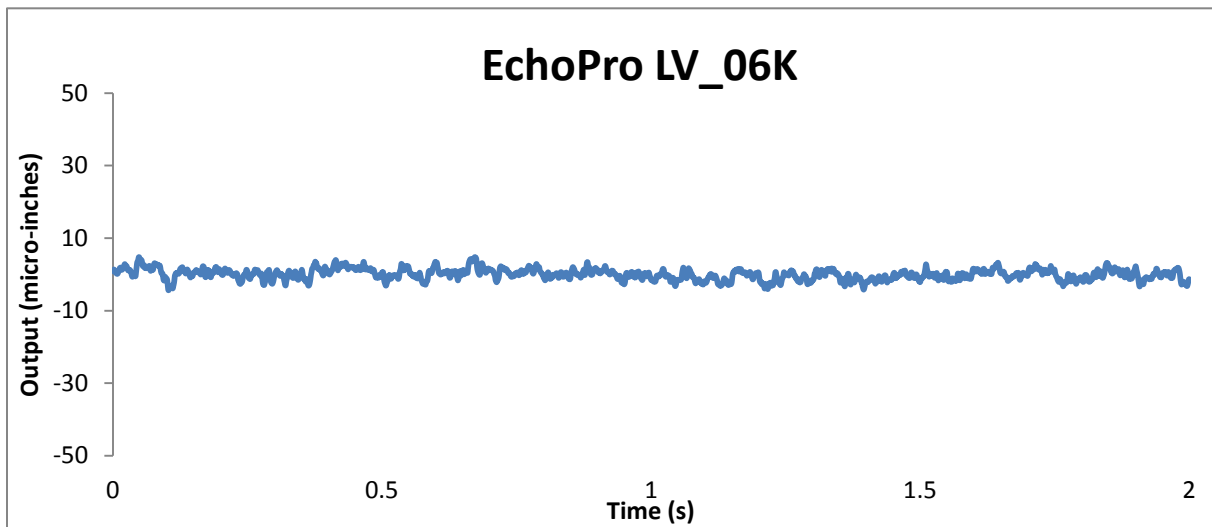
Figure 18: Noise Illustration - EchoPro 2 second Time History

Figure 18 and Figure 19 illustrate two-second time histories for the EchoPro and eDAQ systems respectively. They visually demonstrate the increased resolution of the Kelunji system relative to the eDAQ due to lower noise levels of the recorded data. Figure 20 shows the full EchoPro time history and the two second time window from which the first two figures were developed.

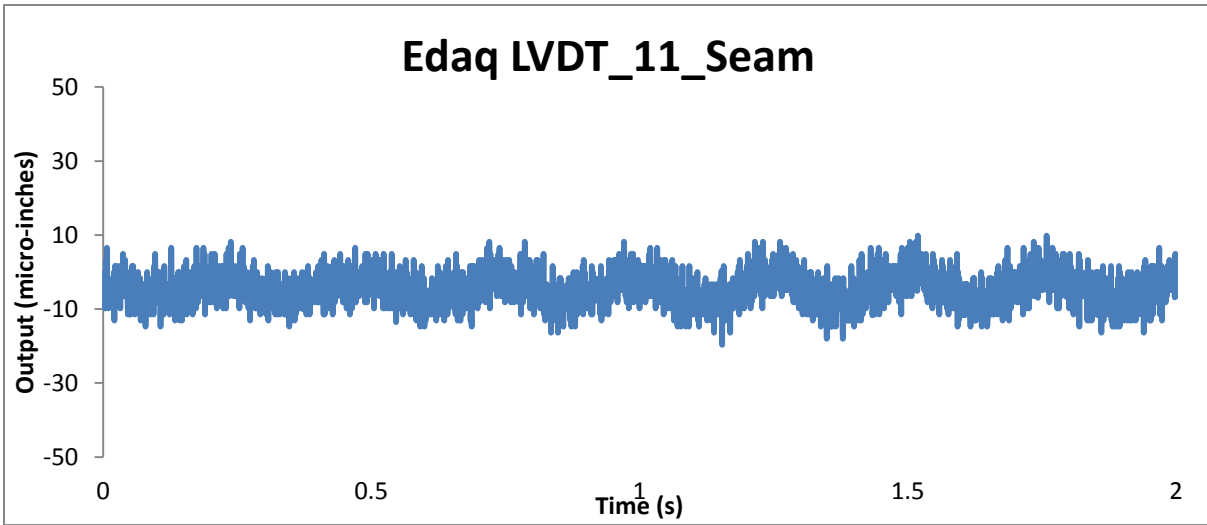
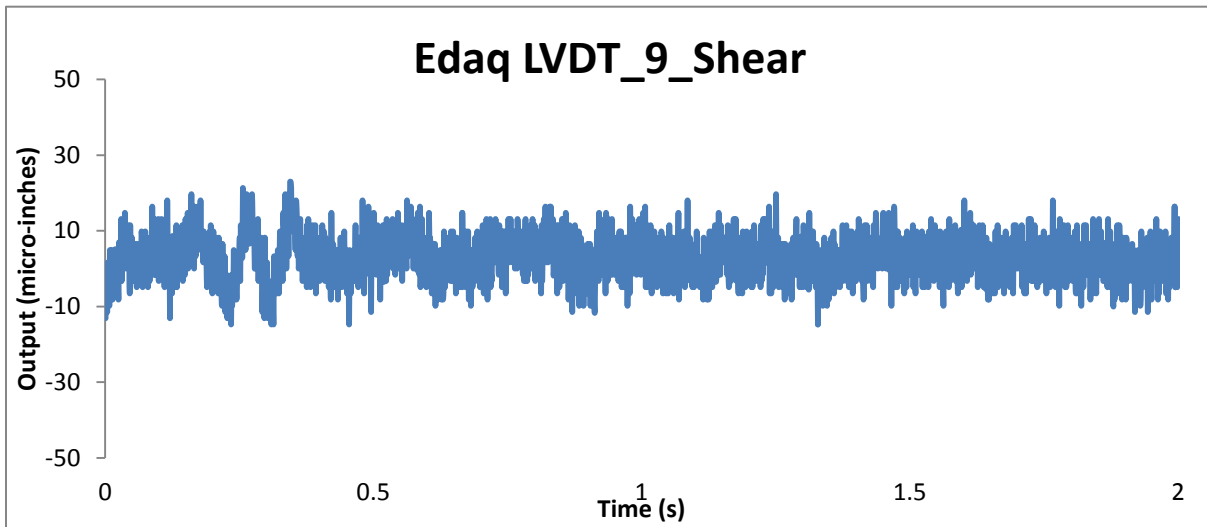
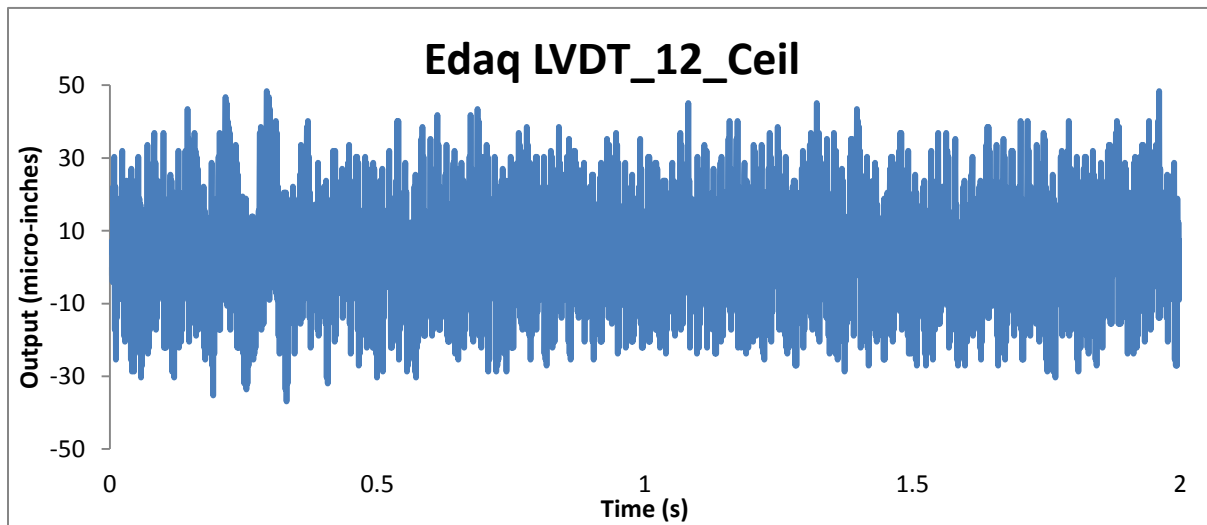
Figure 19: Noise Illustration - eDAQ 2 second Time History

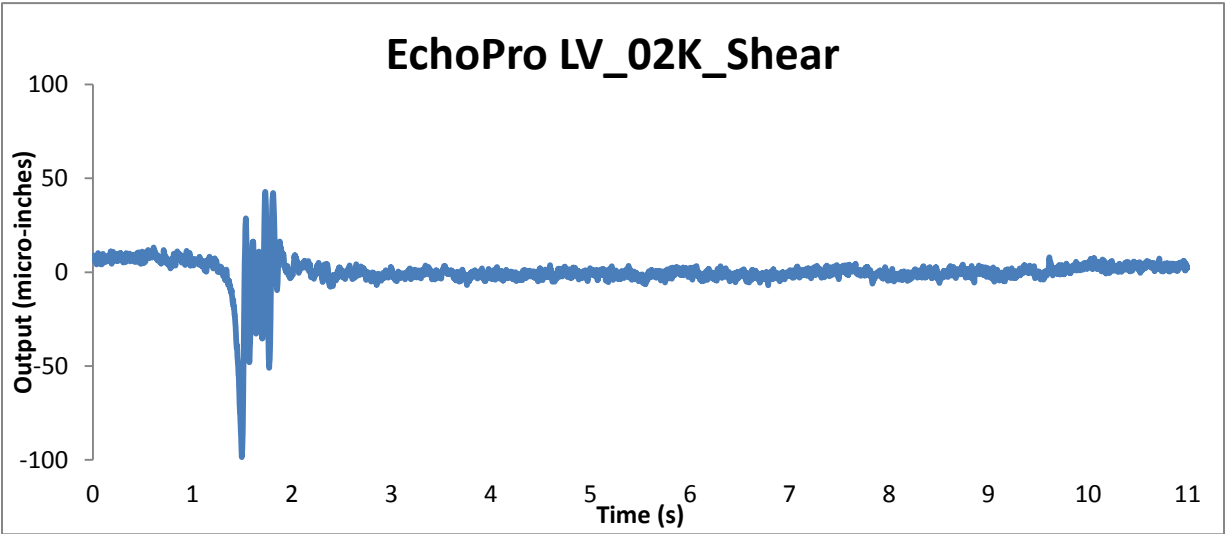
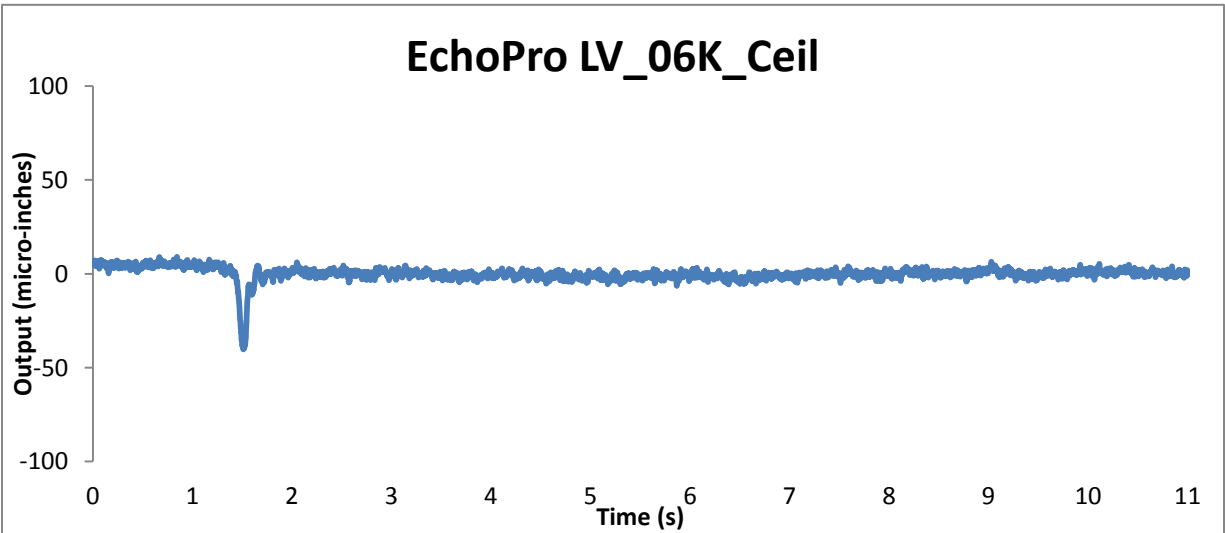
Figure 20: Noise Illustration - EchoPro Full Time History with Annotated 2 Second Window

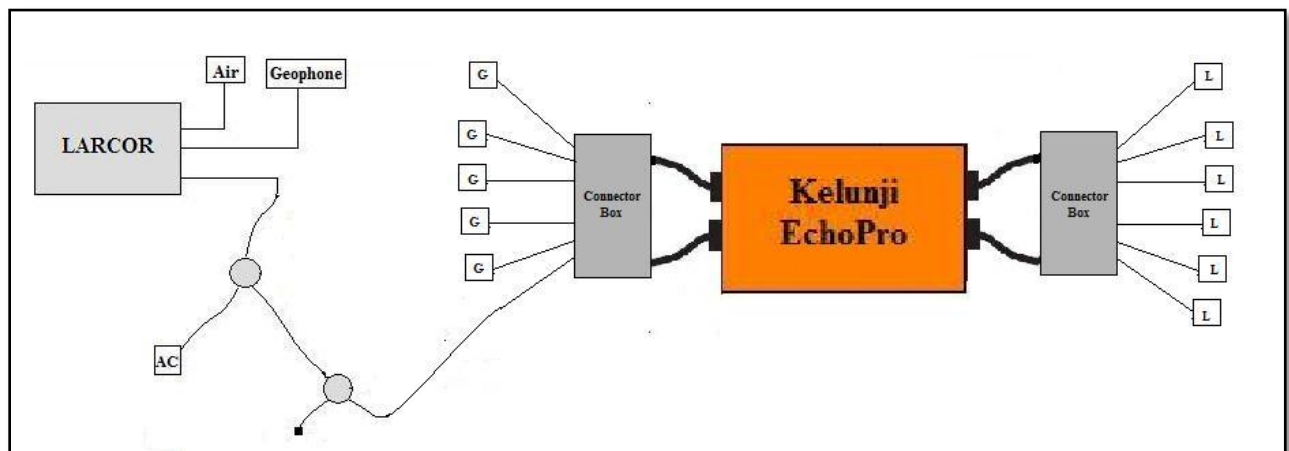
Figure 21: Components of the hybrid autonomous crack & structural monitoring (ACSM) system

The Kelunji EchoPro system is a new hybrid autonomous crack and structural response monitoring (ACSM) system. It is designed as a low cost alternative to the research grade version employing SOMAT's eDAQ data recording system. The concept is to combine a new field portable, 24 bit, 12 channel seismograph with a compliance seismograph. The 24 bit seismograph monitors the crack and structural response, while the compliance seismograph monitors ground motions and air over pressures. As configured the Kelunji EchoPro (KEP) recorder can monitor autonomously monitor crack and structural response in a wide range of field configurations. Cost and simplicity were the main priorities for design of the hybrid system. The full installation, illustrated in Figure 21 includes structural response velocity and crack sensors, a LARCOR compliance seismograph with a trigger connection, connector boxes, and the KEP unit. More information on the Kelunji EchoPro recorder can be obtained from the manufacturer's user manual, which can be obtained at (<http://customer.esands.com/index.php?section=45>)

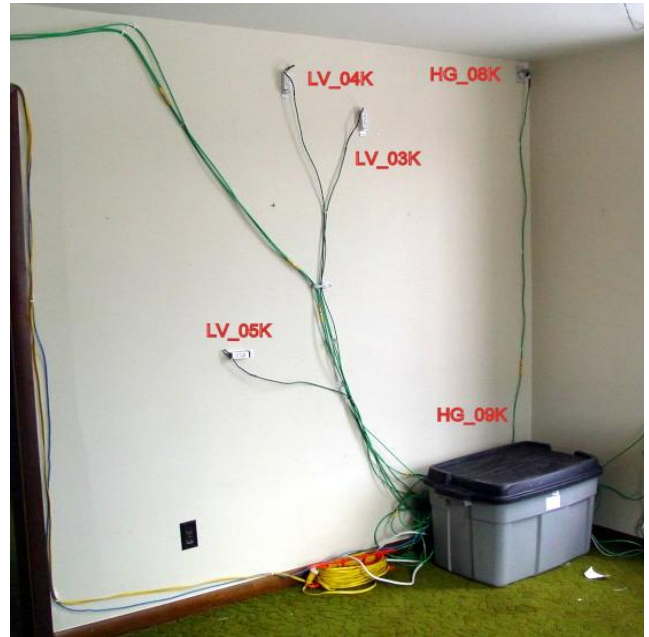
Figure 23: Interior E-W Wall Sensors

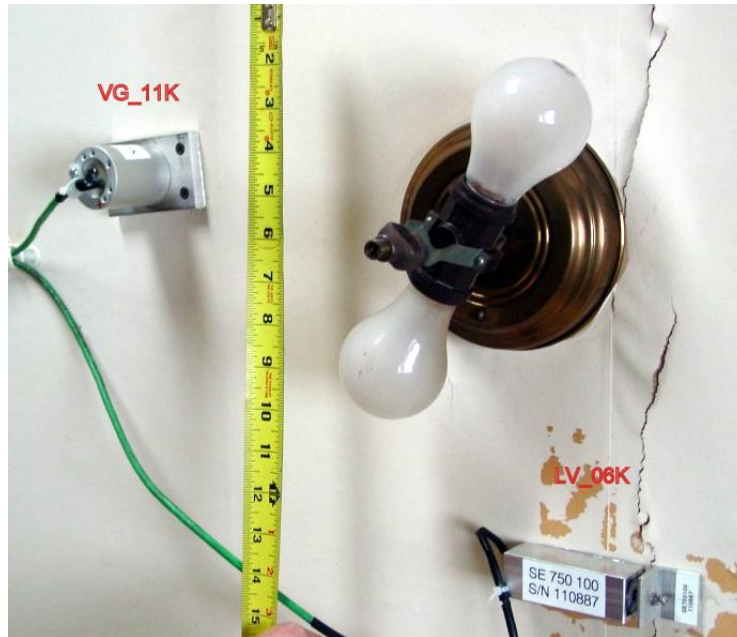
Figure 24: Bedroom Ceiling Sensors

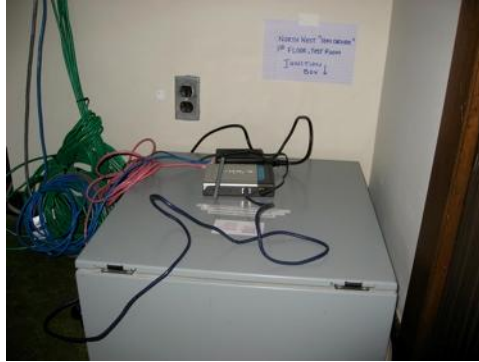
Figure 2.13 - Photographs of enclosure with both top and bottom layer contents

The wires running back from the sensors to the eDAQ all meet at an enclosure box behind the stairs in the Floit House. Photos of this enclosure are shown in **Figure 2.13** with **Table 2.1** describing its contents. Additionally, a wiring diagram of this box is shown in **Figure 2.14**.

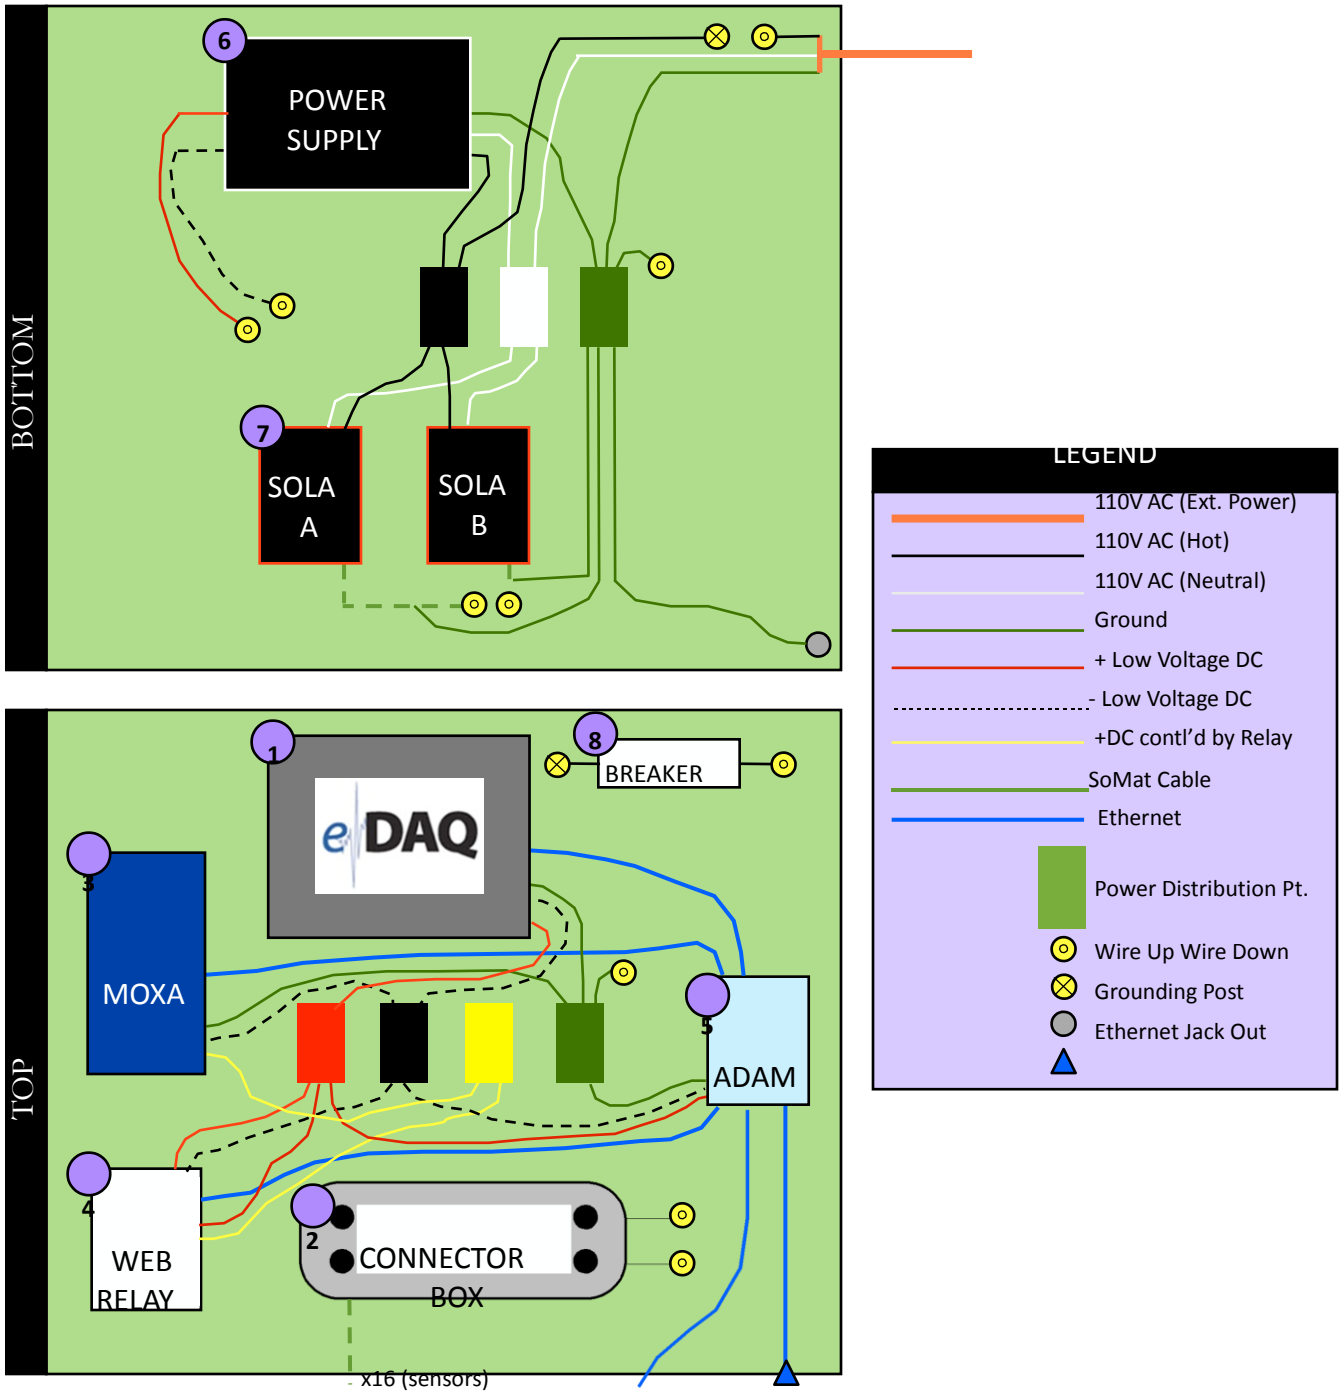
Figure 2.14 - Wiring diagram of top and bottom layers of enclosure in Floit House

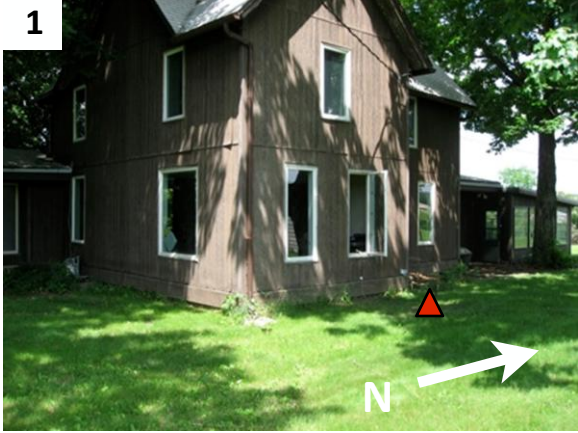
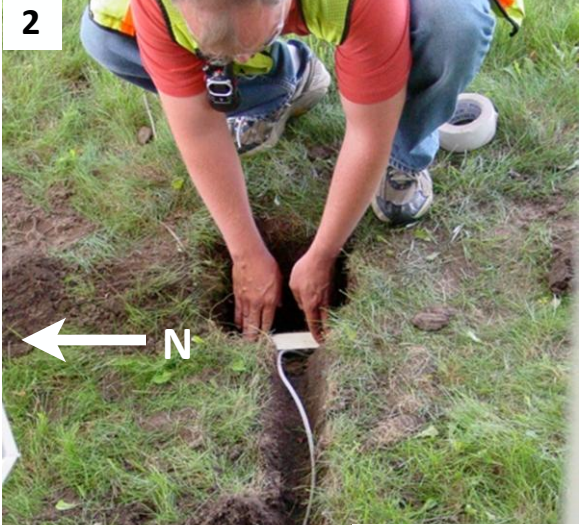
Figure 2.17 -
1 - Southeast corner of house showing seismograph (triaxial geophone) location
2 - View from house of trench and buried geophone
3 - Close-up of buried geophone with longitudinal axis pointing north toward the quarry

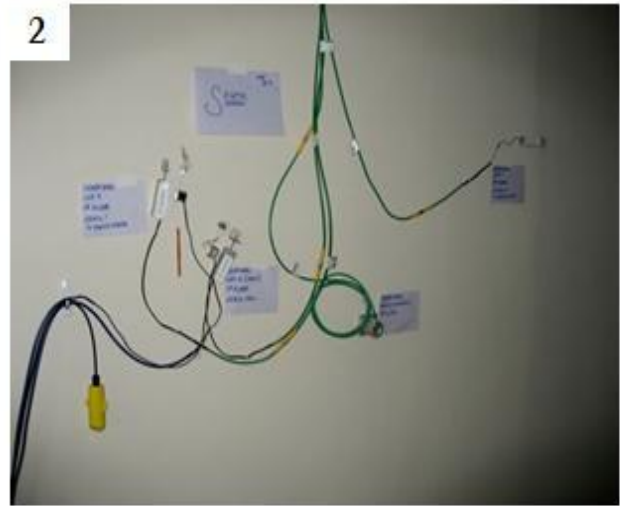
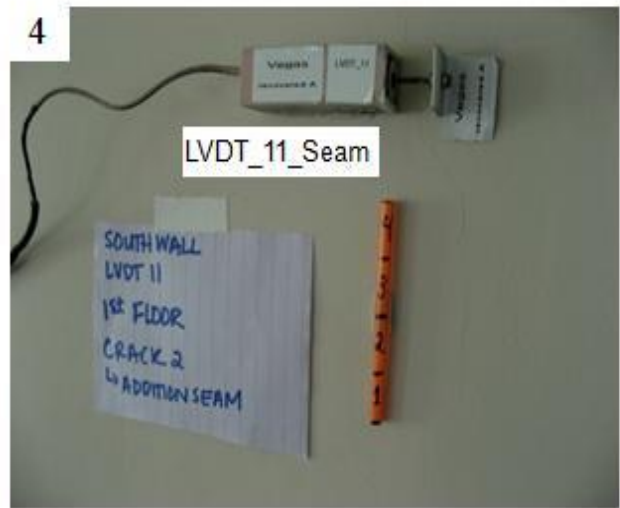
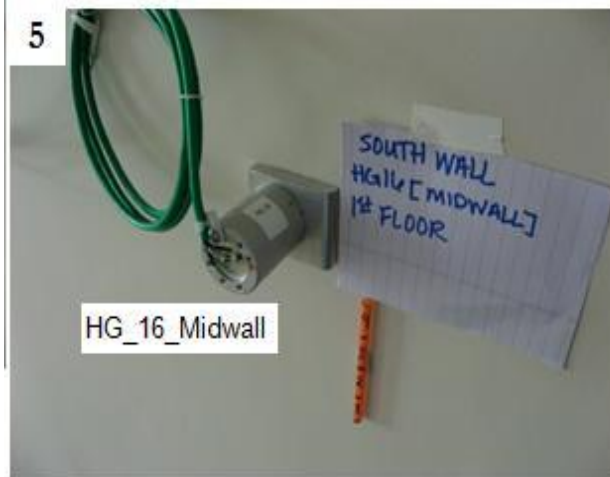
Figure 2.19 -
 1 - Overall view of sensor suite on south wall (first floor)
 2 - Closer view of suite on south wall
 3 - Close-up of Shear crack monitored by LVDT_9 and Null gauge LVDT_10
 4 - Close-up of Addition Seam crack monitored by LVDT_11
 5 - Close-up of midwall geophone monitored by HG_16

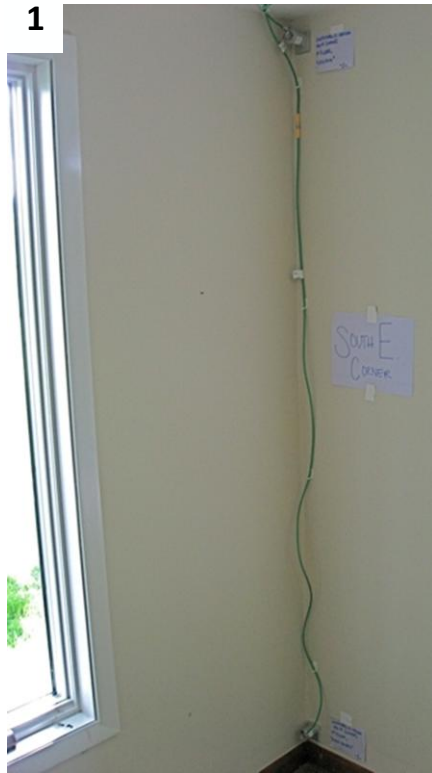
Figure 2.20 -
 1 - Overall view of southeast corner geophones on first floor

2 - Close-up of top geophone monitored by HG_14

3 - Close-up of bottom geophone monitored by HG_13

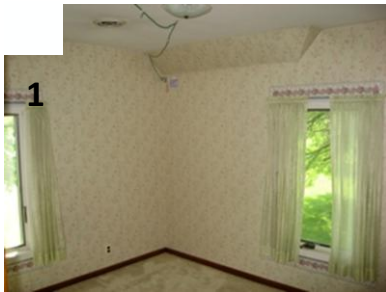
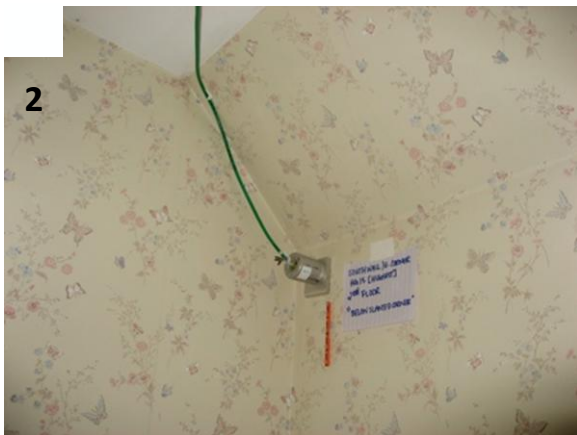
Figure 2.21 -

1 - Overall view of second floor bedroom geophone on south wall

2 - Closer view of geophone below slanted ceiling in top corner

3 - Close-up of top geophone monitored by HG_15
