*Comparative Field Qualification of ACM and ACSM
Systems at Sycamore, IL*

Introduction

The purpose of this comparative field qualification is to demonstrate the new Kelunji EchoPro hybrid ACSM system and its performance relative to the eDAQ and eko Motes systems. These three systems are installed at a test site in Sycamore, IL, adjacent to an active quarry. Data for this report was collected during a period between March 7, 2011 and May 13, 2011. The analysis includes a comparison of the long-term results for all three systems and a comparison of the dynamic results and noise levels for the eDAQ and the Kelunji EchoPro systems.

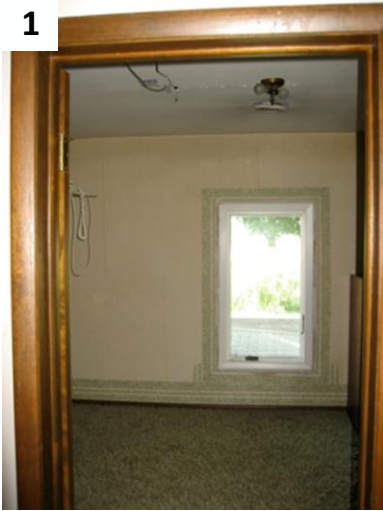
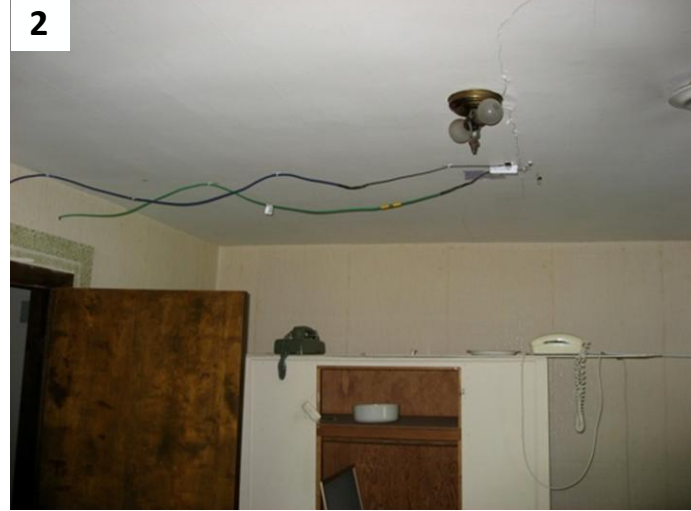
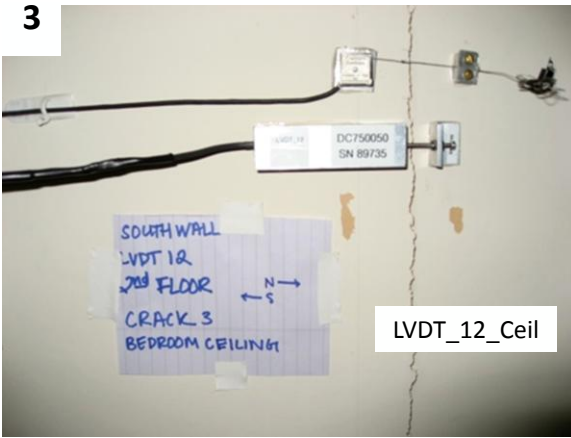
Figure 2.22 -

1 - Overall view of ceiling crack from hallway outside bedroom (looking North)

2 - Closer view of ceiling crack inside bedroom (looking West)

3 - Close-up of ceiling crack monitored by LVDT_12

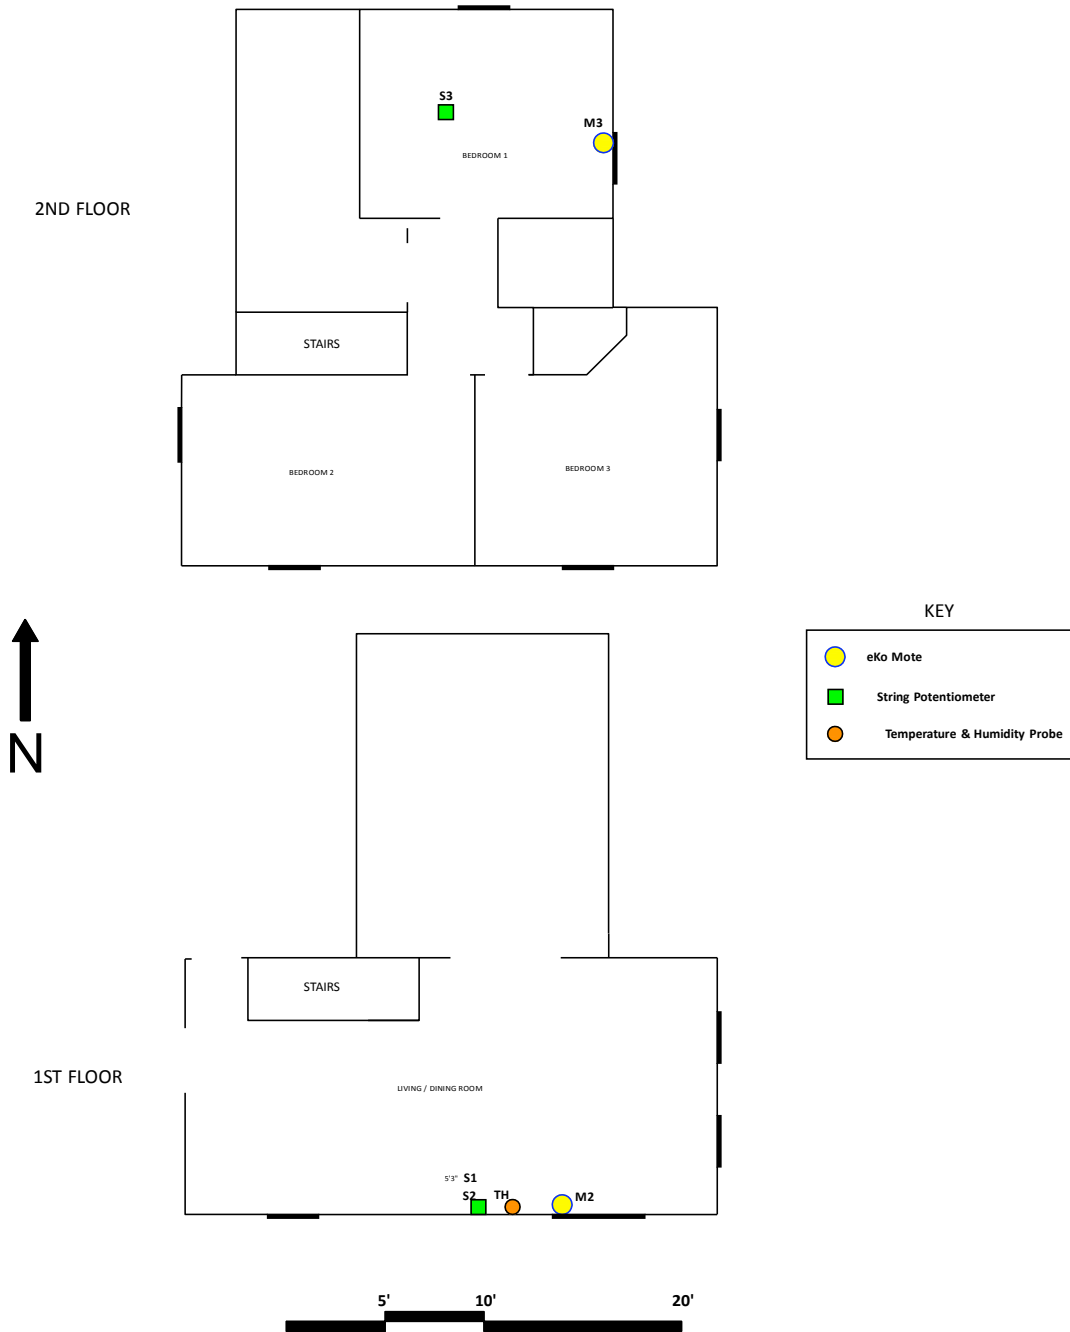
Figure 2.7 - Exact sensor and equipment locations within house. Measure given is distance up wall

The Floit house is outfitted with 3 high precision String Potentiometers (Firstmark Controls 150 series). S1 and S3 measure cracks, while S2 is a null gauge. **Figure 2.7** shows the exact sensor locations within the house and **Figures 2.8-2.11** show photographs of the installed equipment.

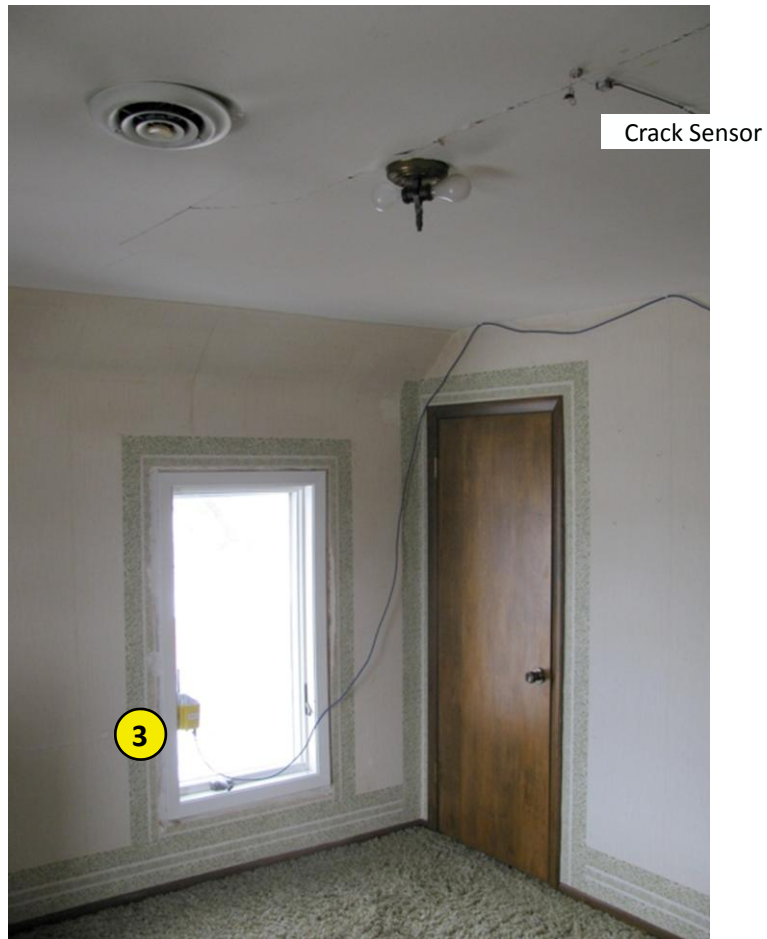
Figure 2.10 - Interior view of Node 3 in upstairs bedroom. Crack sensor connected to eKo Mote.
