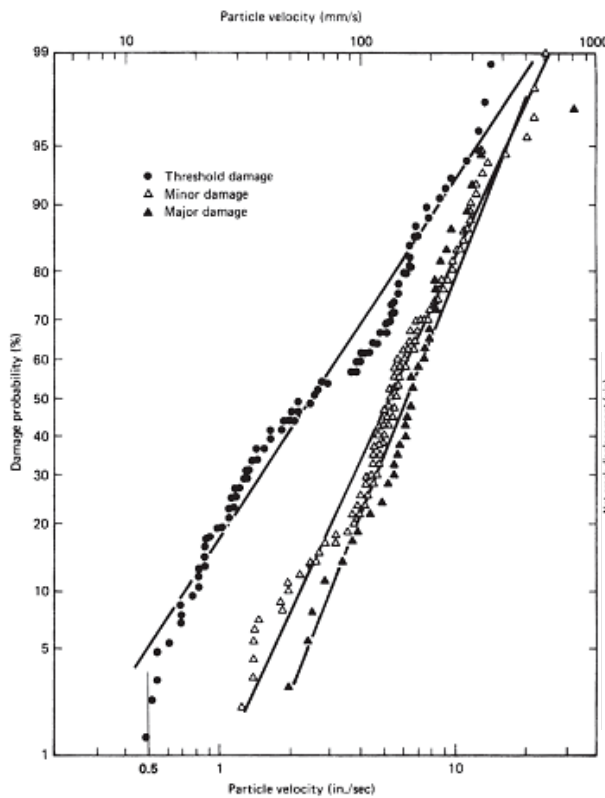
Figure 1(left) Probabilistic analysis of the threshold of cosmetic cracking demonstrates the absence of data below a peak particle velocity (PPV) 12.7 mm/s or 0.5 ips and leads to a conclusion of zero probability of cracking below 12 mm/s for even low frequency excitation. (Siskind, 2000).

Verticality at 0.5 ips (12 mm/s) of the relationship between cosmetic cracking (damage) probability vs particle velocity in Figure 1 (Figure 59 from USBM RI 8507 study) implies that the probability becomes zero at lower peak particle velocities. Results of this study with visual inspections for cracking immediately before and after blasting events were analyzed with the assumption that every cracking observation excludes the possibility of non-cracking at a higher particle velocity. Calculating probability of cracking as the percentage of observations at lower levels of velocity results in the log-normal scaled plot of the probability of cracking versus particle velocity in Figure 1.

This zero probability conclusion was reached by Siskind in his summary book (Siskind, 2000). As shown there is a lower limit of PPV of 12.7 mm/s (0.5 in/sec) below which no cosmetic or threshold cracking (or extension of hair-line cracks) has been observed from blasting. Data in this low PPV region were reported by Dvorak (1962) for low frequency (~ 4 Hz) excitation of older plaster and lath walls. The seminal RI 8507 study was not able to detect even threshold cracking at PPV's below 20 mm/s (0.79 ips) with even a lower level definition of the threshold of cracking then used in previous studies. Since publication of RI 8507 in 1980 only one case of cosmetic cracking at a low PPV has been observed. It was observed in a plaster and lathe walled house with a PPV of 37 mm/s (1.46 ips) that included a 6 Hz driving pulse with a PPV of 13.4 mm/s (0.53 ips). See Newsletters 5, 14 and 15 for further discussion of the implication of driving pulses.

These examples demonstrate that crack responses to PPVs at 12 mm/s (0.5 ips) fall far enough below responses to daily effects that no cracks are produced to be observed below that limit. This lack of crack observations led to the probability of cracking v PPV graph in Figure 1 to turn vertical at 12 mm/s or 0.5 ips.

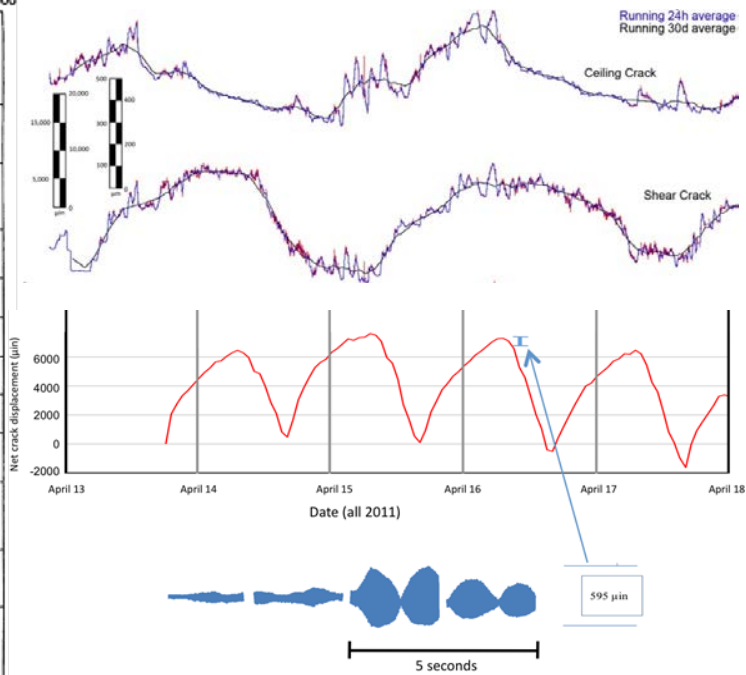
Figure 2(upper right) Shear & ceiling crack response of more than 262 µm (10,500 µ-in) over a two year weather cycle where a quarry blast with a PPV of 13 mm/s (0.52 ips) produces 10 µm crack response demonstrates why blasting would produce insufficient distortion to exceed that of natural causes.

Figure 3 (lower right) Daily climatological crack response (red) of 150 µm (6000 µ-in) compared to 15 µm (595 µ-in) induced by a vibrating roller (blue) producing a PPV of 12 mm/s (0.48 ips) at the wall containing the crack.

Measurements of crack response shown in Figure 2 over a two year period in the Sycamore, IL test house further demonstrate the overwhelming effect of climatological effects. (Abeel, 2012). The zero to peak (~ one half peak to trough) yearly cycle response is over 260 μm for the shear crack, which is about the thickness of three sheets of paper. Anyone with a wall-papered house (like my 1908 vintage home with large settlement cracks) where wall paper spans a crack can attest to the large yearly expansion and contraction of cracks that bunches the wall paper at the crack. For comparison, the Sycamore quarry blasts that produce PPVs of 13 mm/s (0.52 ips) at the test house produce only 10 μm of ceiling crack response, which is only 1/26 or 4% of that produced by the yearly weather (and home heating) cycle. Deactivating heating produced another, separate cosmetic crack. At that time the shear crack had expanded more than 1.2 to 1.3 times the maximum recorded (Dowding et al, 2015)

Vibration-induced crack response has to be large to overcome the continual, daily opening and closing of cracks like that shown **in red** in Figure 3 to produce a permanent change. This large daily, climatologically-induced change in crack width of 150 μm (6000 $\mu\text{-in}$) was measured across a crack on a south facing stucco wall in Albuquerque, NM. Also plotted **in blue** to scale (amplitude, not time) for comparison is the 15 μm (595 $\mu\text{-in}$) response of that crack to a PPV of 12 mm/s (0.48 ips) produced by a large roller vibrating at 35 Hz in front of the wall containing the crack. The average rate of opening and closing of this crack is 150 $\mu\text{m}/12$ hrs or 12.5 μm (500 $\mu\text{-in}$.) per hour. Thus changes in temperature and humidity opens or closes the crack in 1.2 hours (15/12.5) the same amount as will one passage of a large roller producing a PPV of 12 mm/s.
