Long Term Field Measurement of Micro Inch Crack Response to Climatological and Blast Vibration Induced Effects

Charles H. Dowding¹, Ph.D., P.E., M.ASCE, and
Pierre-Alexandre Abeel², M.ASCE

ABSTRACT: This paper compares more than two years of micro inch crack displacement response and structural velocity response of a wood frame house adjacent to an operating aggregate quarry. The same transducers that monitor long term, climatologically induced micro inch crack response also measure dynamic responses induced by blast induced ground motions, occupant activities and wind gusts. The two story house has been expanded several times, is founded on an irregular basement, framed in wood and clad with wood siding and clapboard. This project is part of a larger research effort of structural health monitoring via autonomous crack monitoring [ACM]. The unusually long monitoring period allowed observation of two maximum, climatologically induced peak crack responses, and as such represents one of the longest periods of continuous observation in the literature. These once a year peak climatological responses are compared with unusually intensive ground motions in excess of that allowed by regu

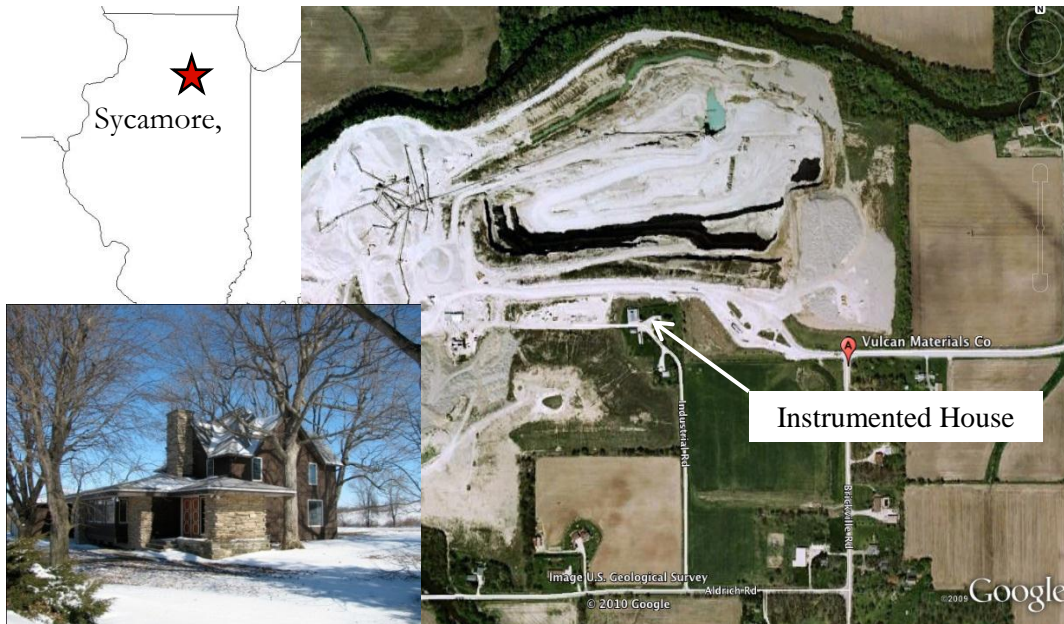
Figure 1. Overall view of Vulcan Materials, CO. Sycamore Quarry and photograph and location of the instrumented house

The instrumented house is a two-story wood-framed structure with a basement foundation. It is located approximately 300 feet (91m) away from the edge of the blasting zone of Vulcan Material, Co. Sycamore #397 Quarry. The house and its location are shown in Figure 1.

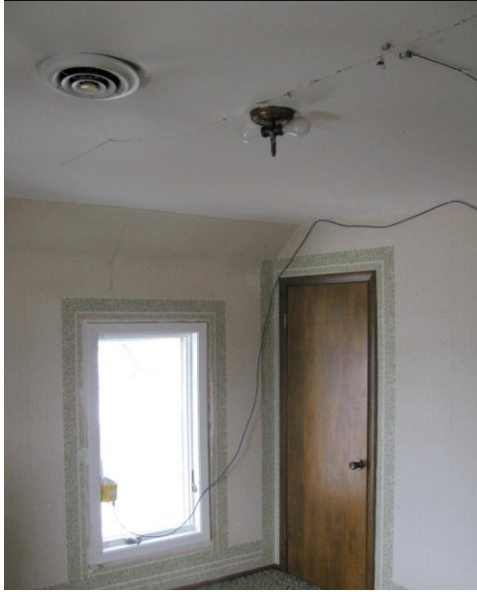
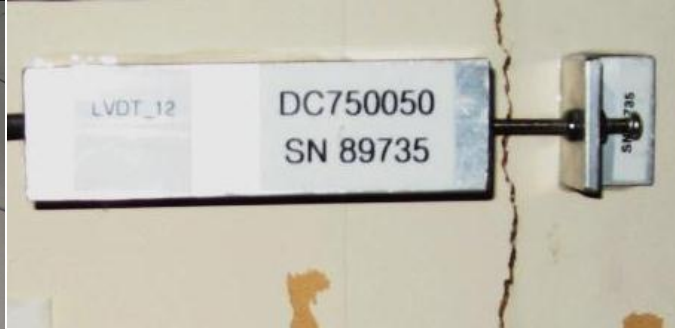
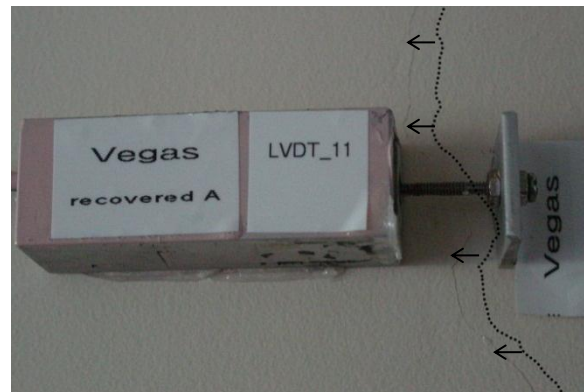
Figure 3. Overall views of the wall-mounted crack sensors

↑ a - Close-up of ceiling crack monitored by LVDT_12

← b - Upstairs bedroom ceiling showing the location of the crack and the transducer

↑ c - Overall view of sensor suite on south wall (first floor)

↗ d - Close-up of Shear crack monitored by LVDT_9 and Null gauge LVDT_10.

→ e - Close-up of Addition Seam Crack monitored by LVDT_11

(NB : The crack paths are indicated by the offset parallel dotted lines)

LVDT displacement sensors have been installed to monitor the in-plane responses of three cracks. Table 2 describes the locations, purposes and sensors used for each crack.

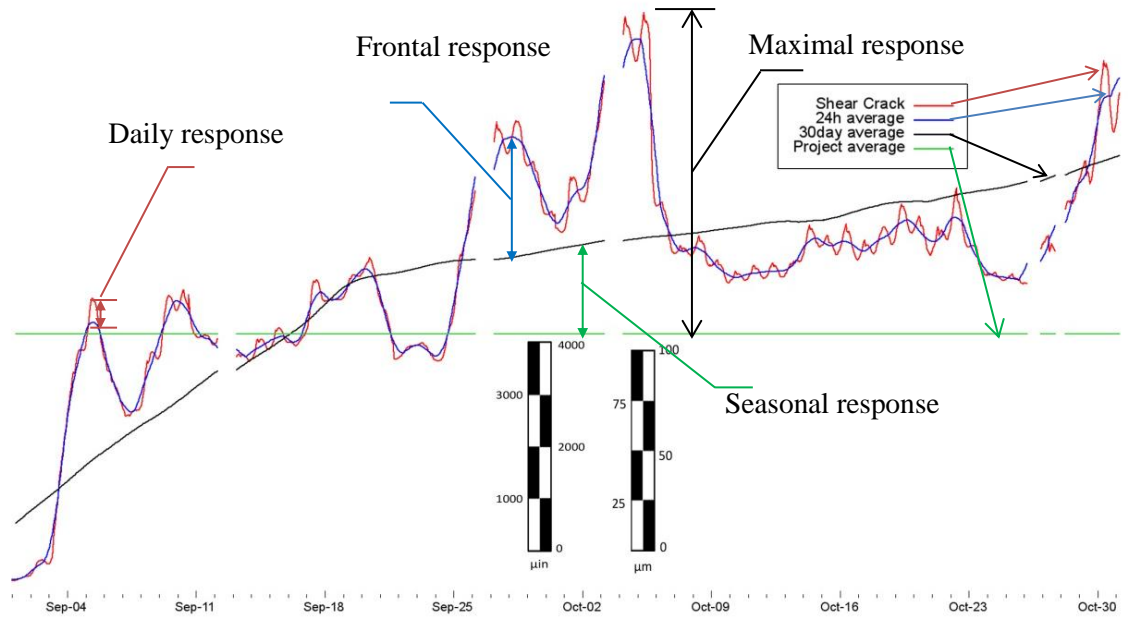
Figure 5. Crack response caused over the course of two months as shown in Figure 6

Climatic responses are defined in Figure 5 to clarify the time scales of these influences. Daily response is defined as the difference between the hourly data and the 24-hour CMA (red arrow). Frontal response is defined as the difference between the 24-hour CMA and the 30-day CMA (blue arrow). Seasonal response is the difference between the black, 30-day CMA curve and the green overall average curve (green arrow). Finally, the maximal response is the sum of the daily, frontal and seasonal effects, which is the difference between the red hourly data and the overall average curve (black arrow). The maximum values from Figure 6 are listed in Table 3.

Long-term crack response is measured every hour as the average of a burst of 1000 sample in one second. Figure 5 presents a two month fragment of the whole project that will be seen again later in this paper. Long-term response to date (28 months) is compared for all three cracks in Figure 6 with indoor temperature and humidity. This hourly data is represented by the red, most highly variable line in Figures 5 and 6. The less variable blue line is a 24-hour central moving average (CMA) of the hourly data, which shows the response to weather fronts. The even less variable black line is a 30-day CMA of the hourly data, which shows the response to seasonal trends as it varies about the 2 year average green horizontal line.

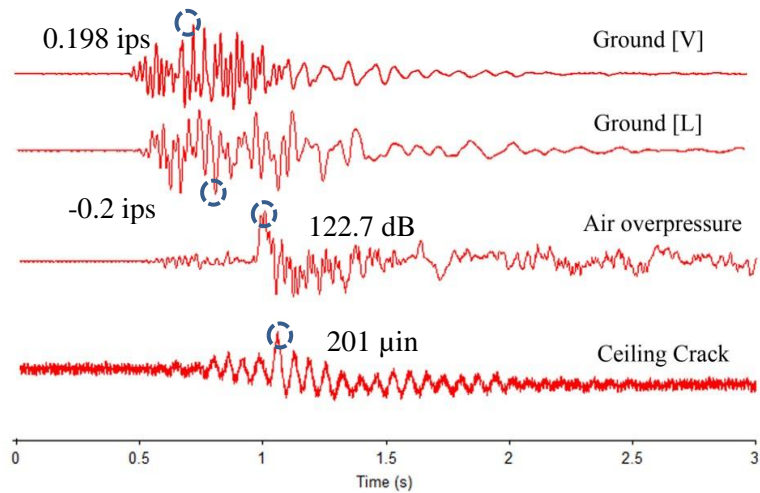
Figure 8. Influence of late arrival of air overpressure – Blast event on May 11, 2011. Measurements are zero-to-peak.

As shown in Figure 8, the air overpressure can cause crack response, especially when the ground vibrations are low. The late arrival of that air overpressure can even be responsible for a larger crack response than the ground vibrations themselves for the ceiling crack, as presented for the blast on May 11, 2011 (Max PPV = 0.201 ips = 5.1 mm/s).

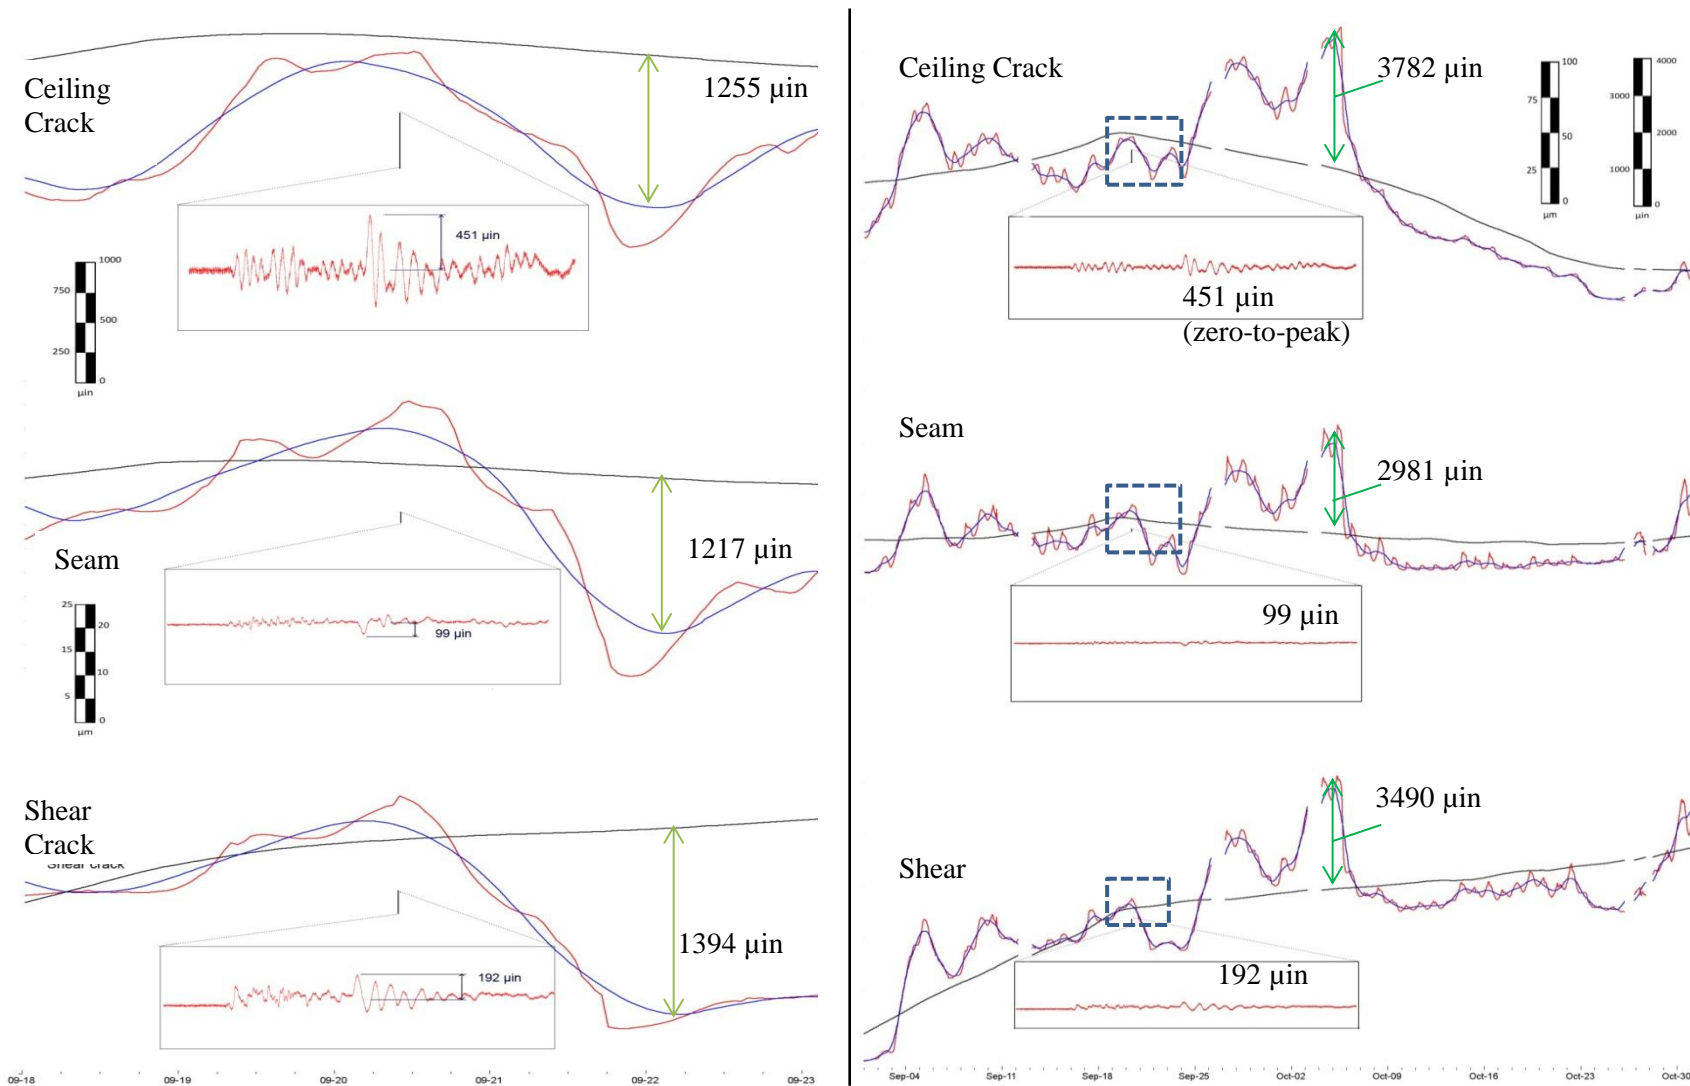
Figure 13. Comparison of zero-to-peak crack response to environmental effects over the course of two months (top) and one week (bottom, delimited in dashed boxes) with that produced by the PPV=0.219in/s event. (1 μin =0.0254 μm , 1in/s=25.4mm/s)

Time histories of crack responses to the 0.219ips blast in Figure 13 can be compared with the long-term climatic response in Figure 6. This comparison is made with the two-month timespan bounded by the vertical dashed lines in Figure 6. Two months of data illustrate the large effect of the passage of large weather systems/fronts. Blast responses are compared to the week of climatic response delimited by the dashed blue rectangle on Figure 13 (top). This week-long comparison illustrates the daily environmental fluctuations that are superimposed over the longer term effects.

Long-term and dynamic responses are plotted on the same vertical scale for both comparisons. The small black vertical bar on September 20th represents the maximum magnitude of the dynamic response, which is expanded in the rectangular box below the graph. Figure 13 shows that the environmentally induced response during the week surrounding the blast event is approximately an order of magnitude larger than the blast induced response. A similar conclusion was reached by Kosnik (2008) and Meissner and Dowding (2009).
