**Crack Response of a Historic Structure to Weather Effects and  
Construction Vibrations**

A Thesis

Field of Civil Engineering

REMI BAILLOT

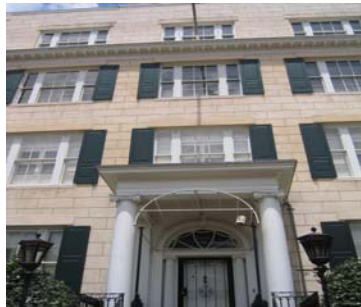
**Figure 2-1: Front view of the façade of the instrumented house.**

Road construction immediately in front of the historic structure shown in Figure 2-1 led to concern over possible cracking. Midway through the project the Autonomous Crack Measurement system was installed as a means of determining the effect of construction induced vibrations. The ACM system was in place for three months from July to October while utilities in the sidewalk were replaced and the roadway surface was repaved.

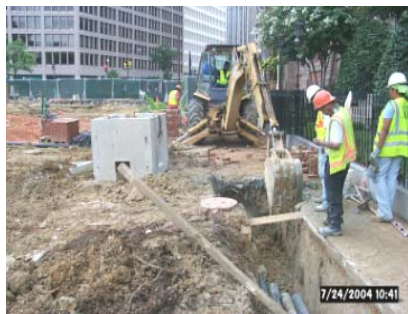
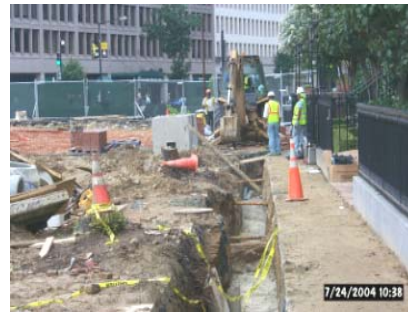
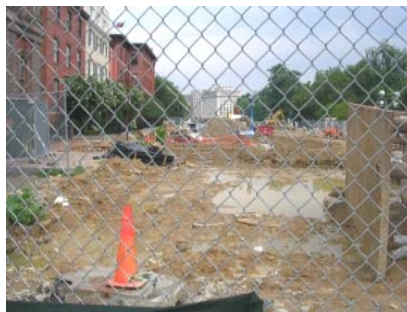
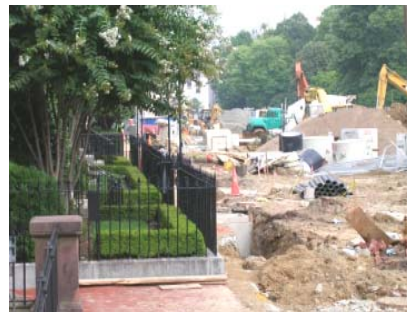
**Figure 2-3: Trenching activities within two meters of the structure.**

Reconstruction activities during the period of observation included the excavation of a 1-meter wide trench several meters from the façade of the house. The four photographs in Figure 2-3 show details of the excavation. As shown in the upper two photographs, trenching was performed in front of the house around the 24<sup>th</sup> of July 2004 by backhoe. Jackhammers were also in use very close to the house by the end of the construction.

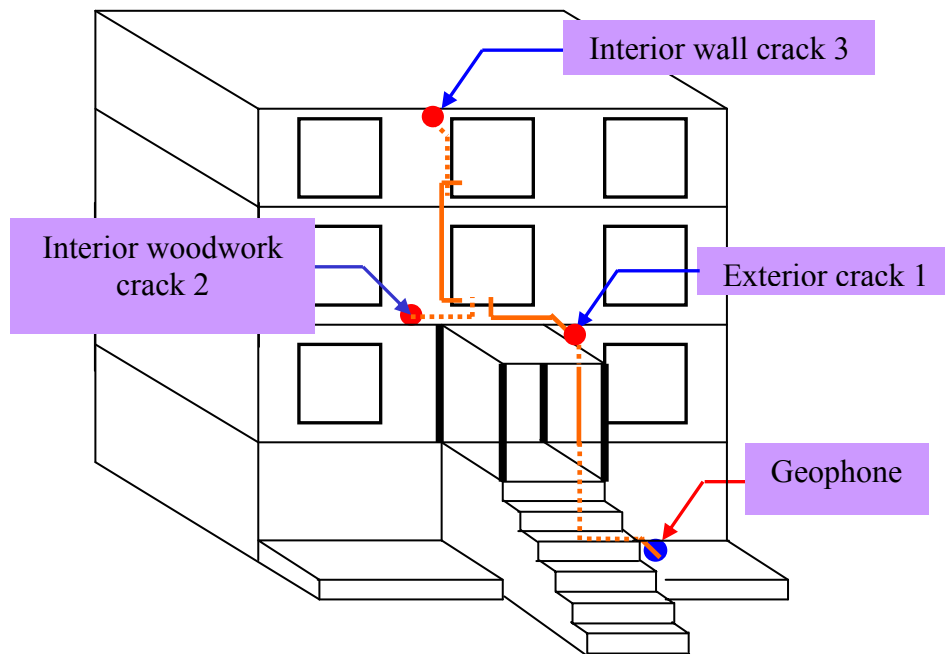
As shown in Figure 2-4, the structure was instrumented with a geophone to record ground motion and 3 sets of sensors to measure changes in crack width. Figure 2-4 shows both the plan location of the instruments (Figure 2-4 a, upper) and the elevation location of the instruments and wiring (Figure 2-4 b, lower). Details of the location of the geophone and crack sensors are shown in Figure 2-5. Each instrument is graphically described by a large scale location and a small scale detail photograph, which are related by the red colors and boxes.

**Figure 2-4: Three dimensional view of the instrumentation: a) (upper) expanded views of floors with x,y locations and b) isometric view with z locations.**

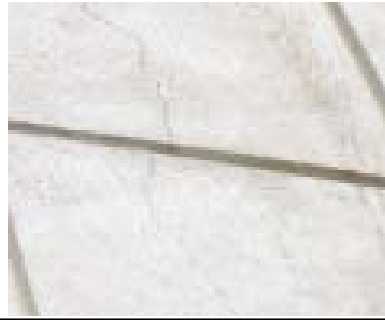
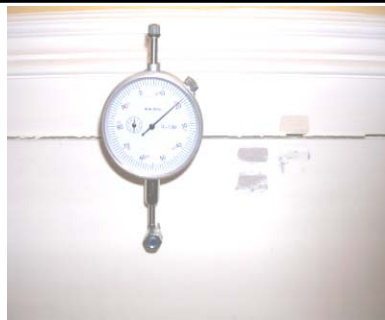
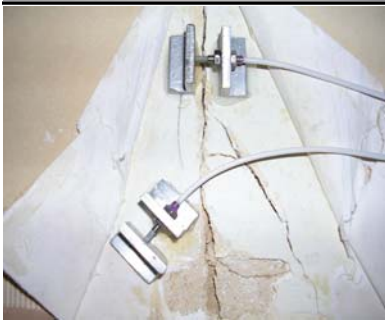
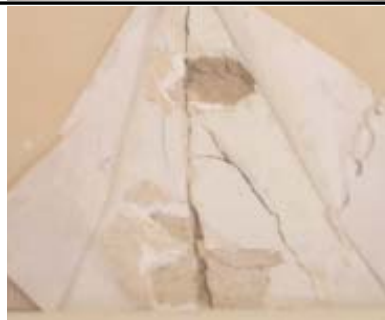
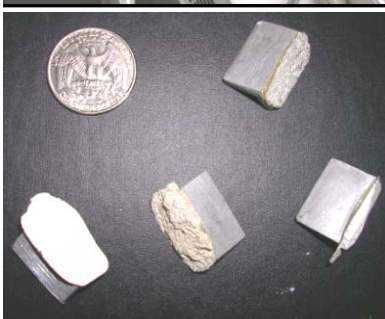
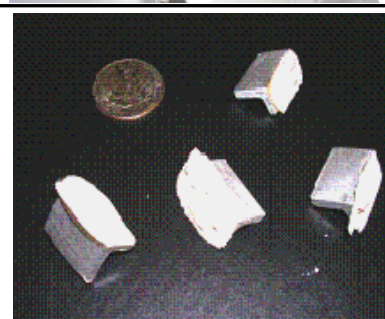
The removal of the Kaman sensors, humidity and temperature sensors inside and outside caused insignificant degradation to the building. The 5 pairs of photographs in Figure 2-8 show respectively on the left and right side the state before and after the removal for the three cracks, cable harness, and finally four brackets after they were removed from the outside stucco and inside wall plaster. Although the sensor bracket

mounts were epoxied to the walls, only small amounts of plaster or stucco remained on the brackets. Scuffing of the painted surface of the molding was even less.

**Figure 2-8: Before and after comparisons of insignificant degradation caused by removal of the instruments.**

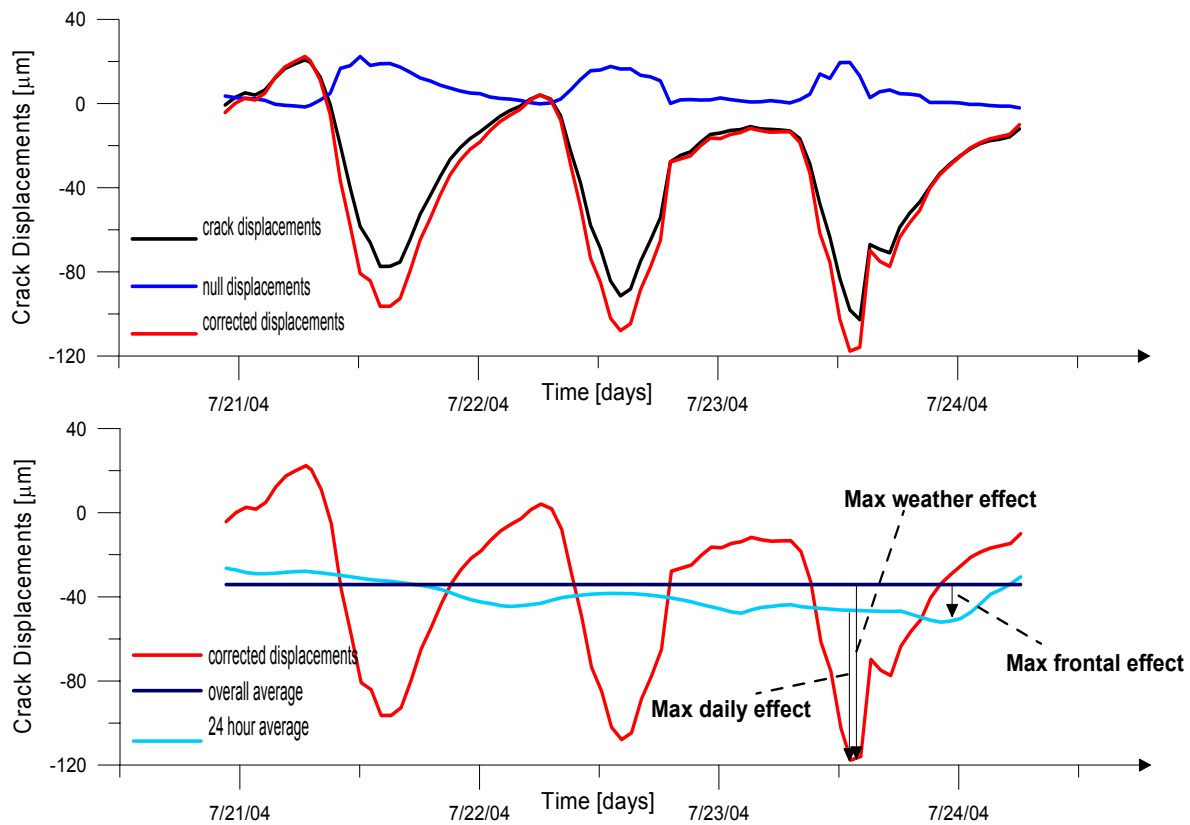
Null sensor readings are subtracted from crack sensor readings as shown in Figure 3-1. Displacements measured by the null sensor are due principally to temperature variations, which tend to expand and contract the metal of the sensor and the wall material. As this same phenomenon occurs for both null and crack sensors, the null sensor displacements are subtracted from the crack sensor displacements to obtain the “corrected displacements” which are those of the crack itself. As the graph shows, the “corrected displacements” are somewhat larger than the crack displacements by a few micrometers. All the following graphs are plotted with the correction mentioned above, therefore “crack response ” will explicitly mean “corrected crack response” for a question of simplicity.

Once the crack response obtained, the 24 hour rolling average is calculated and plotted as shown in Figure 3-1 b (lower). The 24-hour average was systematically calculated at each hourly measurement by averaging the data 12 hours before and 12 hours after each individual sample. See McKenna (2002) for details. The 24-hour rolling average has been calculated for responses of the all three cracks as well as exterior and interior temperature and humidity in the same manner.

**Figure 3-1: Typical crack displacements a) null correction b) weather descriptors and 24-hour average.**

The maximum frontal effect is defined as the absolute largest deviation between the 24-hour rolling average (blue) and the overall average (horizontal purple), which is the average of the field measurements over the full time-period. The frontal effect is shown by the farthest right vertical arrow. The maximum daily effect is defined as the absolute largest deviation between the 24-hour rolling average and the maximum field measurement. The last descriptor is the maximum weather effect (the largest vertical

The effects of the various changes in weather on crack displacement are compared to the vibration induced crack displacement in Table 3-1. The manner in which these effects were determined is explained in conjunction with Figure 3-1 b. Both an average and a maximum value relative to the overall averaging during the three months of observation are tabulated. Measurements of the construction vibration effects are described in the following chapter. The weather-induced effects on external crack 1 were significantly larger than for internal crack 2 and 3. Both the interior floor molding crack 2 and wall crack 3 will be the object of separate special studies of occupant induced response. This disparity in magnitude between internal and external makes sense, as the inside temperature and humidity are controlled and are not subjected to direct sunlight.

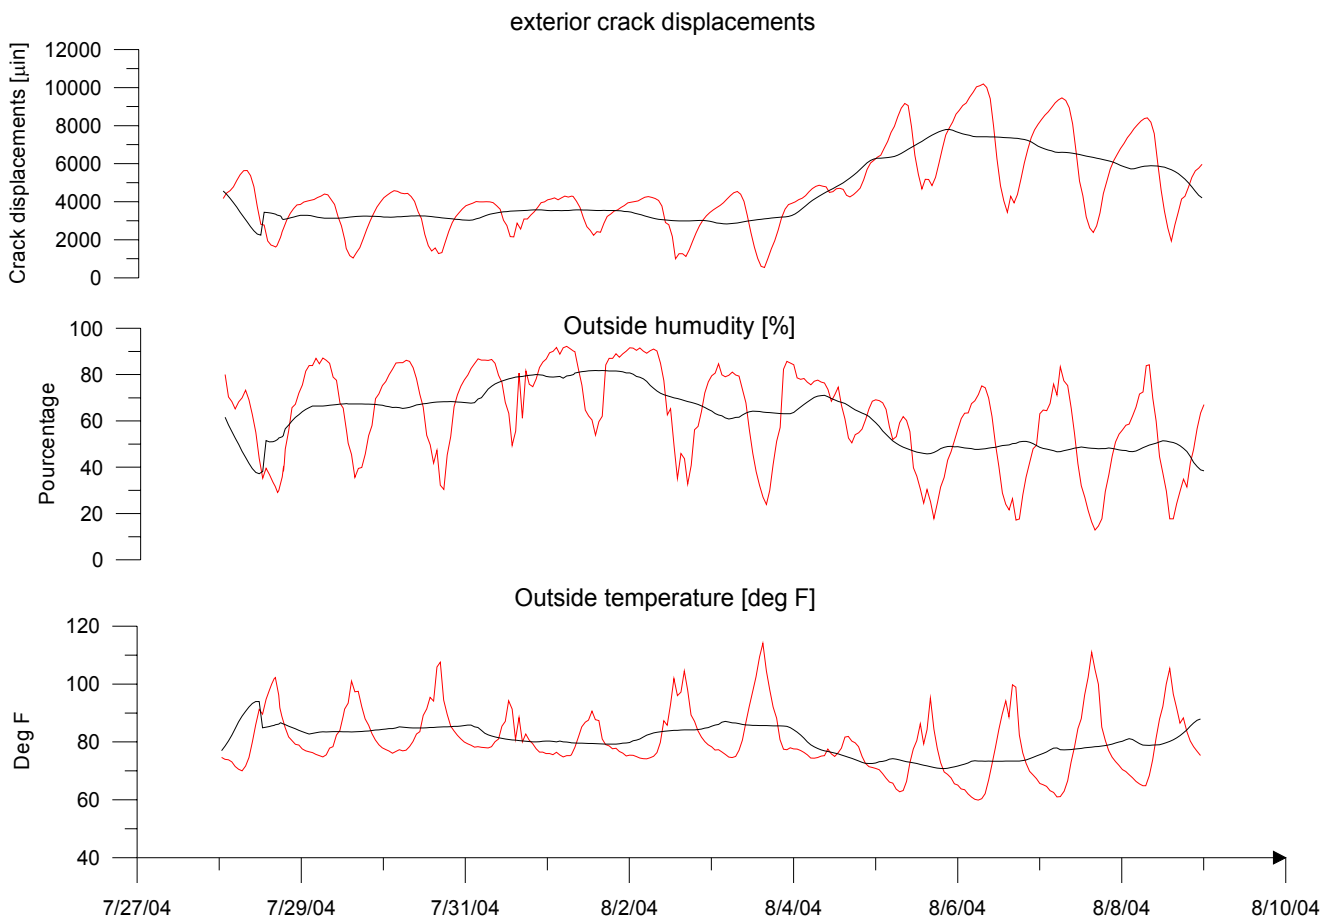
Figure 3-2 compares long-term crack response with long-term weather indicators for the exterior crack for a longer period (12 days). It compares long-term outdoor crack 1 changes to outdoor temperature and humidity. Temperature, humidity and crack displacement are always plotted on the same time-scale for graphical comparison. The red curve represents the field measurements whereas the black curve is the 24-hour average. This 12 day period shows both the daily responses as well as the passage of the weather front at the end (5 through 10 August).

**Figure 3-2: Long-term crack response and weather indicators.**

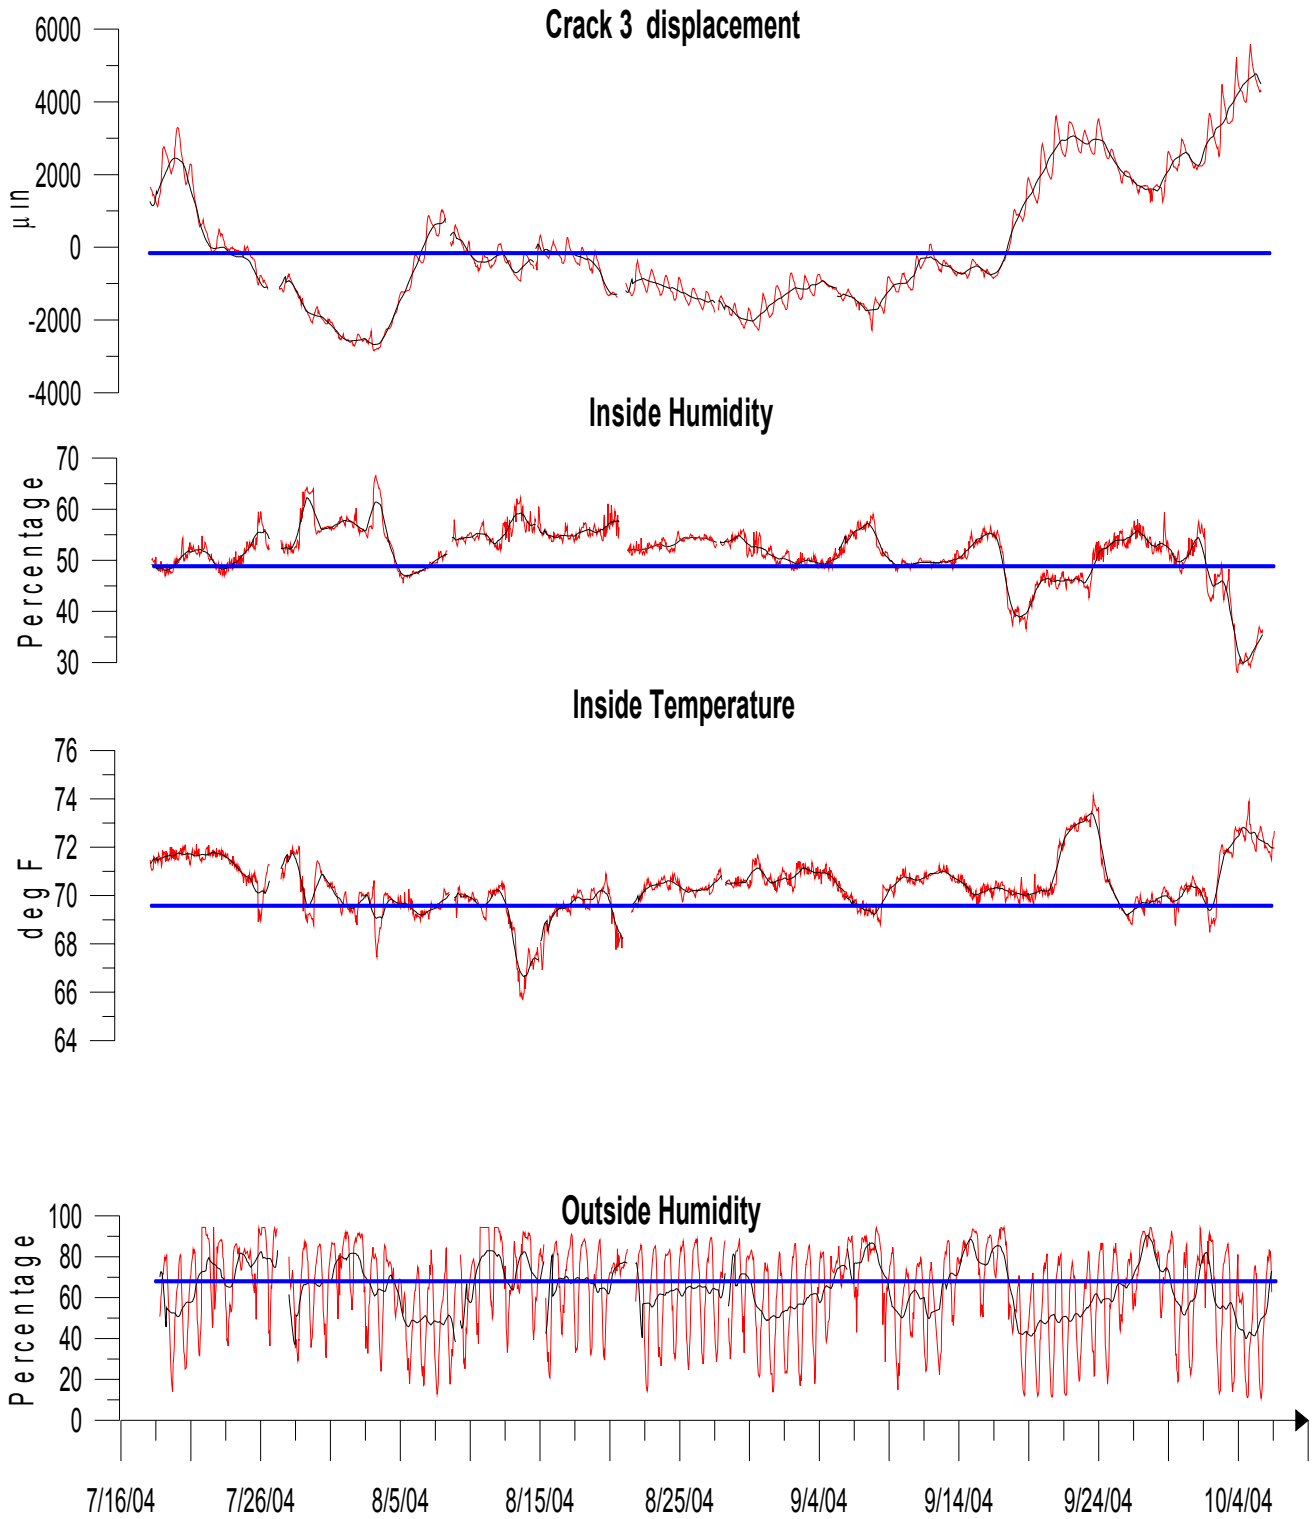
**Figure 3-5: Long-term external crack 3 displacement, outside temperature and humidity and outside humidity.**

Figures 3-3, 4 and 5 compare long-term response of cracks 1, 2 and 3 respectively, with long-term weather indicators. Temperature, Humidity and crack displacement are plotted on the same time scale. Crack displacement, humidity and temperature were measured hourly between the 19<sup>th</sup> of July 2004 and the 7<sup>th</sup> of October 2004. Figure 3-6 compares the long-term response of the three cracks where the differences described above are not easily observable. Null sensor response is also added (green) to demonstrate its insignificance. The large daily changes in the outside temperature and humidity are characteristic of an outdoor climate where the changes occur in a regular daily (temperature induced) pattern as well as a response to the passage of the weather fronts that occur on a quasi weekly cycle.

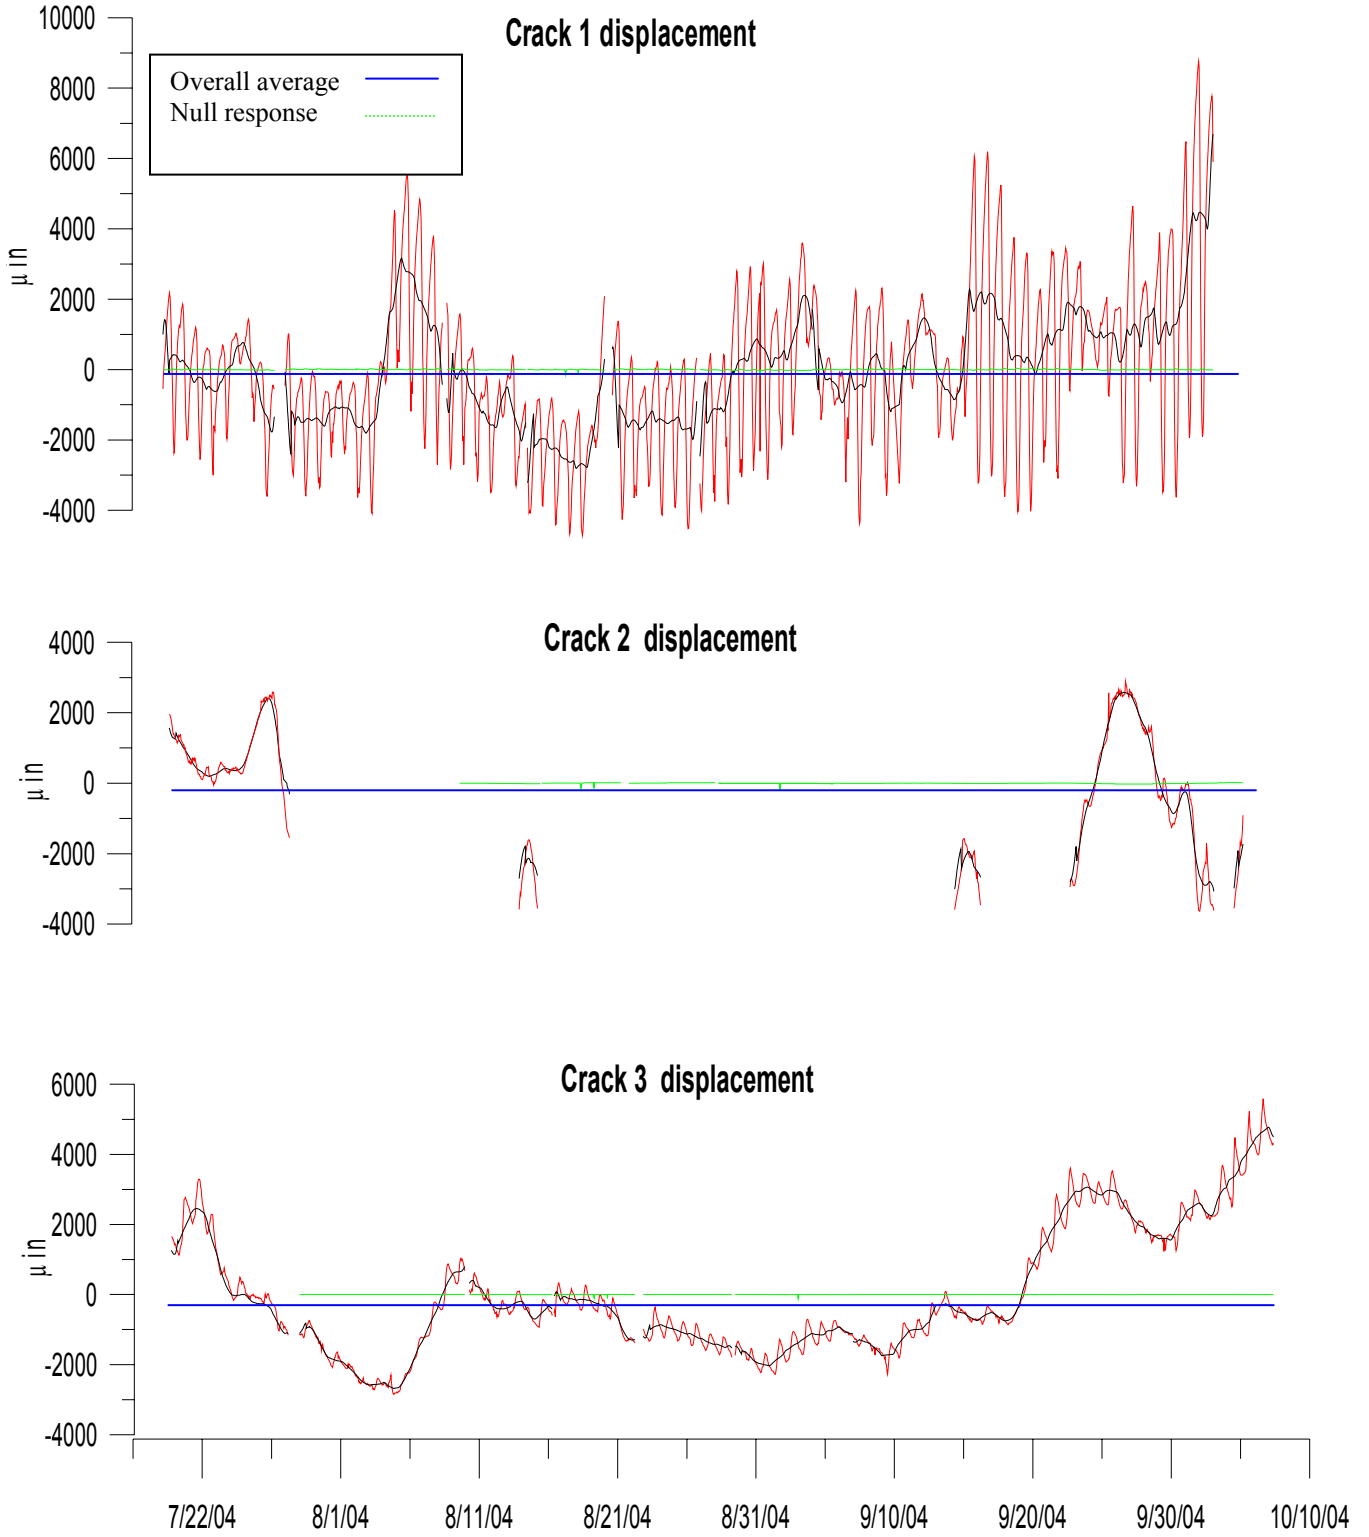
**Figure 3-6: Comparison of the long-term response of all three cracks and adjacent null responses.**

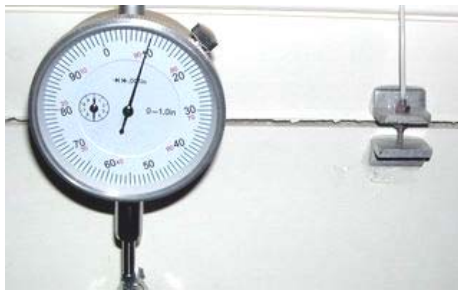
Between visits on 18 June and 28 July, the crack 2's displacement was so large that it went out of range. As shown in Figure 3-9 the dial gauge across this crack (installed by another group) showed a displacement of some 0.0115 in (287  $\mu\text{m}$ ), which explains why crack 2 sensor exceeded its 0.005 inch range. Among the possible causes of the unusually large-displacements was the large moisture driven response of wood.

**Figure 3-9: Large displacement of joint between two pieces of molding verified as dial gauge, a) the 6/18/04 and b) the 7/28/04.**

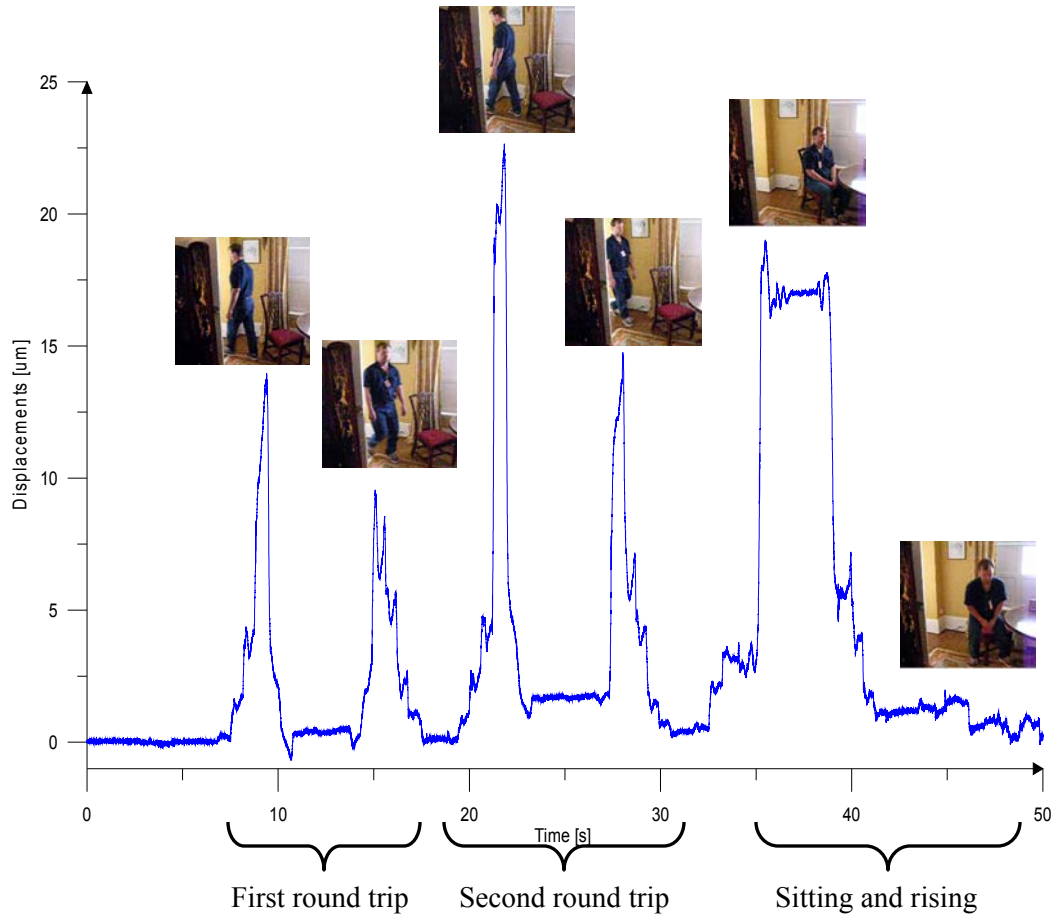
Manual triggering was employed by ITI staff while on site to collect interior crack 2 and 3 responses to occupant activity. Response of the molding joint crack (crack 2) was collected as a person walked back and forth twice and then sat on a chair near the crack. The sequence lasted fifty seconds, during which one point was collected every millisecond in order to accurately correlate crack response with respect to time of activity. Response of the wall crack (crack 3) was collected as a person walked through the doorway, leaned on the door's jamb or slammed the door. Data were collected every millisecond for crack 3 as well.

**Figure 3-10: Time sequence of crack 2 displacement and occupant activity.**

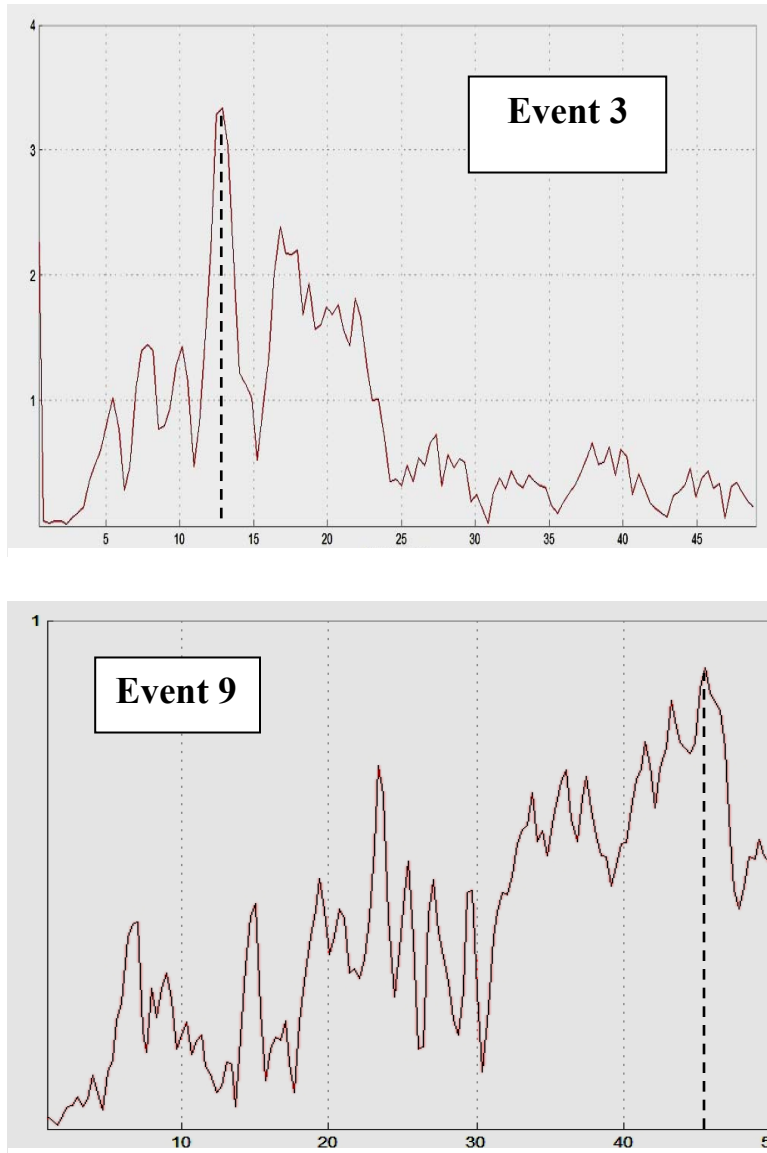
**Figure 4-4: Fourier frequency spectrum of excitation ground motion for backhoe events 3 and 9.**

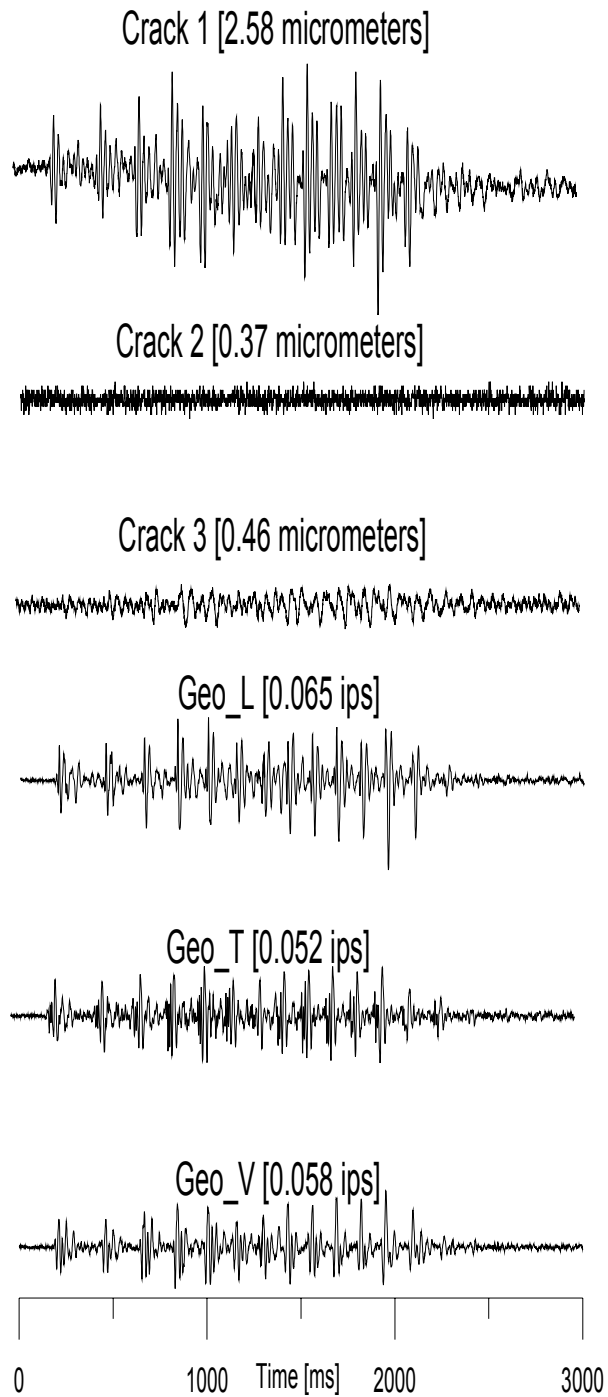
**Figure 4-5: Maximum response of crack 1, which responded the most to the jackhammer excitation.**

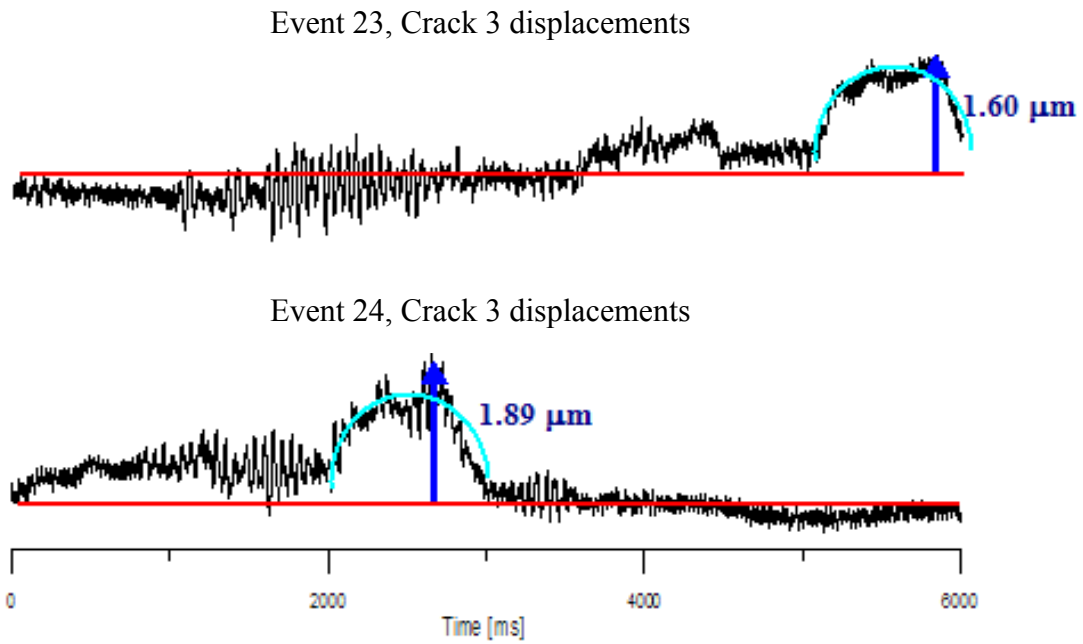
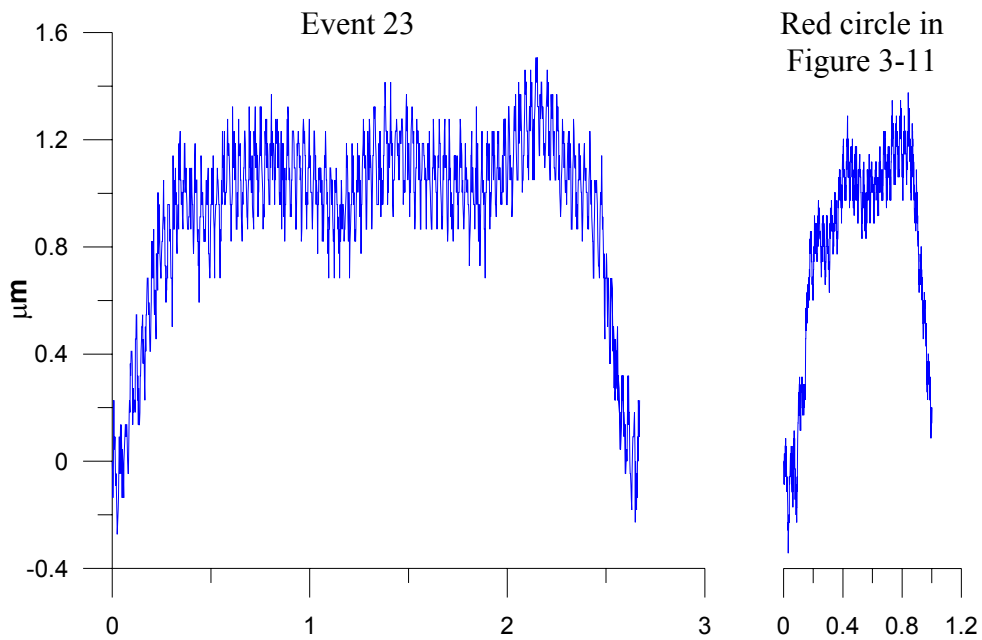
Figure 4-9 compares occupant induced crack 3 responses measured during jackhammer special study with response to events 23 and 24. The lower right time history is the crack 3 response to a quick lean on the jamb of the bathroom door (red circle in Figure 3-11), and the one on the bottom left occurred during jackhammering event number 23. Both crack 3 responses are similar. In both cases crack 3 expanded from a relative zero to approximately  $1.2\ \mu\text{m}$  ( $48\ \mu\text{in}$ ) in 0.4 seconds, and remained at that level until contracting over the same length of time. These rise times are similar to those observed during the occupant test for crack 2. The main difference between these two responses is that the left “arch” lasts 2.7 seconds whereas the right arch last less than 1.2 seconds. This difference is probably the result of the length of contact while leaning on the door’s jamb.

**a) Simultaneous occupant induced and jackhammer excitation**

**b) Comparison of occupant induced responses**

**Figure 4-9: Comparison of occupant induced crack displacements measured during jackhammering and special study.**

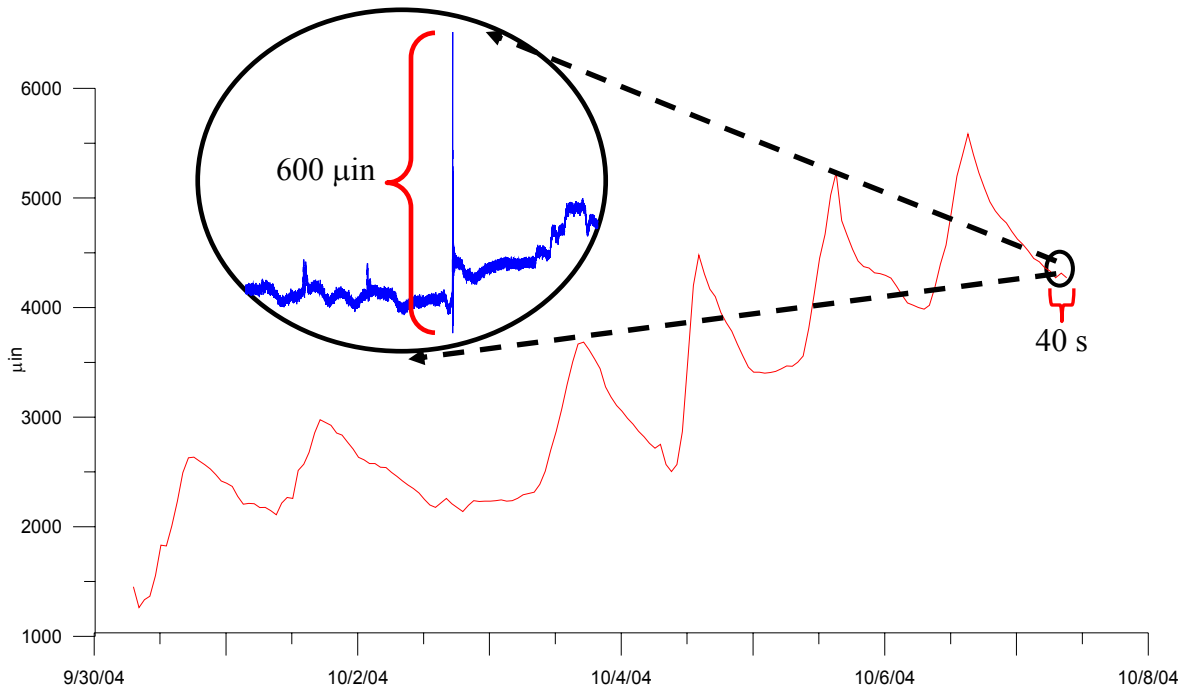
Figure 4-10 compares response of crack 3 displacement during an energetic slamming of the bathroom door and the long-term cyclic weather effects. The long-term effect is plotted over a period of 8 days (in red), whereas 40 seconds surrounding the door slam are expanded in the inset in order to be seen. This expansion itself demonstrates how large and significant are the long-term cyclic weather effects. As the graph shows, in 8 days crack 3 widened some 100  $\mu\text{m}$  (4000  $\mu\text{in}$ ) versus 15  $\mu\text{m}$  (600  $\mu\text{in}$ ) when the door immediately below was energetically slammed. The long-term effect is then more than seven times larger. Cyclic daily changes show that the crack opened and closed some 25  $\mu\text{m}$  (1000  $\mu\text{in}$ ) each day.

**Figure 4-10: Crack 3's 24-hour average and magnified door slam event.**

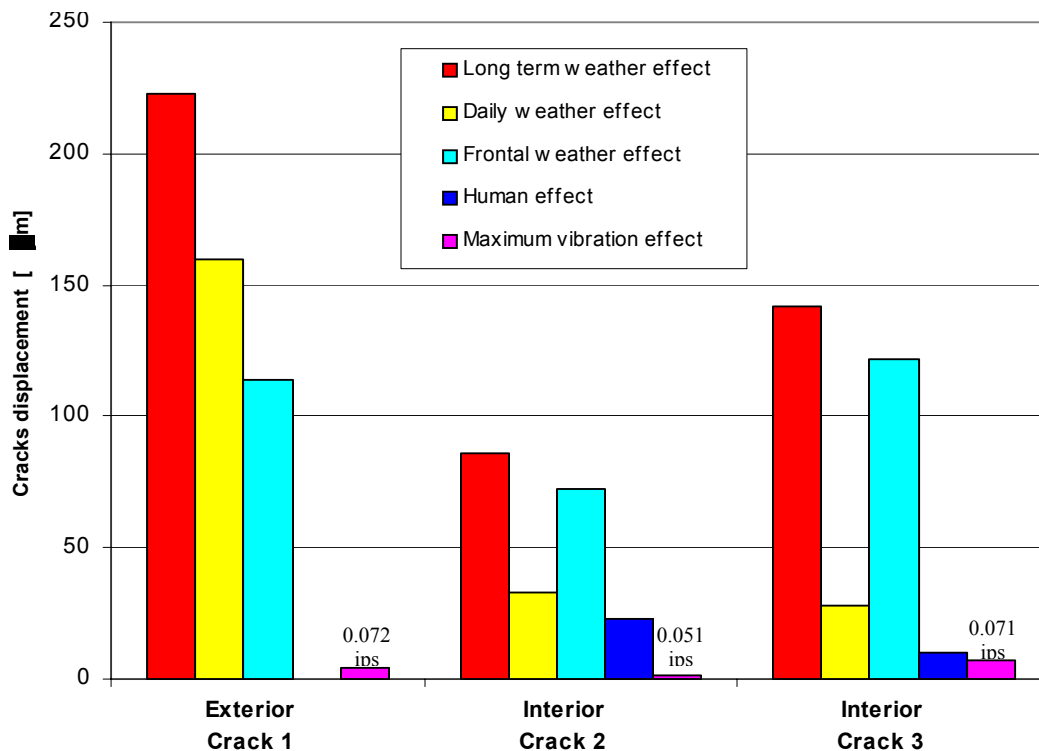
Figure 4-11 compares the long-term or weather with the construction vibration-induced displacement responses for the three instrumented cracks. The maxima of all three types of effects (weather, occupant and construction vibration) are compared. In all three cases the long term maximum weather effect produces the largest displacement, which is more than 10 times greater than that induced by the maximum vibration event during the adjacent construction. Daily effects dominated the response of crack 1 probably because of its direct exposure to sun on the south facing wall. On the other hand weekly or frontal effects dominate the response of the interior cracks 2 and 3. Occupant or human effects produced much greater effects than construction vibration. As discussed in the last section, simply leaning on the door jamb produces significant crack displacement.

**Figure 4-11: Comparison of weather, occupant and construction vibration induced displacement of all 3 cracks.**

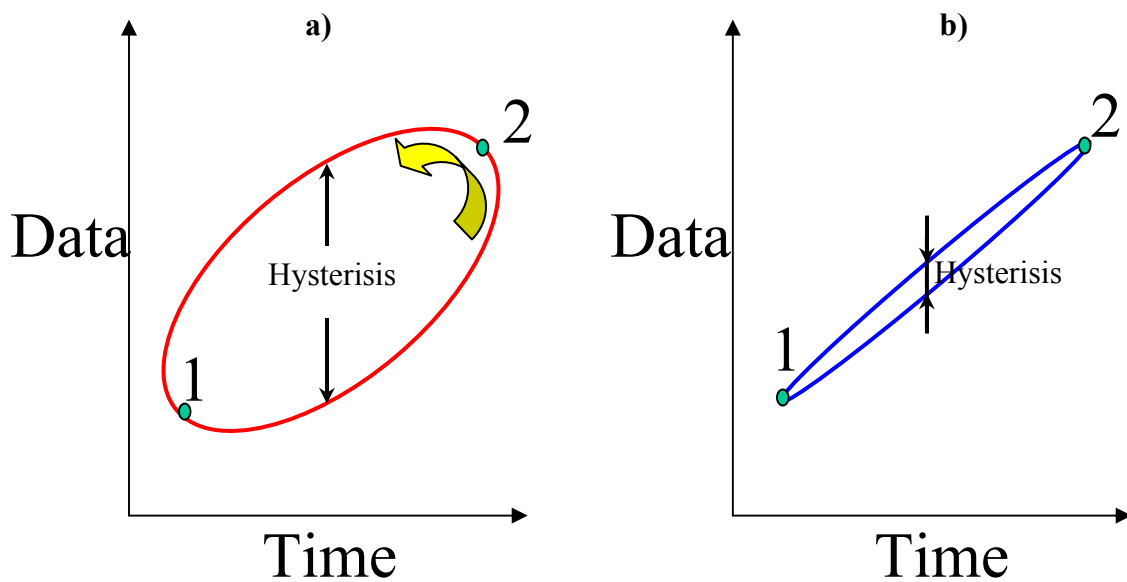
When a system, such as an LVDT sensor is placed across a crack, subjected to cyclic environmental changes over time (as occur inside and outside of structures) it should have a small hysteresis. Hysteresis is the difference between voltage output when the displacement is increasing and when it is decreasing over the same temperature range during one cycle. Figure A-1 illustrates large (a) and small (b) hysteresis where displacement (Data) varies temperature over time.

**Figure A-1: Illustration of Hysteresis during a temperature cycle, showing a) poor and b) good performance.**

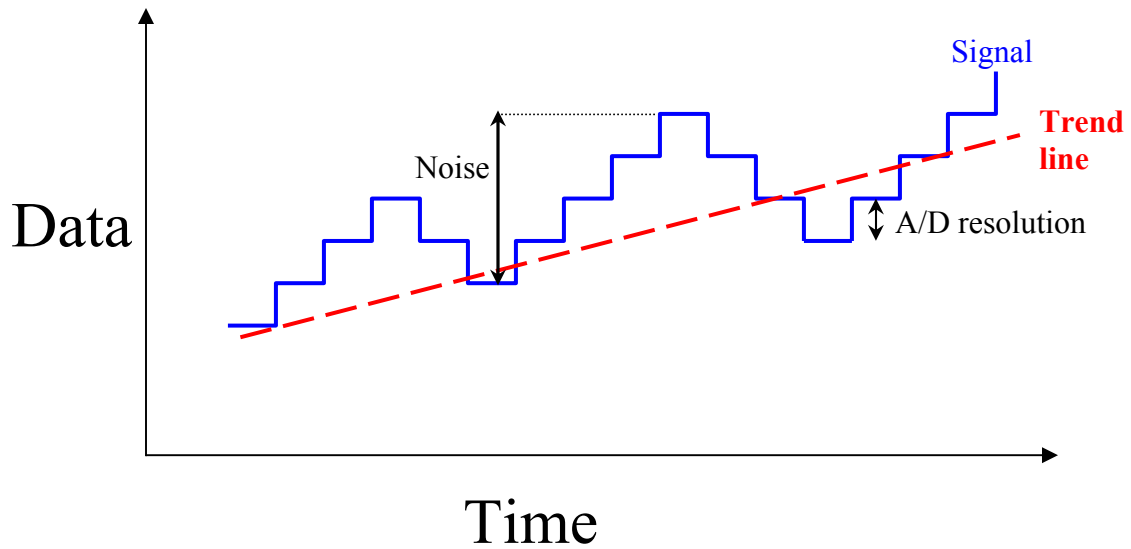
When crack displacements (data) are small the instrument noise level (or variation) shown in Figure A-3 must be smaller than the data trend over time as shown. In addition, the stair step analog to digital conversion resolution should be similar or less than the noise level.

**Figure A-3: Illustration of Noise during temperature variation.**

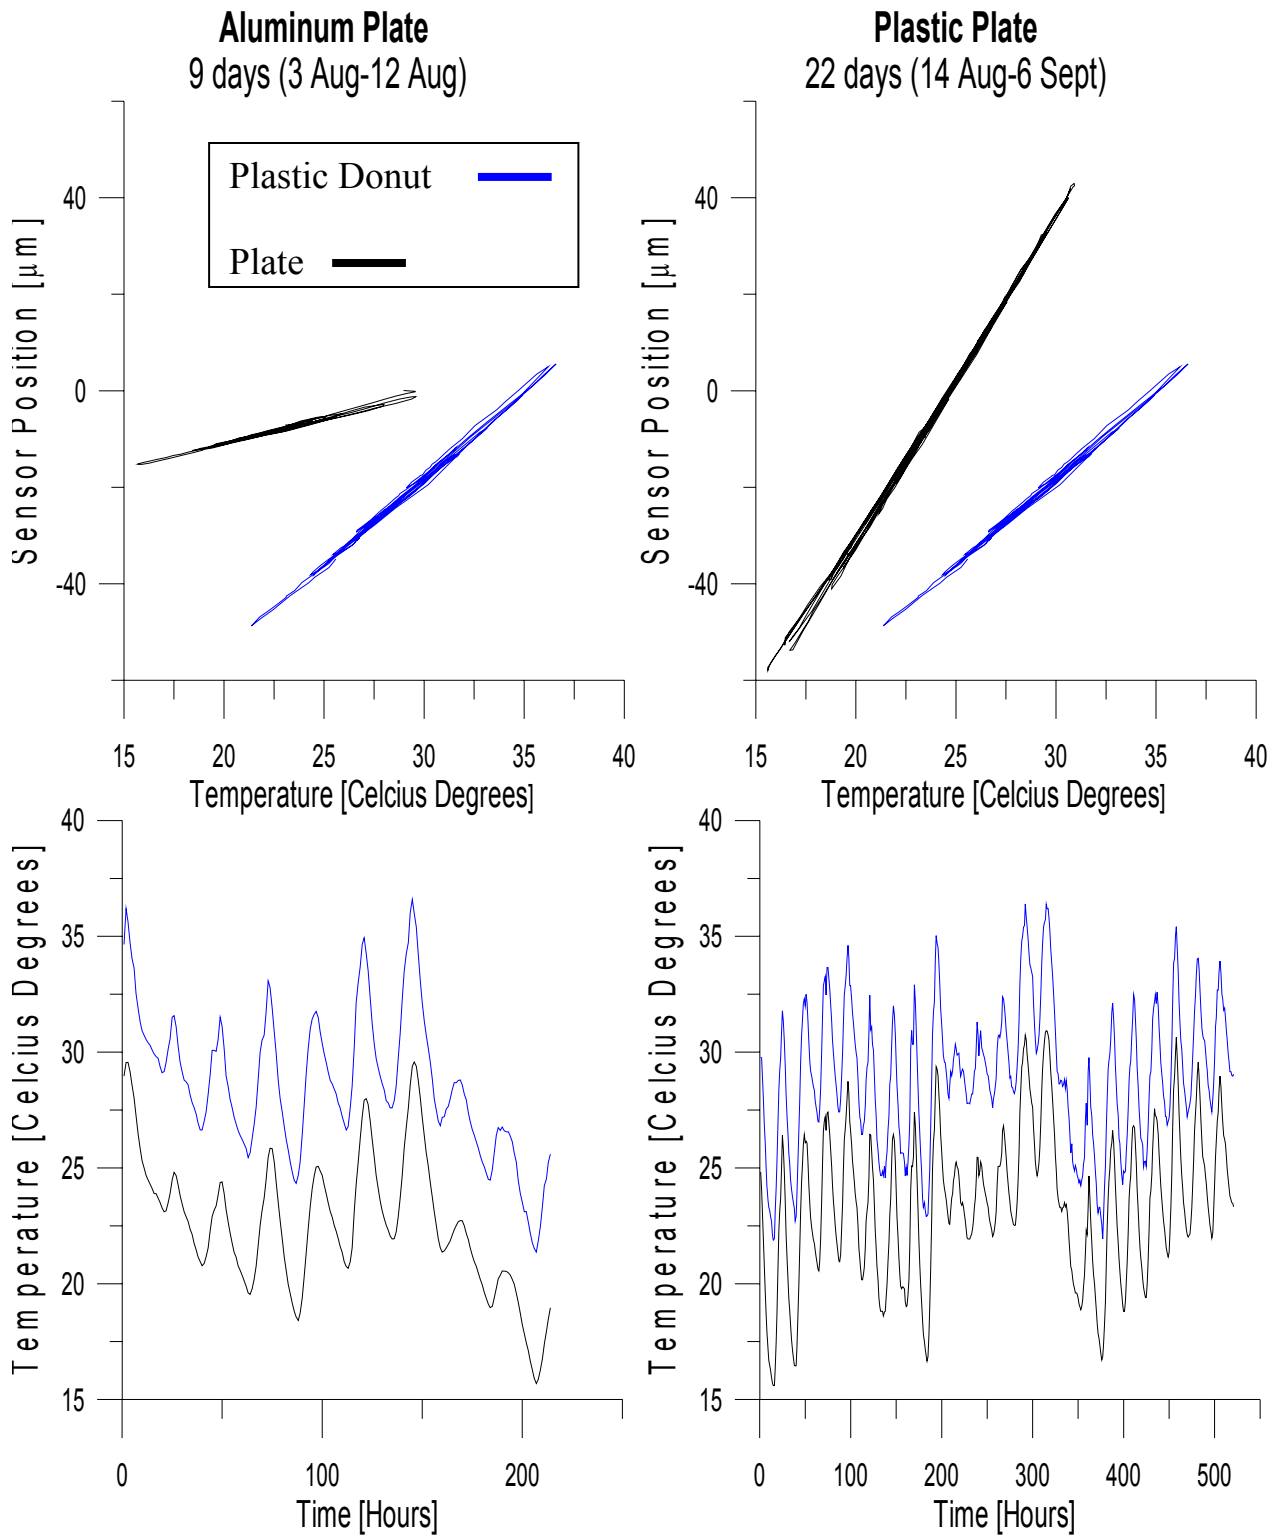
- Plastic produces a larger displacement per degree temperature change, which is similar to the expansion experienced by system spanning crack in typical wall materials.
- The air temperature ranged between 16 °C and 30°C (61°F and 86°F), which is more than the span of typical indoor temperatures (60 °F to 75°F).
- Temperatures cycled daily as would occur in the field, and thus any drift or hysteresis could be observed.
- The LVDT installed on a plastic plate experienced greater displacement than did the donut although the distance between the coil and the bracket was the same.
- This difference in donut and plate response is equivalent to adding 50 μm (200 μin) distance between the coil and the bracket.

**Figure A-7: Comparisons of LVDT responses to thermally induced when attached to plates (aluminum or plastic) or donuts.**
