**Crack Response of a Historic Structure to Weather Effects and  
Construction Vibrations**

A Thesis

Field of Civil Engineering

REMI BAILLOT

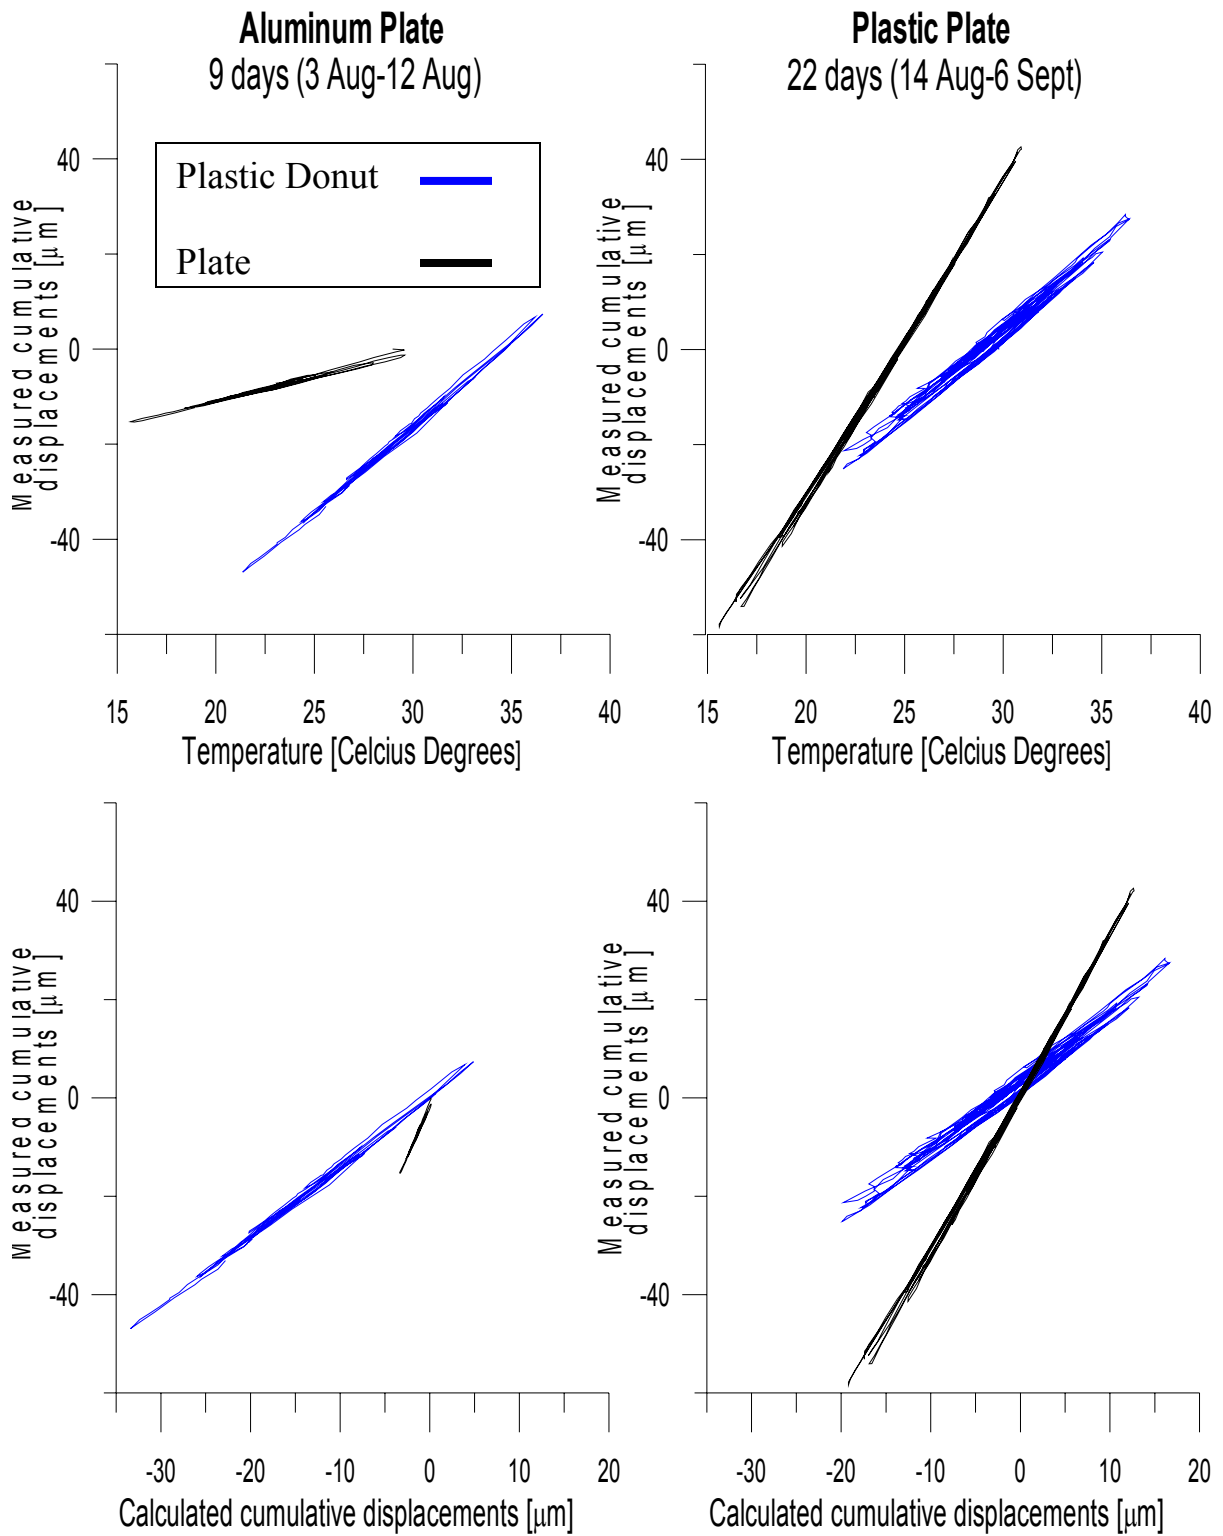
Calculated displacement,  $\delta$ , is computed from temperature with the formula  $\delta = \alpha * L * \Delta T$ , where  $\alpha$  is the coefficient of thermal expansion of the material (plate or plastic donut),  $L$  the length of the donut and  $\Delta T$  the temperature difference. One temperature and one LVDT position data point are available for each hour for each displacement sensor. From these data are computed the calculated cumulative displacements in micrometers. The cumulative displacements are path related. Calling  $T_i$  the temperature at hour  $i$ , starting from  $T_0$ , the calculated cumulative displacement at time  $t$  is equal to  $D_t = \alpha * L * (T_t - T_0)$ .  $T_0$  is the reference point for the calculated cumulative displacement.

**Figure A-8: Comparisons of measured and calculated LVDT responses for the aluminum or plastic plate and plastic donut installation.**

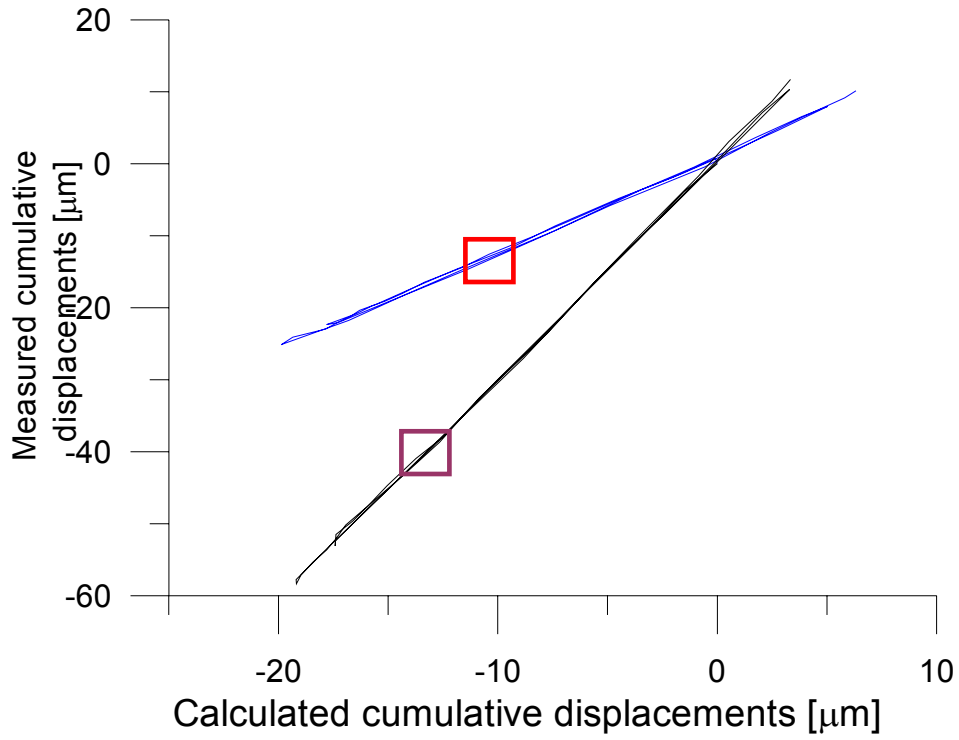
Figure A-9 is a plot of a two-day portion of the graph in Figure A-8. Two days of data imply two loops, which is enough to display the typical drift, hysteresis and noise level. The two frames at the bottom are expansions of the colored frames on the upper graph. In those frames the red arrows indicate the first loop, whereas the blue ones indicate the second loop, and the green dot by the red arrows indicate the first loop direction. As the two lower frames show, there was little drift or hysteresis. The loops are tight and occur in the same space with little divergence. As the frames show the noise level is also very low as the measured displacement ranges between  $-35$  and  $10 \mu\text{m}$  while the A/D resolution is  $0.031 \mu\text{m}$ .

**Figure A-9: Expansion of two daily loops of temperature induced expansion and contraction from Figure A-8.**
