APPENDIX AB

Albuquerque, New Mexico (2012) Vibratory Roller Compaction

Abeel_2012

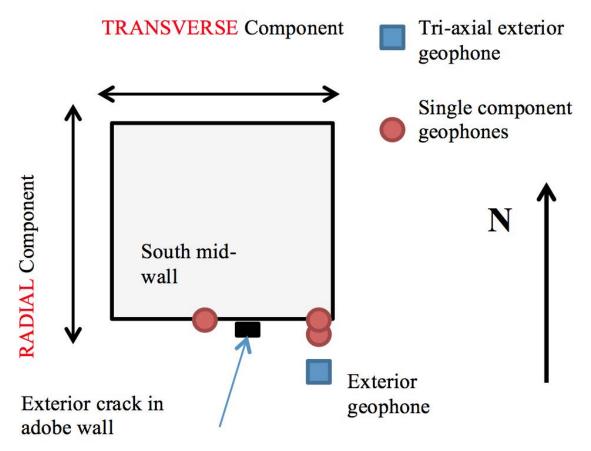
Figure AB-2 - Specific instrumentation locations on south wall

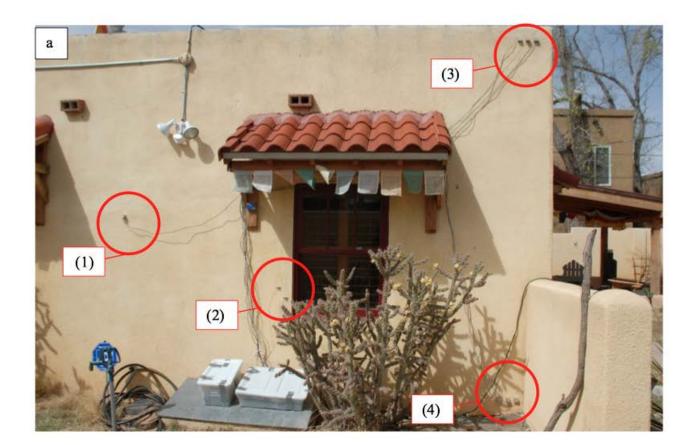
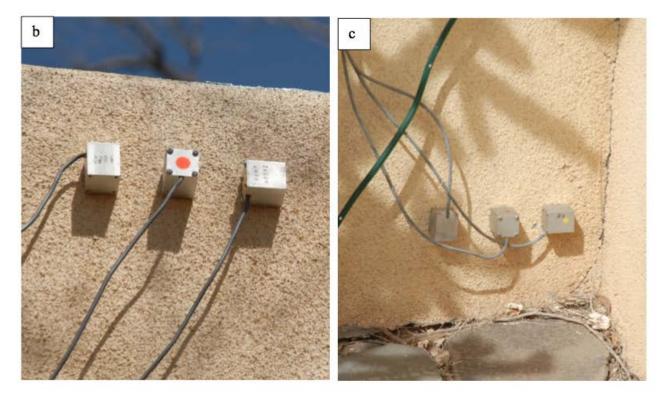
This report presents the structural and crack response of a 80-year old, one-story adobe house (Figure AB-1) to construction activities involving vibratory rollers and the long-term effects of weather on crack motions. The structure was instrumented with single-axis velocity geophones to measure whole structure and mid-wall vibratory motions during road compaction. Displacement-type gauges were used to measure the movement of an existing exterior wall crack and a section of un-cracked wall material. A single exterior tri-axial geophone was buried in the ground outside the structure to record ground motions. Locations of instrumentation are shown in Figure AB-2. Context and details of instrumentation are shown in Figures AB-3 and AB-4.

Figure AB-3 - Exterior south wall instrumentation (a), with Midwall sensor (1), Crack gauges (2) and upper (3)(b) and lower (4)(c) cluster of single axis motions sensors
