APPENDIX AUS

Singleton, Australia (2002)

Rix's Creek Blasting

Richards & Moore_2002

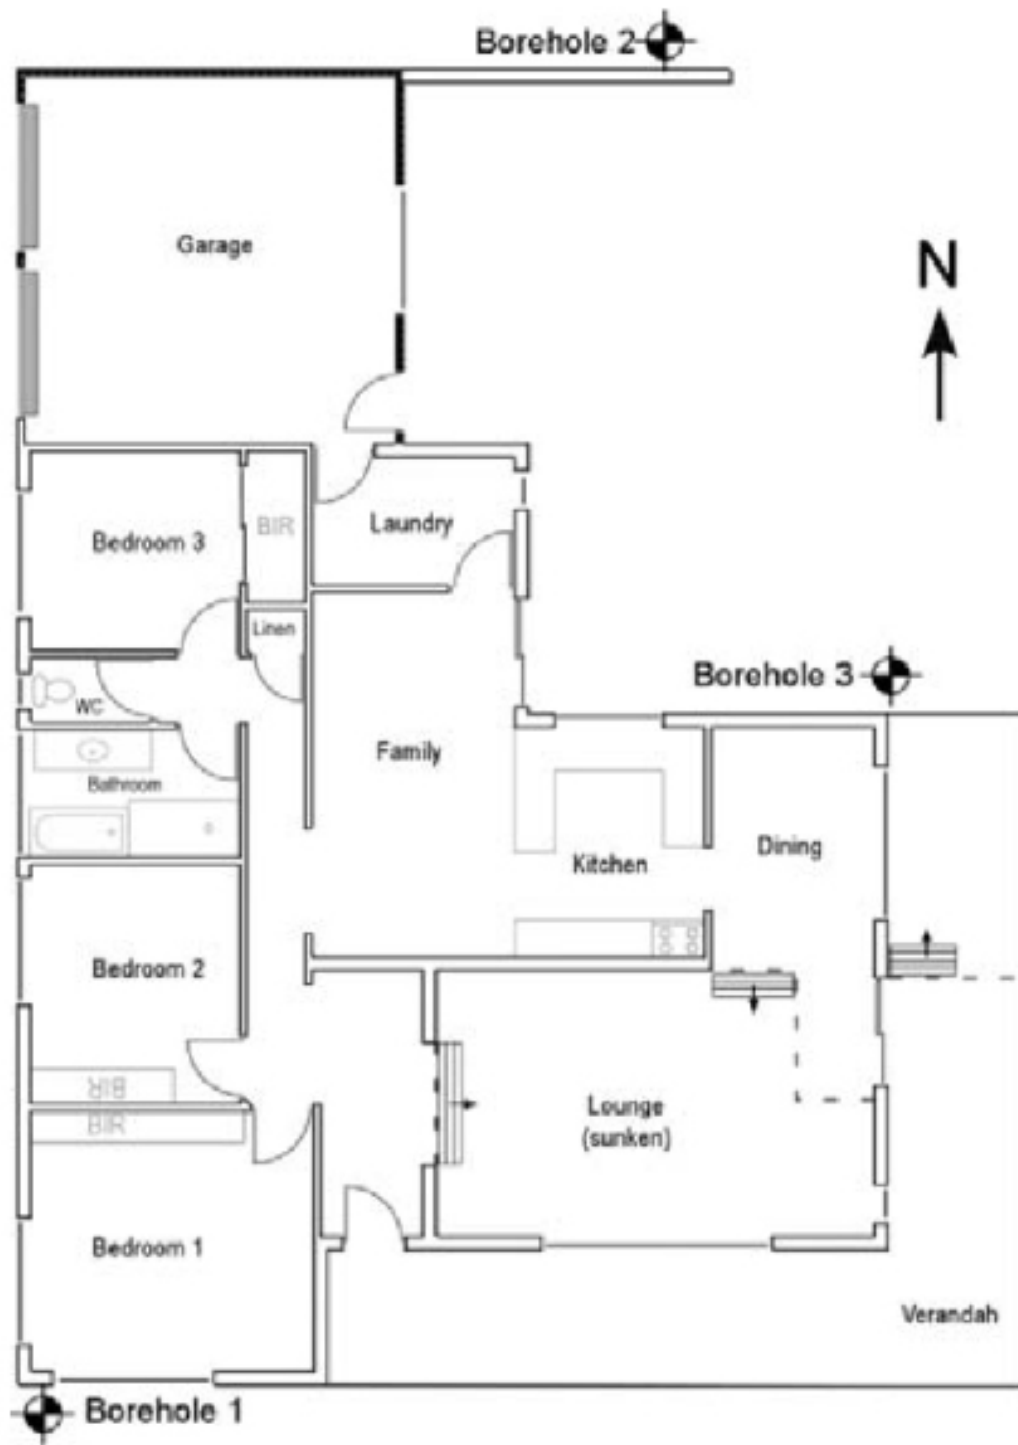
Figure AUS-2 – House floor plan

This report aims to assuage the concerns about blasting vibrations near a residential structure in the township of Singleton, Australia by comparing crack responses caused by weather fronts to those caused by ground motions. The test house is of conventional brick veneer construction, with a timber frame, 10 mm plasterboard internal lining, tiled roof, timber floor boards and aluminium framed windows. Refer to Figure AUS-1 for a look at the structure and Figure AUS-2 for the floor plan.

Prior to the project, a number of cracks had developed over the life of the house generally consistent with loss of foundation support and settlement of footings, although some related directly to poor building practices. The growth pattern of all cracks was recorded between March 2000 and April 2001. The width of seven cracks in the house structure have been accurately monitored with DE-MEC gauge measurements between installed targets.

The monitored cracks are described in Table AUS-2 together with the maximum movement during blasting and movement after blasting ceased. The peak air vibration exceeded 145 dBL, but no glass damage resulted in windows or sliding doors. Crack width movement diagrams are shown in Figures AUS-3 and AUS-4 and cumulative rainfall total, together with peak ground vibration measurements and daily rainfall totals. From these figures it can be seen that the rainfall pattern shows a strong correlation with the variation in width of some cracks. These cracks have responded to a high rainfall period after the cessation of blasting.
