APPENDIX DT

Detroit, Michigan (2006) Vibrations and Crack Monitoring

Dowding_2007

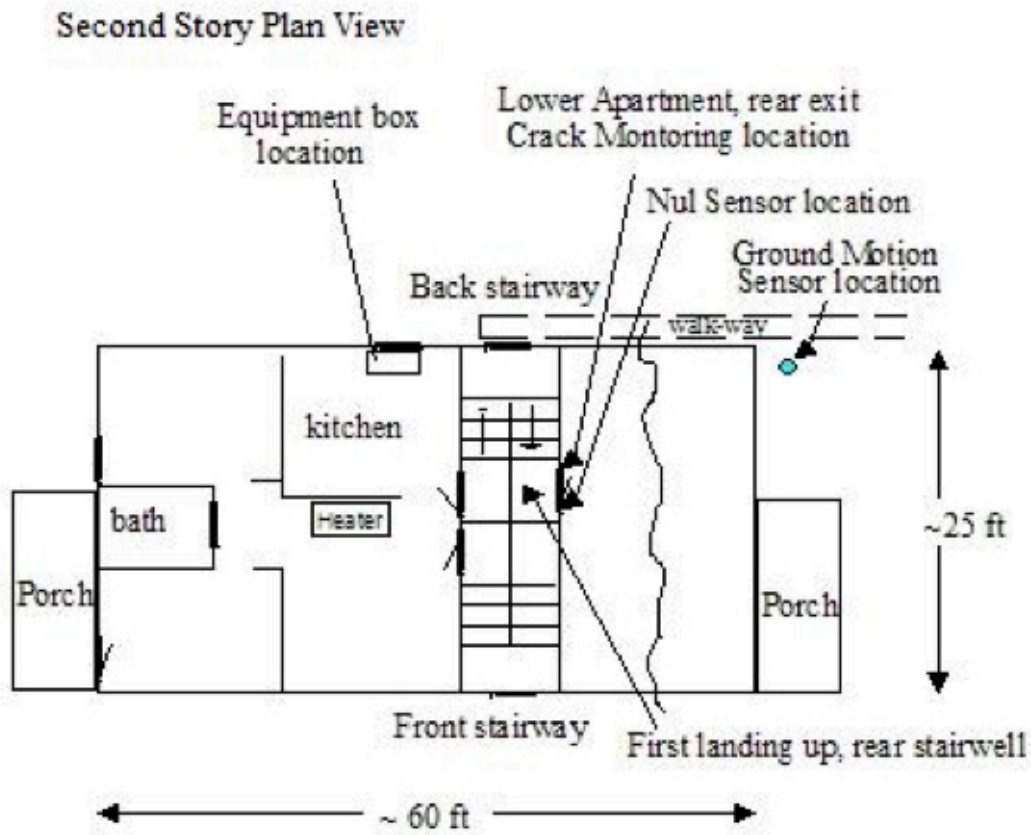
Figure DT-2 - Plan view of test structure and instrument locations

The test structure is an elderly, two-story wood-frame house with plaster and lath walls in Detroit, Michigan 48217. The structure, shown in Figure DT-1, at the edge of a residential neighborhood is located in close proximity to Interstate 75 and railroad tracks. The test structure was fitted with Vibri-Tech ground motion, air over pressure and crack displacement sensors as shown in Figure DT-2. Crack displacement and null sensors (Transtek series 200 LVDTs) were placed in the stairwell above the back doorway to the upstairs apartment of the test structure as shown in Figure DT-3. They were installed across an existing crack and on the adjacent un-cracked wall (null sensor).
