# APPENDIX FWII

## Franklin, Wisconsin (2008-09)

### Phase II - Quarry Blasting

*Meissner & Dowding\_2000*

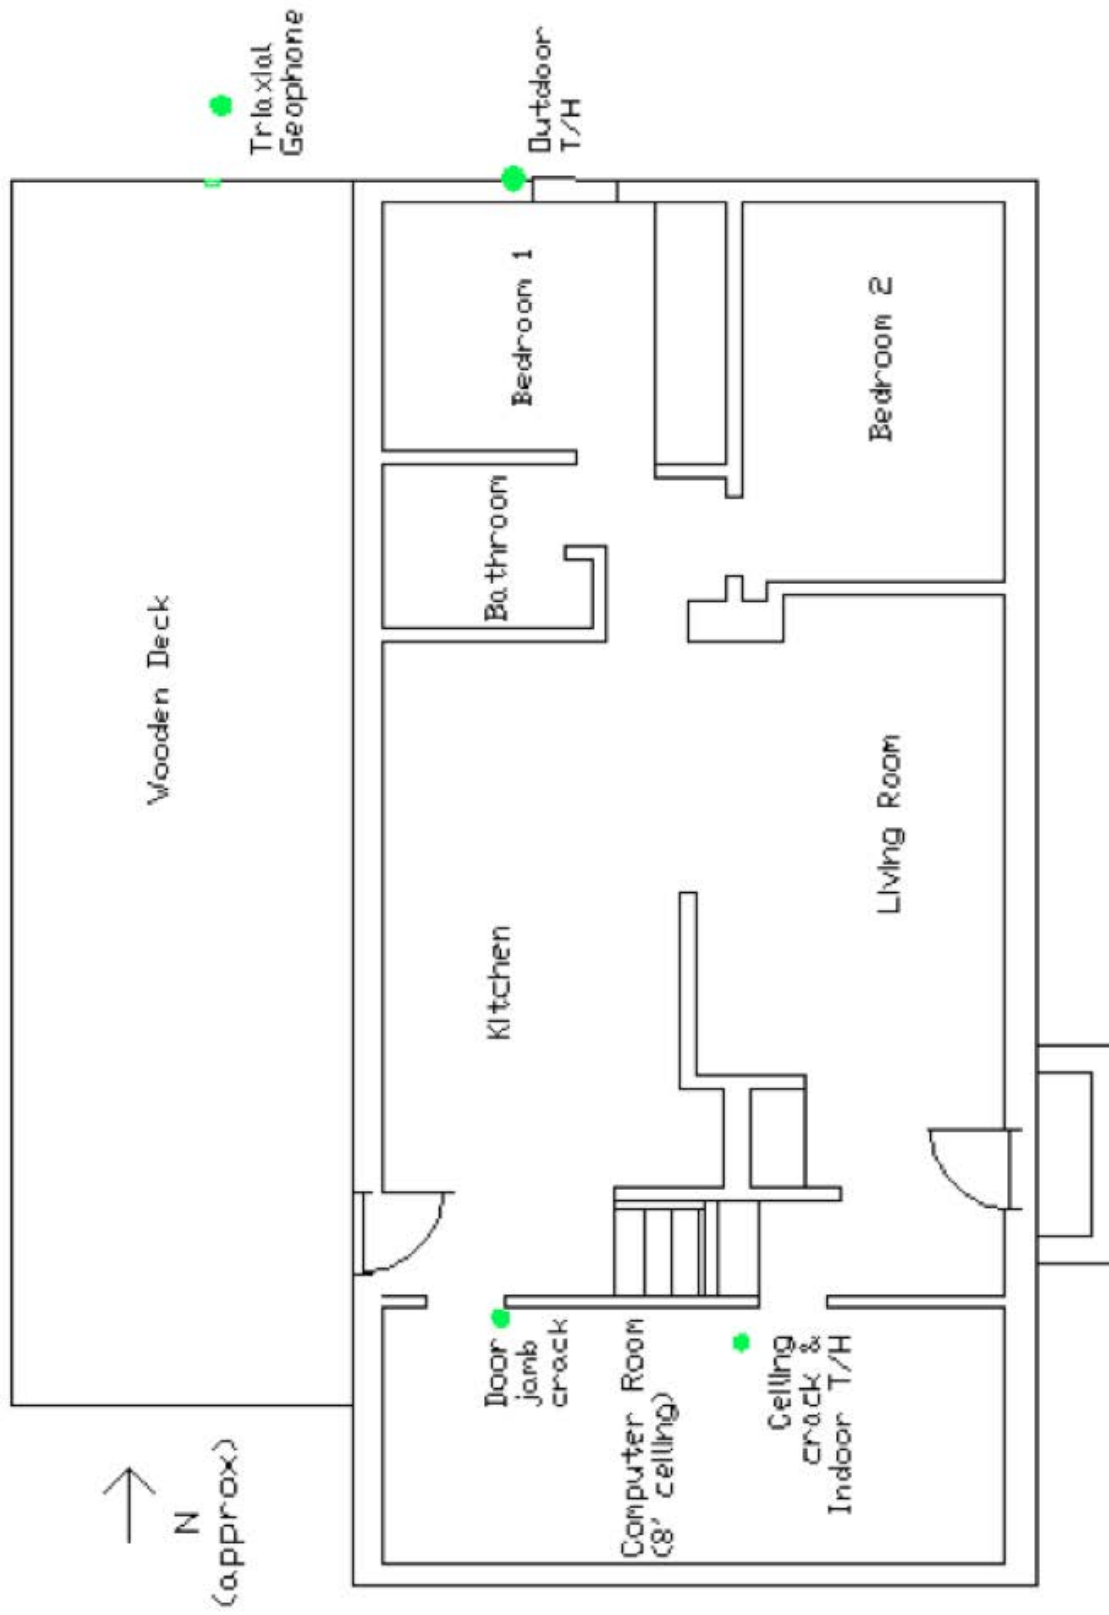
Figure FWII-2 - Exact sensor and equipment locations in the house.

To account for weather and blast effects, ground vibrations, air overpressure and temperature and humidity levels outside of the house have been measured. The locations of all sensors are indicated in Figure FWII-2. Two cracks were selected for observation, one on a ceiling and one next to a doorway. Their respective locations can also be seen in Figure FWII-3. To monitor crack development, similar sensors were installed across each crack and on the wall next to the crack. A triaxial Geosonics geophone was installed in the ground on the north side of the house to monitor the propagation of shock waves from the quarry. This sensor registers movement in all three directions on separate channels and stores the results in the form of peak particle velocity (PPV) data.

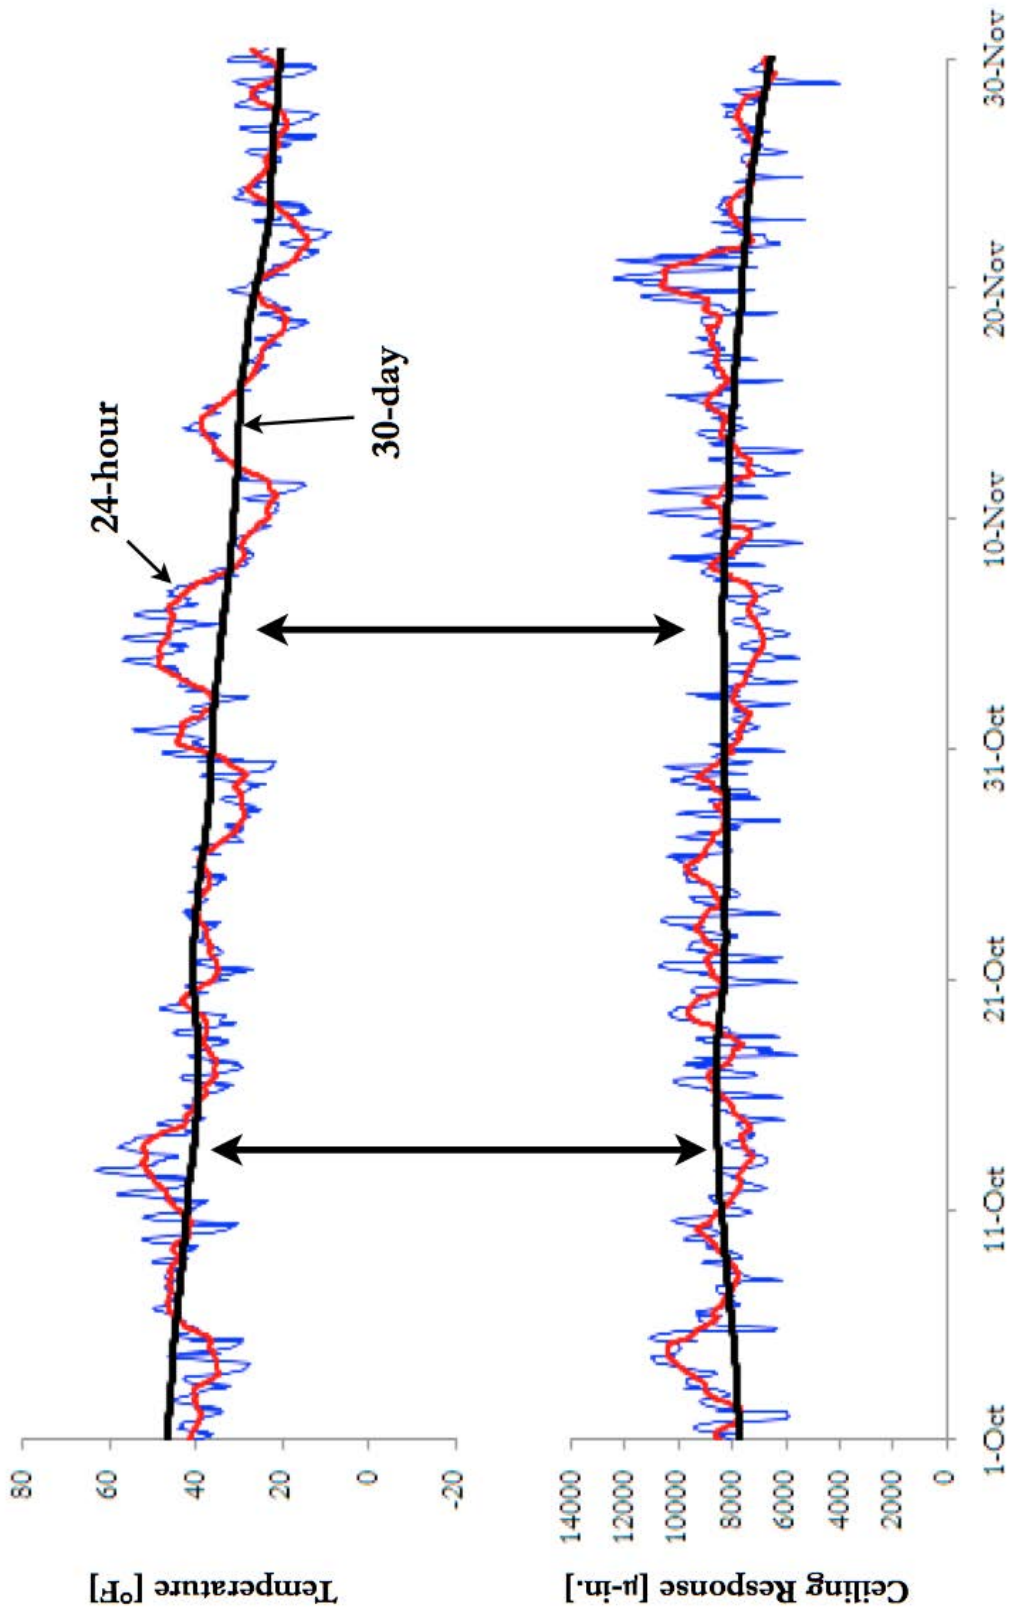
Figure FWII-5 - Correlation of Temperature and Ceiling Crack Response over a two-month period

The crack sensors and outdoors temperature and humidity sensors were read every hour, registering a total of 6503 data points during the observation period. The results can be seen in Figure FWII-4 where individual readings are plotted in blue, the 24-hour central moving average in red and the 30-day central moving average in black. The same data plotted for a shorter period demonstrate that temperature variations correlate well with crack displacement. Since the red line is the 24-hour moving average and the black that for 30-day, the distance between them is indicative of the magnitude of change; a large, continuous change in temperature causes a deviation in crack response.
