**Structure Response
to Blast Vibration**

**C9040
November 2002**

ACARP

**AUTHORS: ADRIAN MOORE, ALAN RICHARDS,
THOMAS LEWANDOWSKI
- TERROCK CONSULTING ENGINEERS**

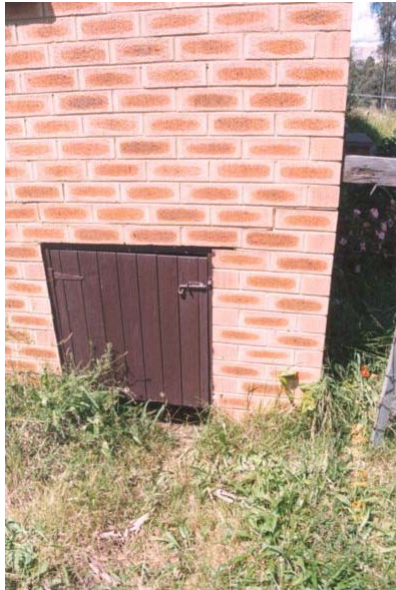
Figure 3a - Stepped brick crack at south-west corner below DPC

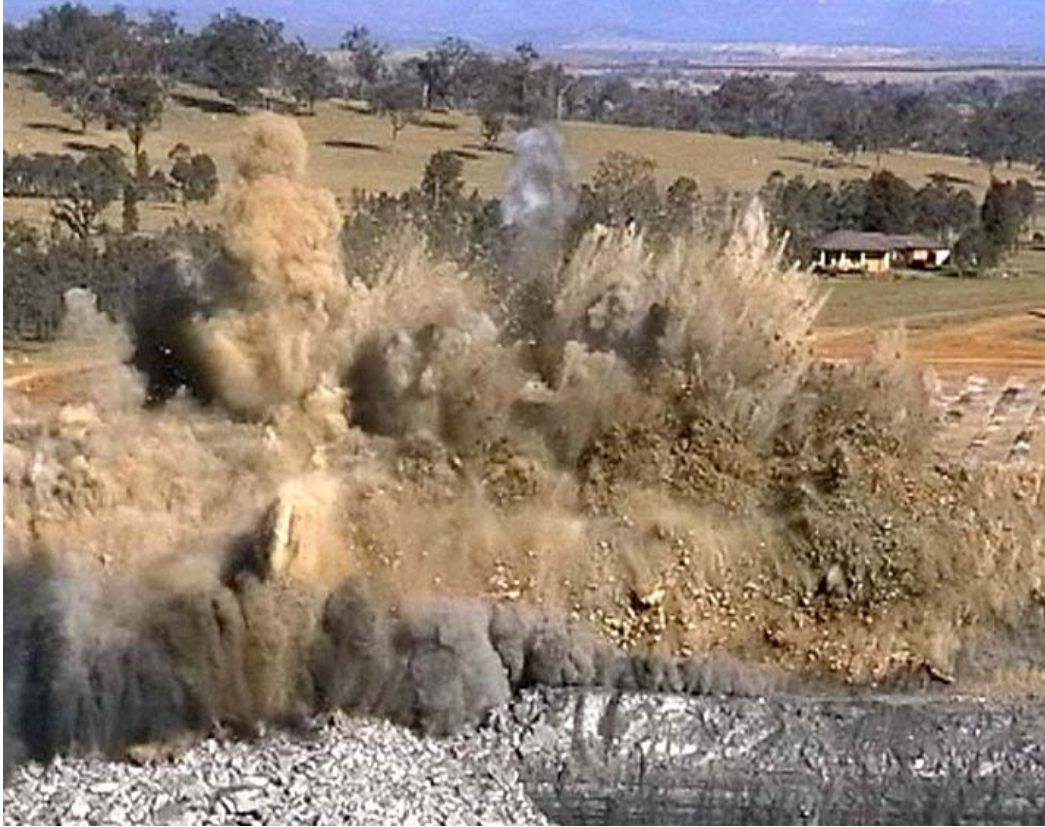
Another strip closer to the house was blasted after this photograph was taken, resulting in blasting to within 50 metres of the house.

Figure 4 - Blasting in close proximity to the test house – 11/08/00

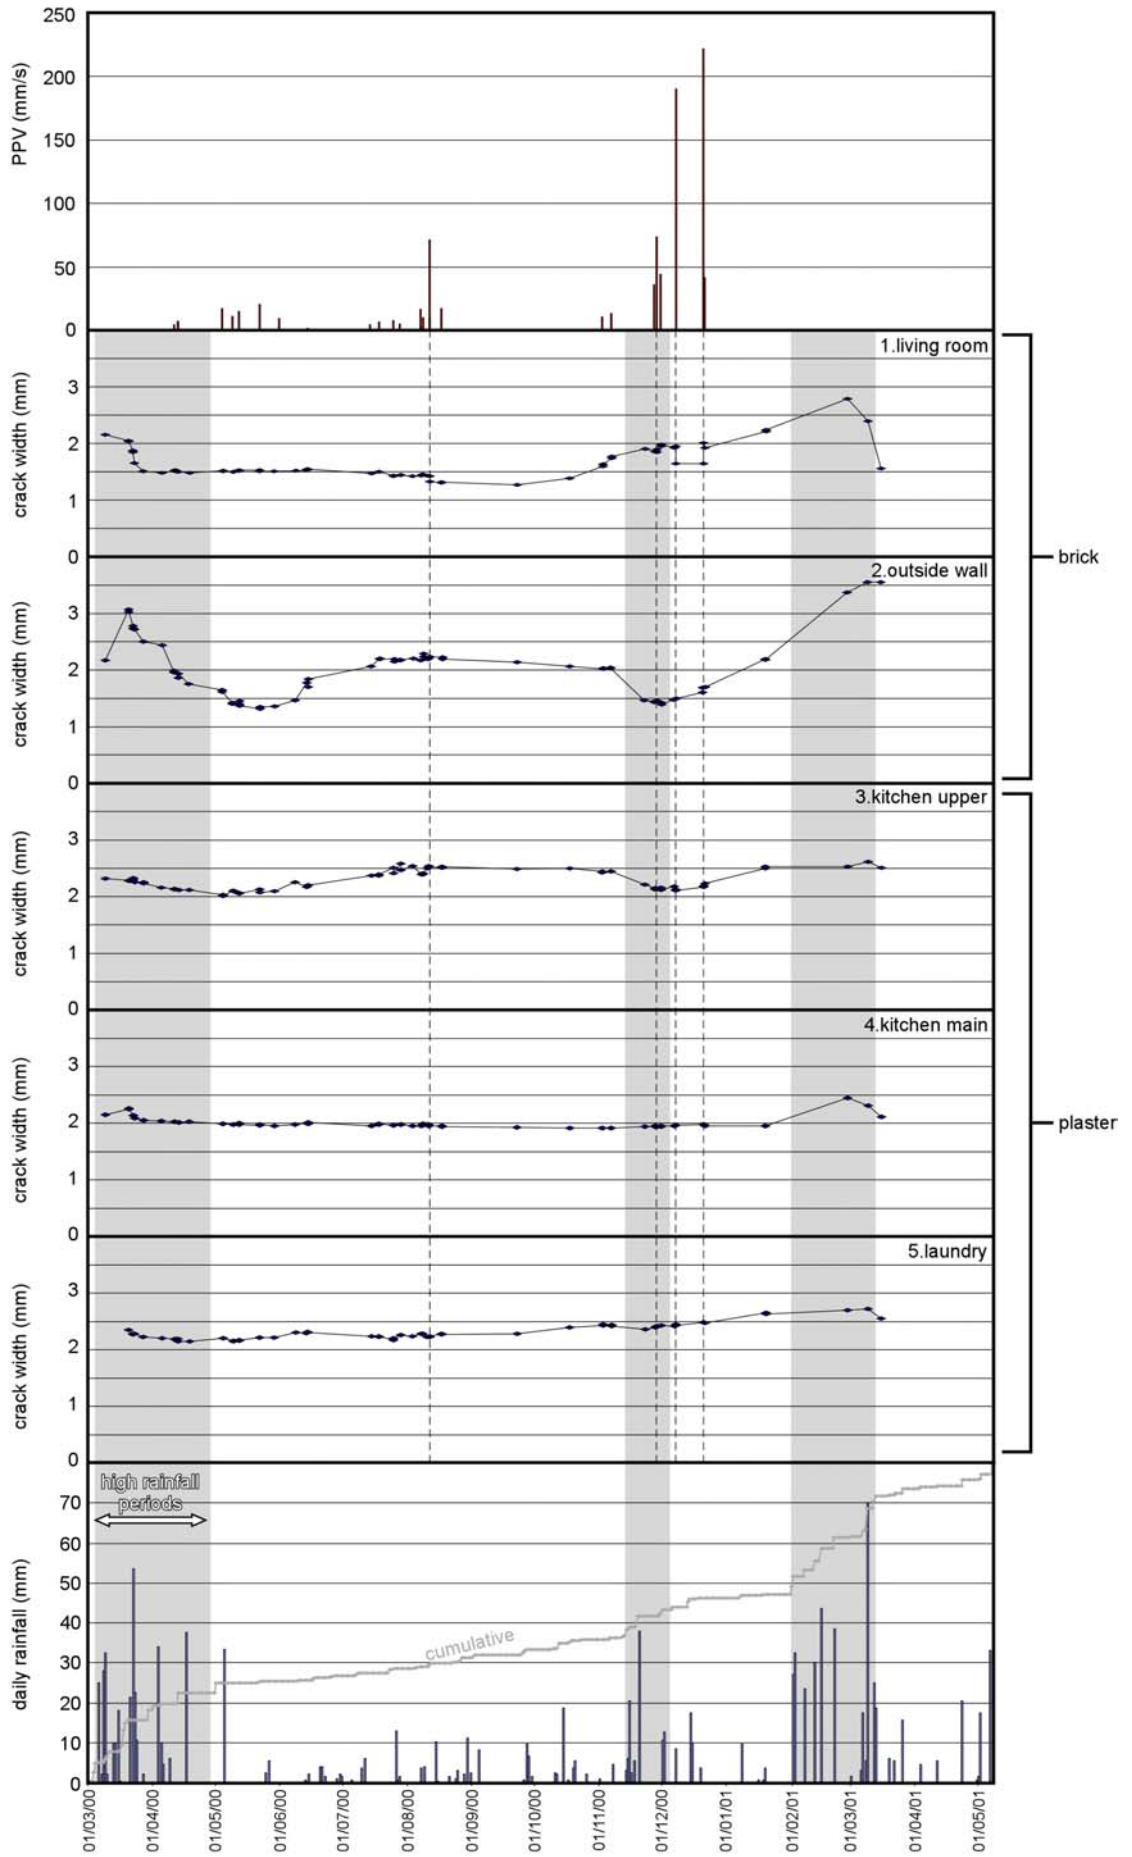
The external crack showing the most movement was adjacent to where the tank overflow water ponded against the kitchen wall. The extremes of width behaviour of all cracks over the monitoring period shows similar complex movement that is unrelated to blasting but is related to periodic variations in rainfall. Limited width movement of some cracks is related to ground vibration for the 4 blasts in excess of 70 mm/s.

Figure 7 – Crack width movement diagrams compared to PPV and rainfall

From **Figures 7 and 8** it can be seen that the rainfall pattern shows a strong correlation with the variation in width of some cracks. These cracks have responded to a high rainfall period after the cessation of blasting. Permanent widening of cracks listed as 1 and 2 in **Table 4** were recorded after receiving a ground vibration measurement of 222 mm/s. The widening was 0.3 mm and 0.12 mm respectively. However, crack movements of 1.3 mm and 2.2 mm were recorded in the same cracks after blasting ceased and are due to the effects of ground moisture change.

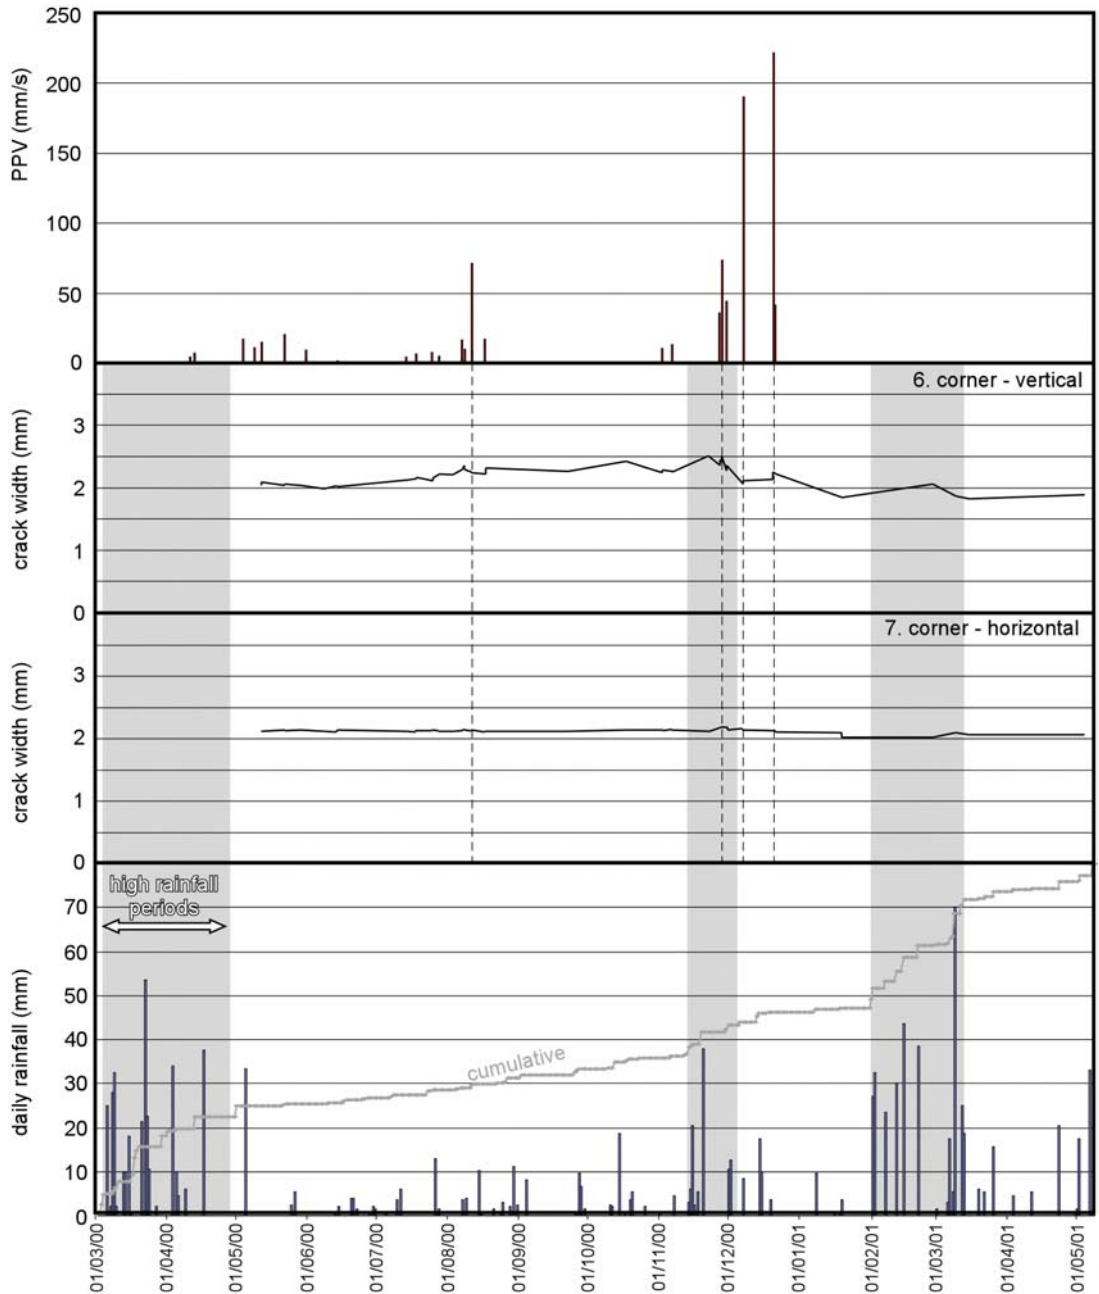
Figure 8 – Crack width movement diagrams compared to PPV and rainfall (continued)

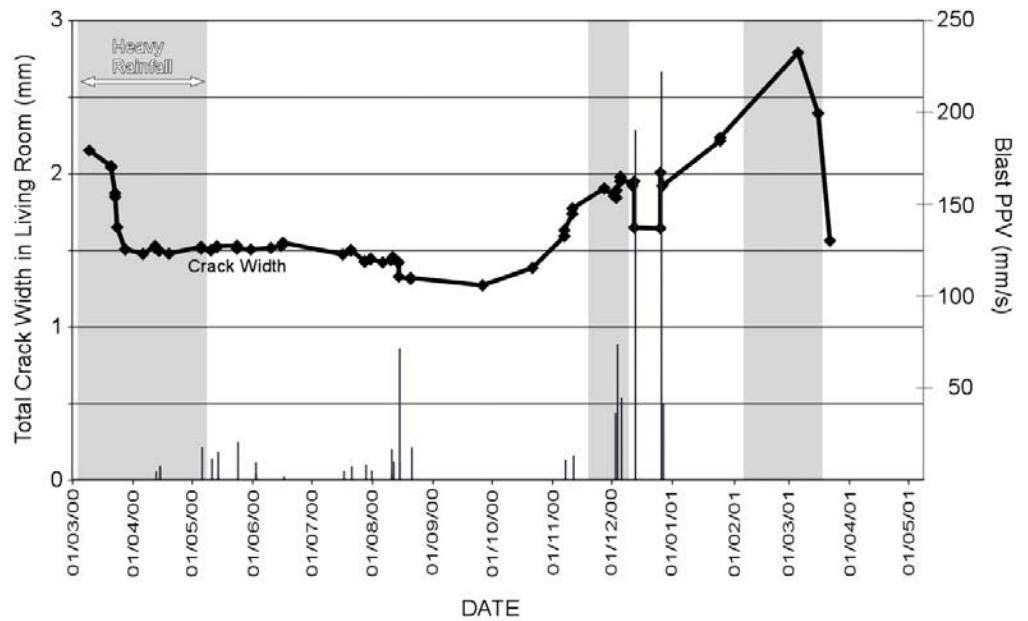
The internal crack showing the most width movement was located in a low (700 mm high), non-structural brick wall in the sunken lounge room. Sub-floor inspection disclosed that the foundations of this wall were extremely sub-standard, being mortar spread on the natural ground surface. The variations in width of the lounge room (crack No. 1 refer **Table 4**), between March 2000 and May 2001, is plotted in detail in **Figure 9**.

Figure 9 – Detail crack width movements of crack No. 1

The width of crack No. 1 did not appear to be effected by the numerous blasts with PPV less than 20 mm/s over the period 1st April to 10th August 2000. A permanent offset of 0.1 mm was measured following Blast No. 23 on 11th August 2000, with a peak ground velocity of 70 mm/s. In contrast, the crack closed from a width of 2.2 mm (5th March 2000) to 1.5 mm (25th March 2000), following a period of heavy rainfall, and then remained constant at 1.5 mm up to July 2000. Between July and October 2000 the crack width reduced to 1.3 mm and then widened to 1.6 mm by November 2000. The blast of 7th December 2000 (190 mm/s) caused the crack to close from 2.0 mm to 1.7 mm and the next blast (220 mm/s) caused the crack to re-open to 2.0 mm. The crack widened to 2.8 mm following a period of heavy rain after the end of the close blasting and monitoring period and then closed to 1.6 mm by mid March 2001.

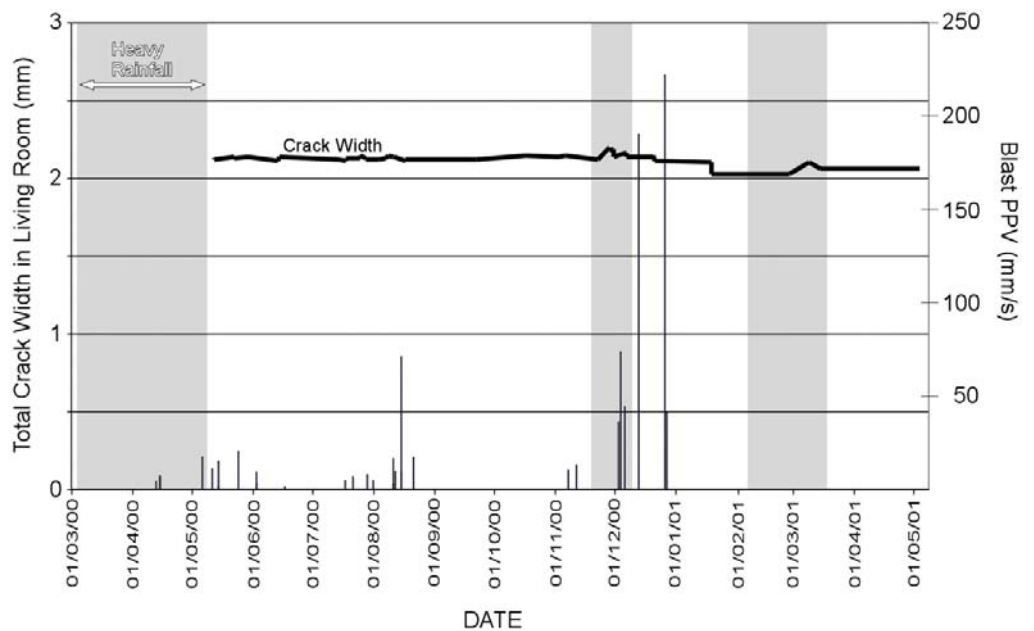
Figure 10 – Detail movements of crack No. 6

As a contrast, crack No. 6 in the external brickwork (**Table 4**), detailed in **Figure 10**, was relatively unaffected by blasting and soil moisture variations.

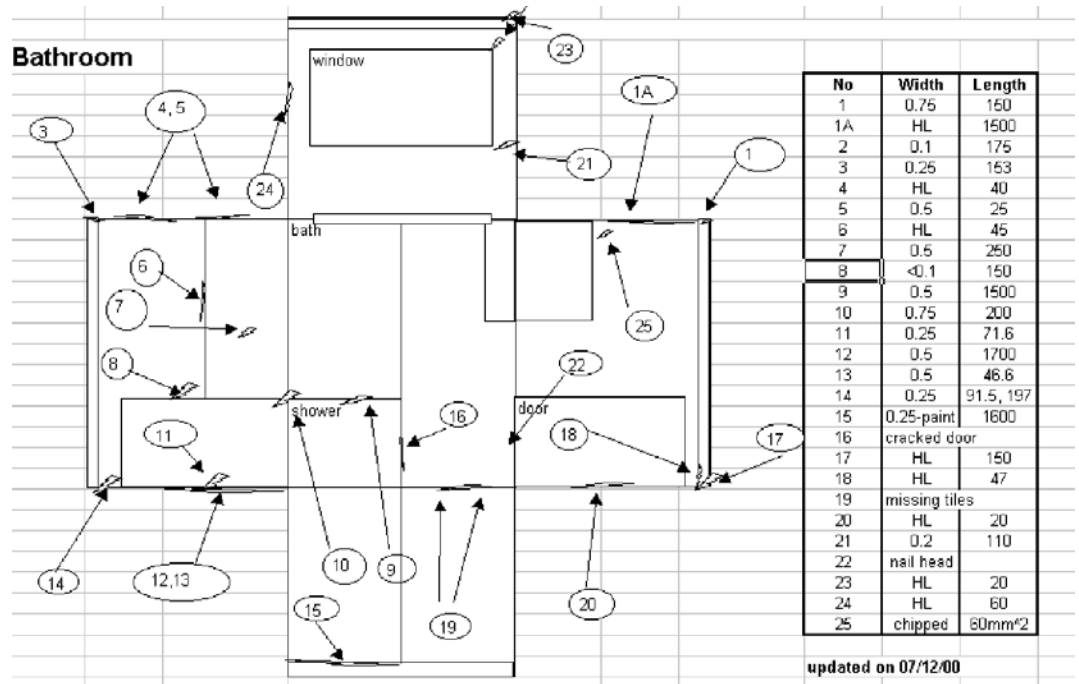
Figure 11 – Typical survey of the bathroom showing all cracks on the walls and ceiling

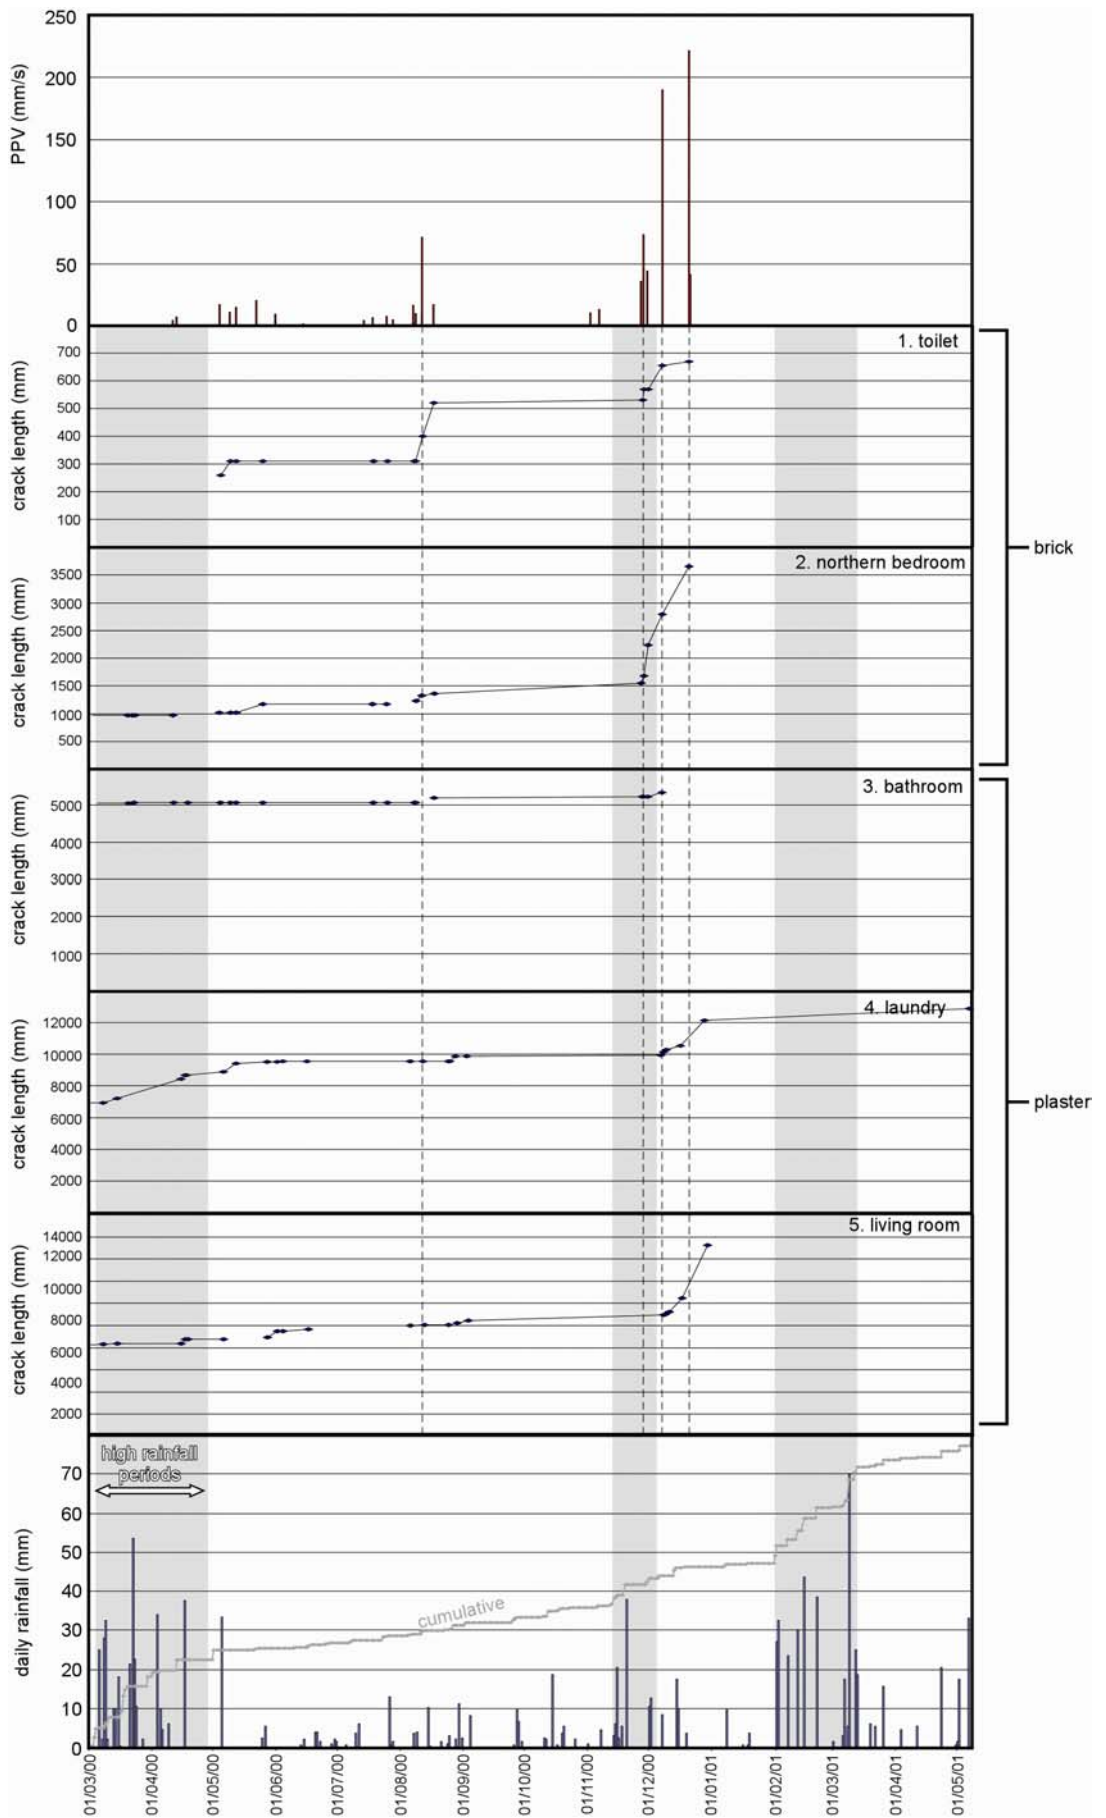
The four blasts with vibration levels in excess of 70 mm/s resulted in additional cracks in the plaster of all rooms, but the bathroom was relatively unaffected.

Figure 12 - Total crack length for 5 rooms compared to rainfall and PPV

Figures 12 and 13 demonstrate that the total crack lengths between May and August 2000 did not increase, despite some 12 blasts with PPV in the range of 2 mm/s to 20 mm/s.

The crack growth survey of bedroom three (see **Figure 12**) is typical of the crack growths measured. Blast No. 23, where a level of 71.2 mm/s was recorded at the test house, resulted in an extra 250 mm of hairline cracks. The series of blasts in excess of 35 mm/s from 27th November 2000 (including 190 mm/s and 222 mm/s) resulted in an additional 2200 mm of cracks.

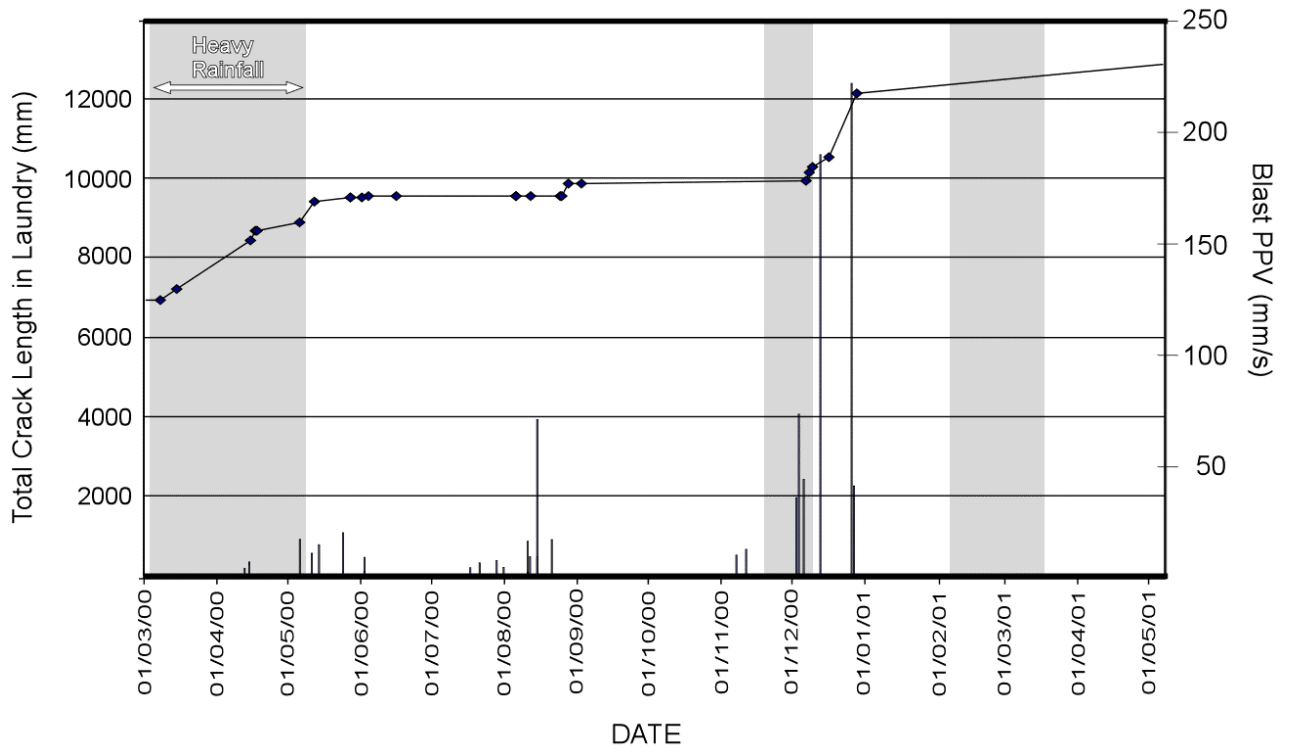
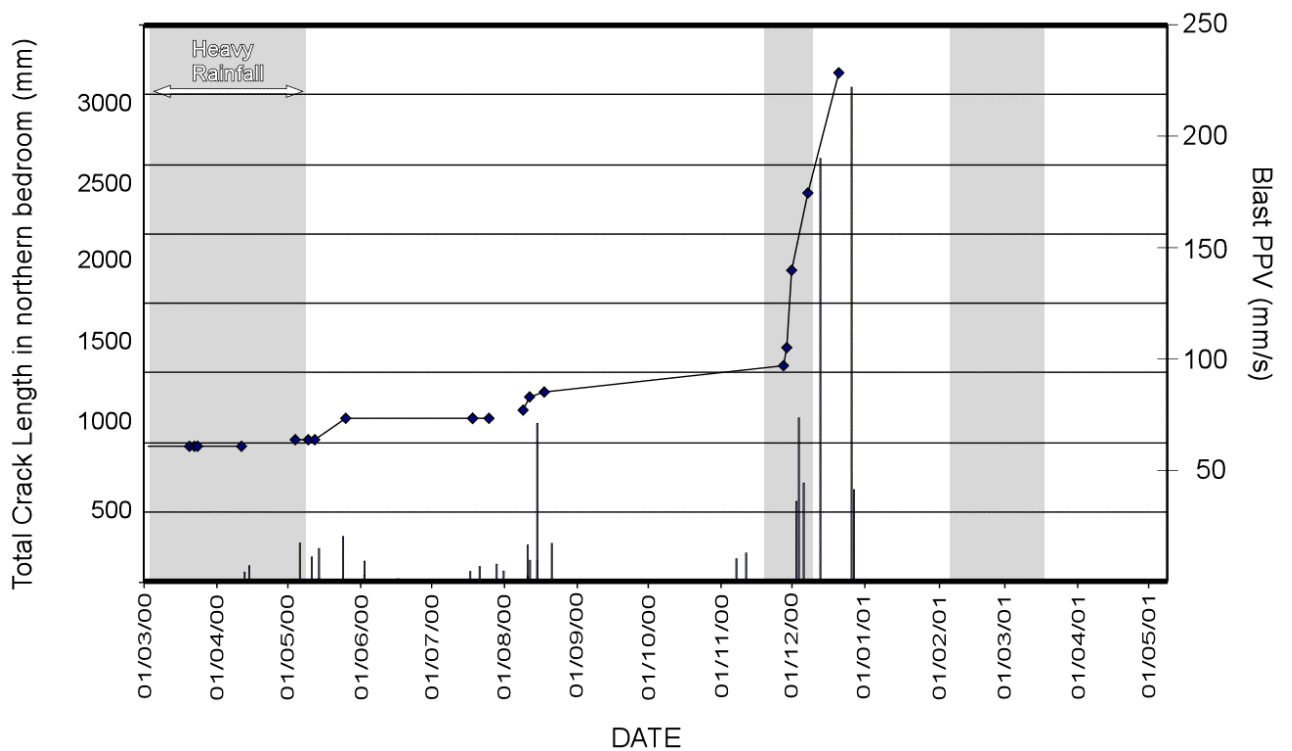
Figure 13 – Total crack lengths for the laundry and bedroom 3 and blast history for 2000

An explicit change in crack lengths of some rooms was observed on 11th August and 28th November 2000 associated with blasts with ground PPV in the order of 70 mm/s. Further significant change to the total crack lengths was observed following blasting on 28th November 2000, which produced a ground PPV of 73.6 mm/s and subsequent blasts recording 44.4 mm/s, 190.0 mm/s, 222.0 mm/s and 41.4 mm/s. It may be concluded that vibration levels of 70 mm/s and above can result in cosmetic damage to plaster. The crack width behaviour in the laundry is evidence that the effects of rainfall can also cause the lengthening of plaster cracks.

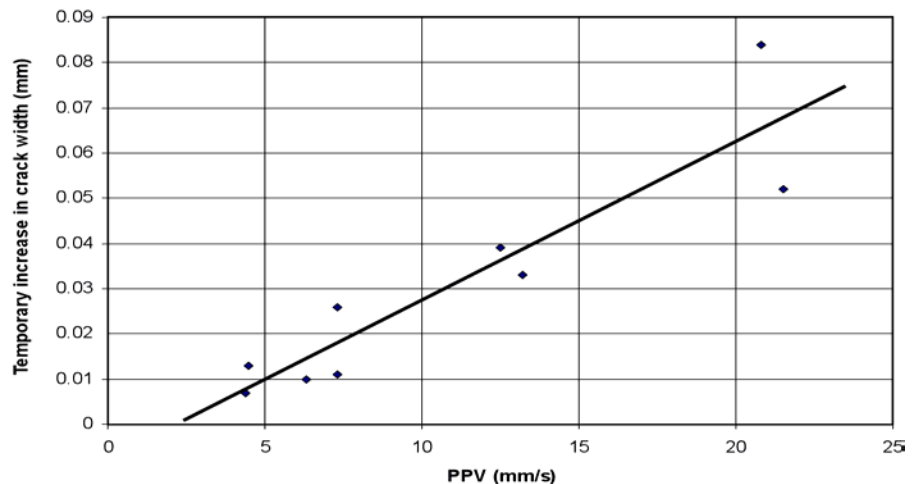
Figure 14 shows the plot of increased crack width versus PPV. There is a close correlation and it may be reasonably concluded that a ground PPV of 20 mm/s results in cracks temporarily opening between 0.05 mm and 0.08 mm.

Figure 14 - Change of crack width versus PPV – crack No. 4

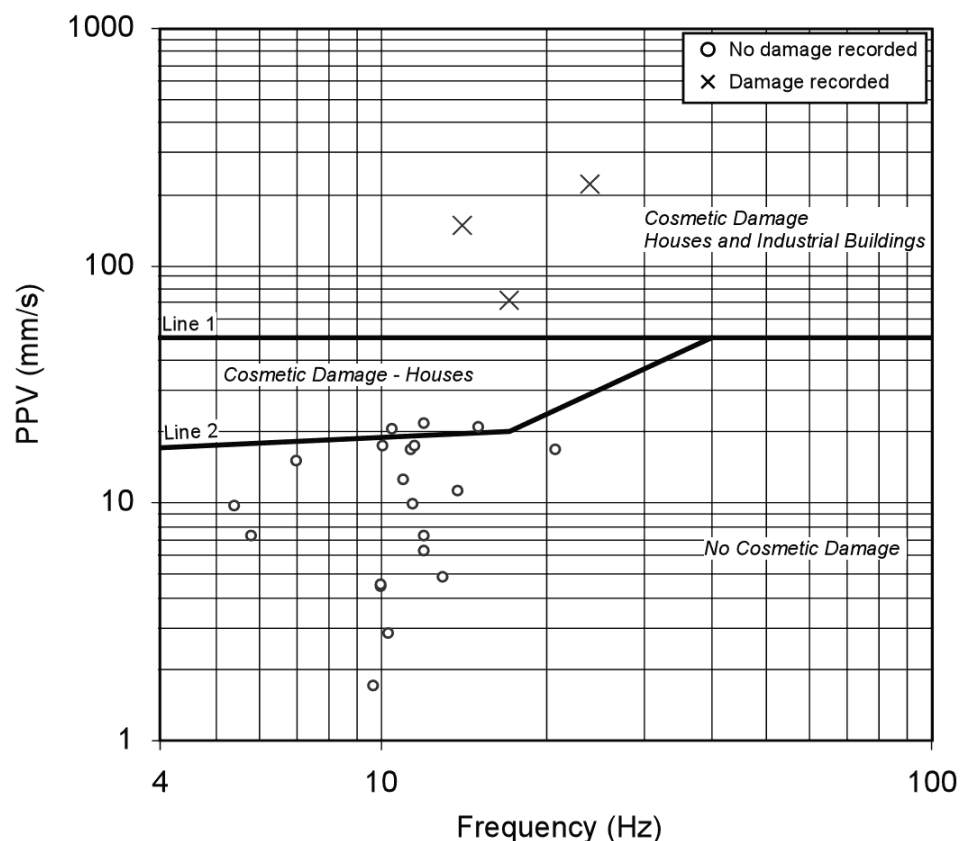
The vibration levels in excess of 70 mm/s clearly have had an effect on the crack lengths. Vibration levels less than 25 mm/s have had no perceptible effect on crack widths or lengths. This is consistent with the guide values of BS7385: Part 2: 1993 to prevent cosmetic damage, reproduced as **Figure 16** and including the vibration and damage observations from this investigation.

Figure 16 – Transient vibration guide values for cosmetic damage (BS7385: Part 2: 1993) and ACARP Investigation C9040 damage observations

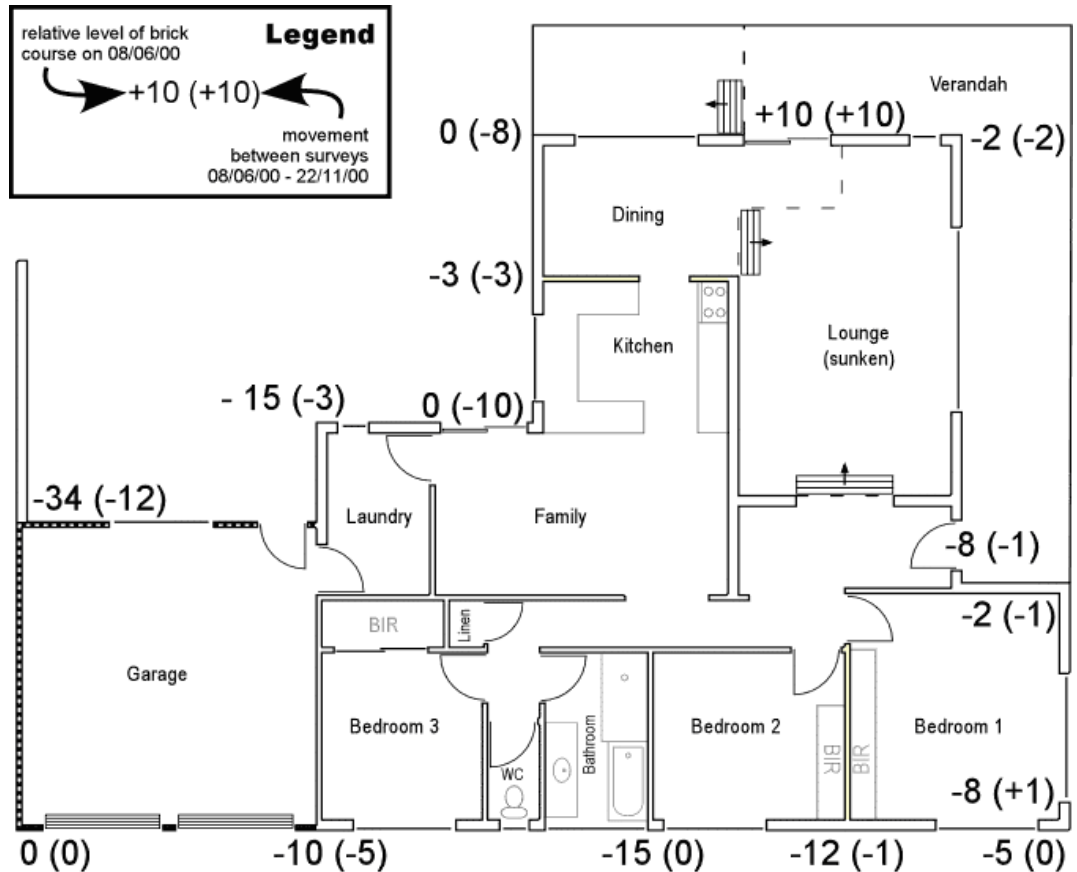
Figure 17 – Level loop survey - 8th June and 22nd November 2000

The maximum variation between surveys was -12 mm in the south-east corner of the garage and a 10 mm rise in the middle of the eastern wall, near the sliding doors. The levels measured by individual surveys included variations in tolerance of the original bricklaying, which could be ± 5 mm. Relative measurements between surveys indicated footing movement.

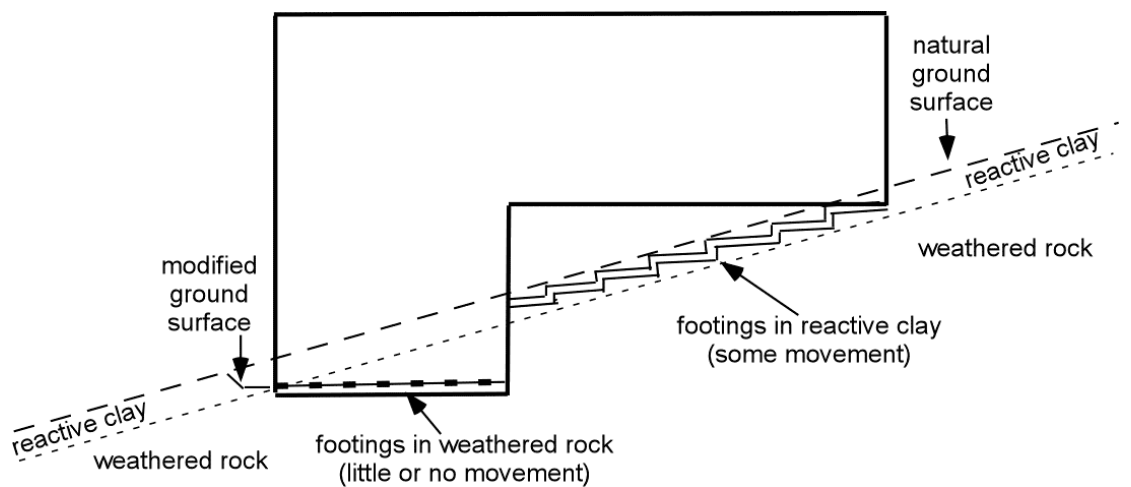
19b – Schematic section showing footings

The strip footings were examined adjacent to hole SBH2 and were found to be 250 mm to 280 mm deep. By the provision of AS2870-1996, a footing of 400 mm is regarded for a masonry veneer dwelling on a Class S site, and a depth of 500 mm is required at a Class M site. A schematic section of the house showing the footings and excavation is shown in **Figure 19b**.

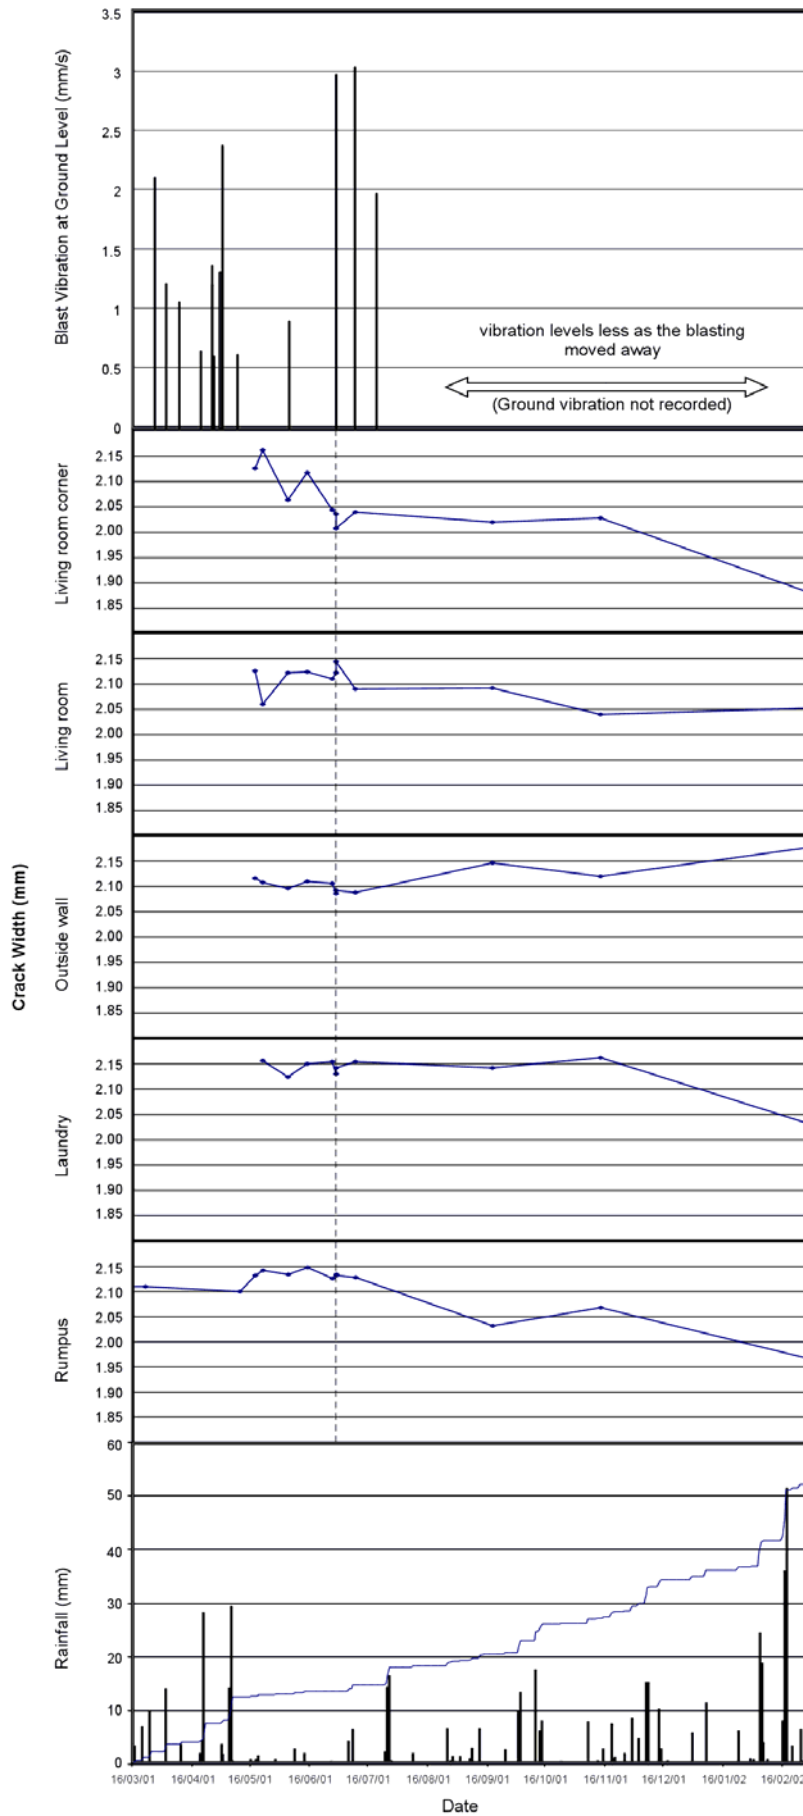
Figure 22 – Crack movement diagram Test House No. 2 (Wybong Road)

The vibration levels were much lower than Test House No. 1 and there was no clear correlation between blast vibration levels and crack growth. There was a period of pronounced crack movement following a high rainfall period in January to February 2002. The blast vibration levels after the monitoring period were less than 3 mm/s because the blasting had moved away from this end of the pit.

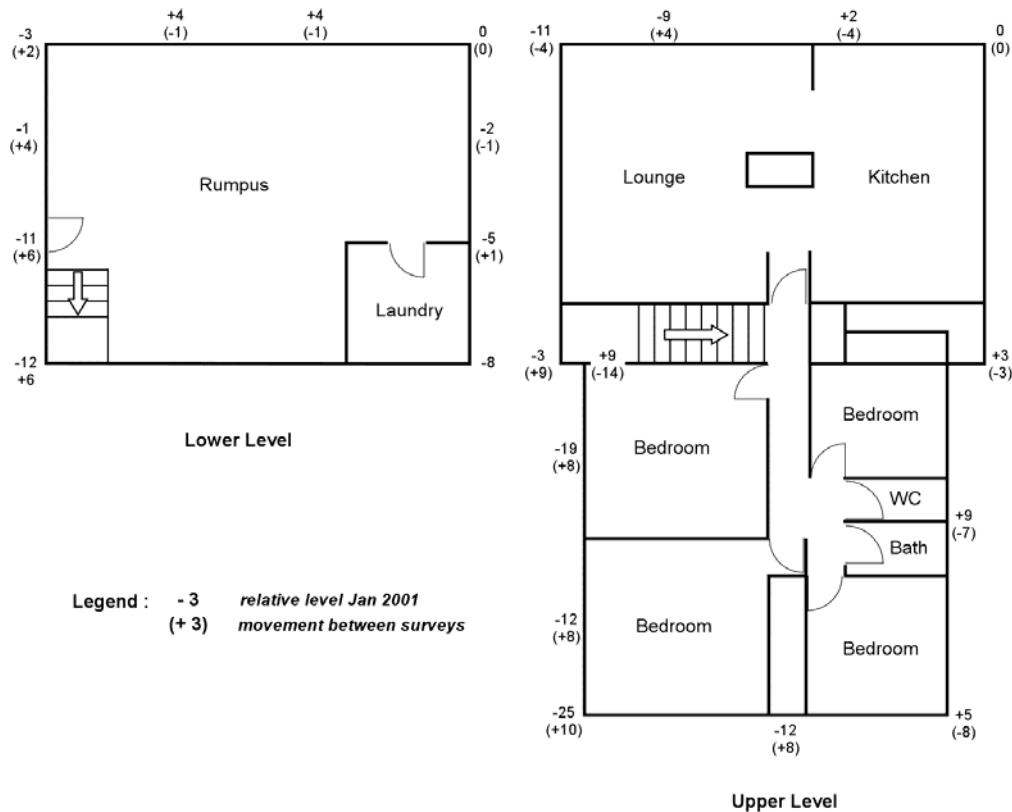
The relative levels of two courses of bricks representing top and ground floors were measured during January 2001 and February 2002. The original survey showed the bottom course of bricks to vary by 16 mm from level and the course above the first floor level to vary by 34 mm (refer **Figure 23**). In between surveys, there was a maximum of 6 mm difference in relative levels on the bottom course and a maximum of 10 mm in the first floor course.

Figure 23 – Level loop survey Test House No. 2 (Wybong Road)

Part of the original variation in level can be explained by the allowable trade bricklaying construction tolerance of ± 5 mm/10 metre length (10 mm overall), but the location of the movement in relation to the cut/fill/natural surface suggests that foundation movements are responsible with the amount of variation consistent with that suggested by the geotechnical investigation.

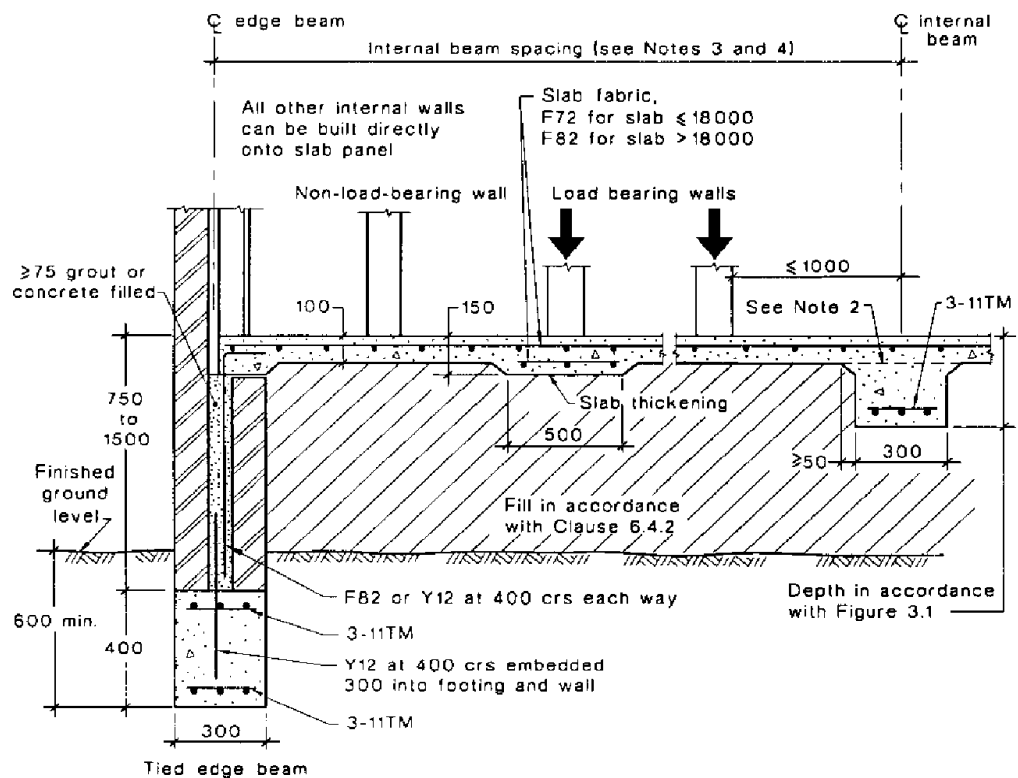
Figure 25b – Schematic of footings

The footings used in the construction of the house are shown in **Figure 25b**. The footings are suitable for a Class M site, as required by AS2870-1996, and while they could be considered inadequate for the site Class H category determined, they appear to be performing satisfactorily, as evidenced by the lack of masonry cracks and movement indicated by level loop surveys.

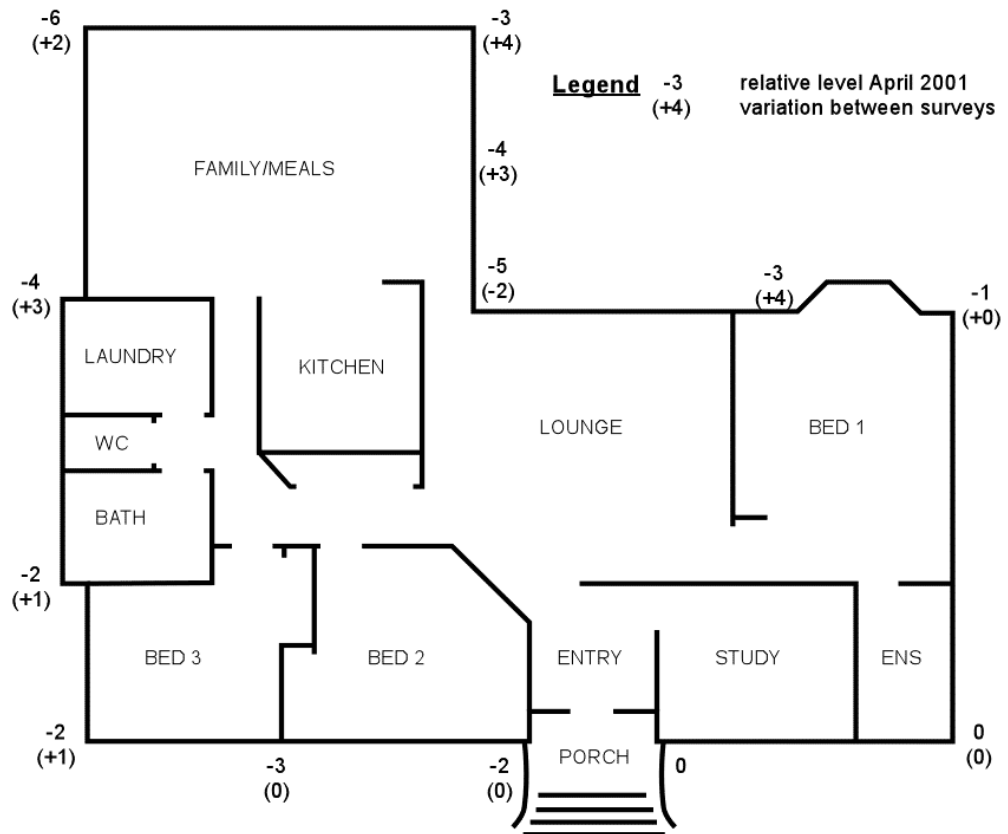
Level surveys were conducted around the course of bricks above the damp-proof course in April 2001 and February 2002. The relative levels are shown in **Figure 27**. The maximum variation in the level of the brick course was 6 mm after the original survey, which is within construction tolerance, and 3 mm on the second survey. The maximum movement between surveys was +4 mm to -2 mm. This was insignificant compared to movements at the other test houses.

Figure 27 – Level loop survey results

The lack of relative movement shown by the level loop survey is reflected in the lack of brickwork cracking, which demonstrates the adequacy of the footing construction.

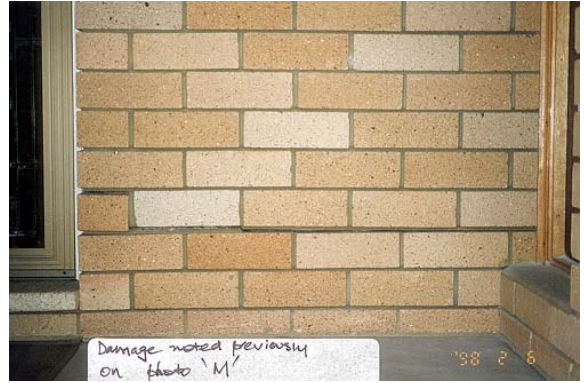
Figure 29b – Reference House R4 (Fennell Bay 2) – bed joint separation

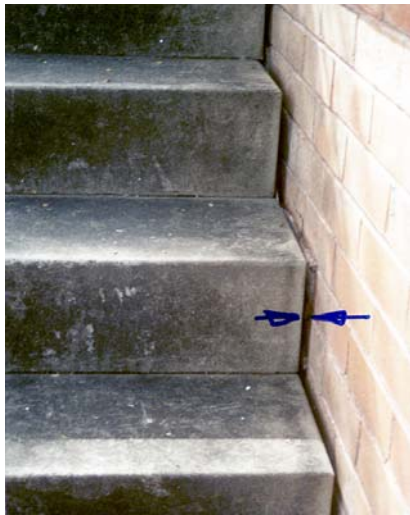
Figure 29o – Reference House R6 (Kotara) – relative movement

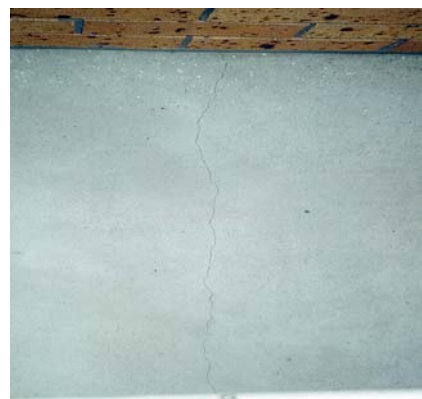
Figure 29r – Reference House R8 (Jewell) – slab crack
