# **Instrumental Detection of a Climatologically-Induced Cosmetic Crack in Wall Covering**

**Charles Dowding, Dept. of Civil & Environmental Engineering, Northwestern University  
Justin Lueker, Ebert & Baumann, Washington, DC  
Pierre-Alexandre Abeel, Subsea 7, Houston TX**

## **Abstract**

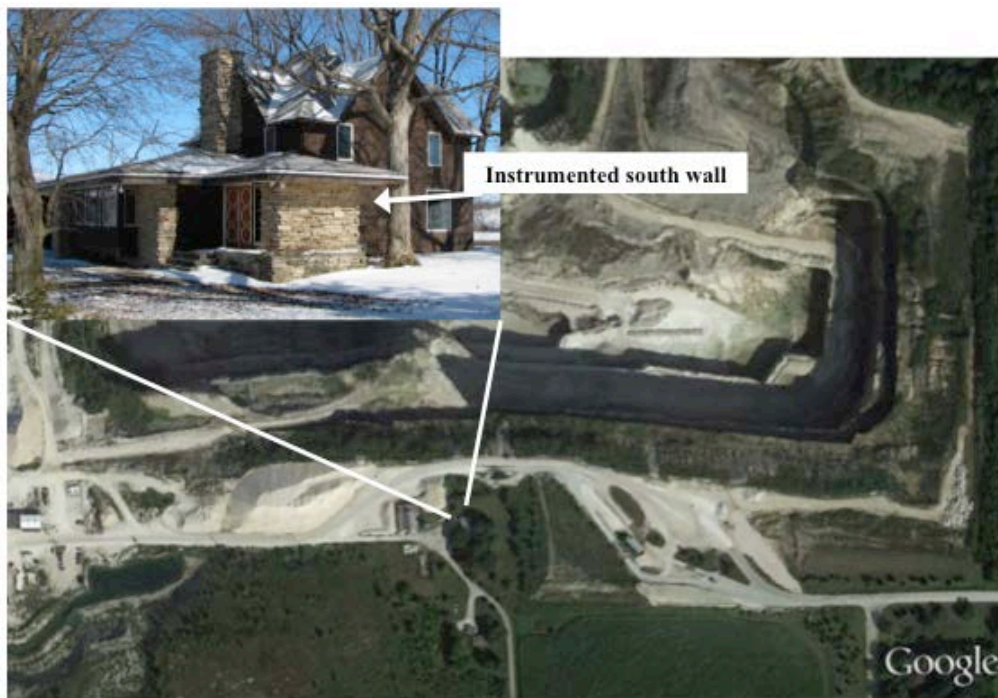
**Figure 1. Instrumented house located just south of the quarry. Response of cracks in south wall (indicated by white arrow) under observation at time of the appearance of new crack. Map data © 2013 Google, USDA Farm Service Agency.**

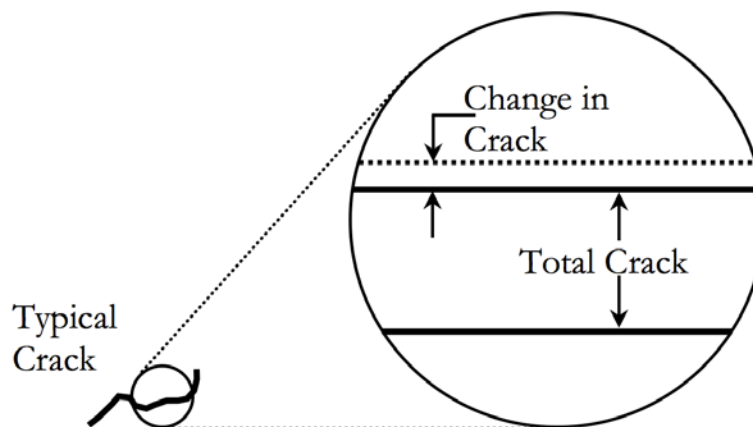
Crack response is the change in crack width, not total crack width, and is called response in this report. Figure 5 (Siebert, 2000) illustrates this definition. All transducers have been installed so that positive response indicates crack opening and negative indicates crack closing. All measurements are made in micro-inches. The null sensor placed on an adjacent uncracked area was intended to provide a record of any drift or thermal effects on sensor metal or electronics. Prior to the null gauge activity outlined in this report, it was been shown that the null sensor's responses were small relative to those of the cracks (Kosnik, 2008).

**Figure 5. Crack response is change in crack width, not total crack width (Siebert, 2000).**
