# Why Did the World Trade Center Collapse?—Simple Analysis<sup>1</sup>

Zdeněk P. Bažant, F.ASCE,<sup>2</sup> and Yong Zhou<sup>3</sup>

**Abstract:** This paper presents a simplified approximate analysis of the overall collapse of the towers of World Trade Center in New York on September 11, 2001. The analysis shows that if prolonged heating caused the majority of columns of a single floor to lose their load carrying capacity, the whole tower was doomed.

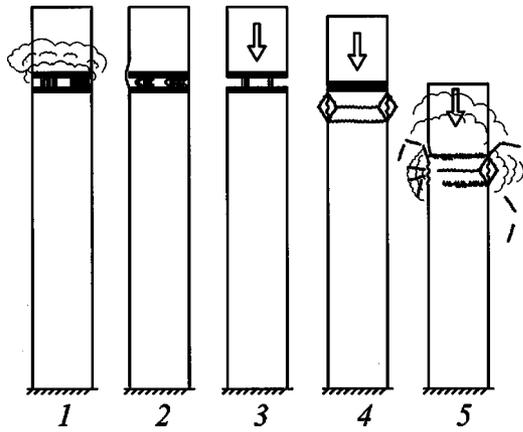
In stage 1 (Fig. 1), the conflagration, caused by the aircraft fuel spilled into the structure, causes the steel of the columns to be exposed to sustained temperatures apparently exceeding 800°C. The heating is probably accelerated by a loss of the protective thermal insulation of steel during the initial blast. At such temperatures, structural steel suffers a decrease of yield strength and exhibits significant viscoplastic deformation (i.e., creep—an increase of deformation under sustained load). This leads to creep buckling of columns (Bažant and Cedolin 1991, Sec. 9), which consequently lose their load carrying capacity (stage 2). Once more than half of the columns in the critical floor that is heated most suffer buckling (stage 3), the weight of the upper part of the

Fig. 1. Stages of collapse of the building (floor height exaggerated)

structure above this floor can no longer be supported, and so the upper part starts falling down onto the lower part below the critical floor, gathering speed until it impacts the lower part. At that moment, the upper part has acquired an enormous kinetic energy and a significant downward velocity. The vertical impact of the mass of the upper part onto the lower part (stage 4) applies enormous vertical dynamic load on the underlying structure, far exceeding its load capacity, even though it is not heated. This causes failure of an underlying multifloor segment of the tower (stage 4), in which the failure of the connections of the floor-carrying trusses to the columns is either accompanied or quickly followed by buckling of the core columns and overall buckling of the framed tube, with the buckles probably spanning the height of many floors (stage 5, at right), and the upper part possibly getting wedged inside an emptied lower part of the framed tube (stage 5, at left). The buckling is initially plastic but quickly leads to fracture in the plastic hinges. The part of building lying beneath is then impacted again by an even larger mass falling with a greater velocity, and the series of impacts and failures then proceeds all the way down (stage 5).

[Fig. 1, stage 4, and Fig. 2(c)], and so the buckles must fold one after another. Thus, at least one plastic hinge, and no more than four plastic hinges, per column line are needed to operate simultaneously in order to allow the upper part to continue moving down [Fig. 2(b)] (Bažant and Cedolin 1991). (This is also true if the columns of only one floor are buckling at a time.) At the end, the sum of the rotation angles  $\theta_i$  ( $i = 1, 2, \dots$ ) of the hinges on one column line,  $\Sigma\theta_i$ , cannot exceed  $2\pi$  [Fig. 2(b)]. This upper-bound value, which is independent of the number of floors spanned by the buckle, is used in the present calculations since, in regard to survival, it represents the most optimistic hypothesis, maximizing the plastic energy dissipation.

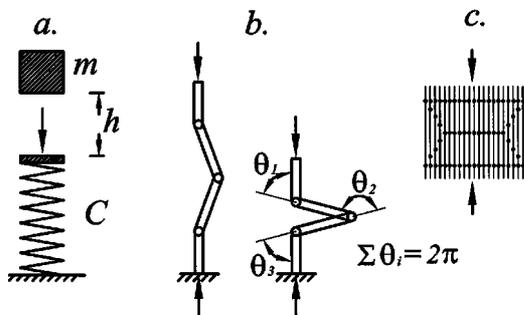
Fig. 2. (a) Model for impact of upper part on lower part of building; (b) Plastic buckling mechanism on one column line; (c) Combination of plastic hinges creating a buckle in the tube wall

The downward displacement from the initial equilibrium position to the point of maximum deflection of the lower part (considered to behave elastically) is  $h + (P/C)$  where  $P =$  maximum force applied by the upper part on the lower part and  $h =$  height of critical floor columns ( $=$  height of the initial fall of the upper part)  $\approx 3.7$  m. The energy dissipation, particularly that due to the inelastic deformation of columns during the initial drop of the upper part, may be neglected, i.e., the upper part may be assumed to move through distance  $h$  almost in a free fall (indeed, the energy dissipated in the columns during the fall is at most equal to  $2\pi \times$  the yield moment of columns,  $\times$  the number of columns, which is found to be only about 12% of the gravitational potential energy release if the columns were cold, and much less than that at  $800^\circ\text{C}$ ). So the loss of the gravitational potential energy of the upper part may be approximately equated to the strain energy of the lower part at maximum elastic deflection. This gives the equation  $mg[h + (P/C)] = P^2/2C$  in which  $m =$  mass of the upper part (of North Tower)  $\approx 58 \times 10^6$  kg, and  $g =$  gravity acceleration. The

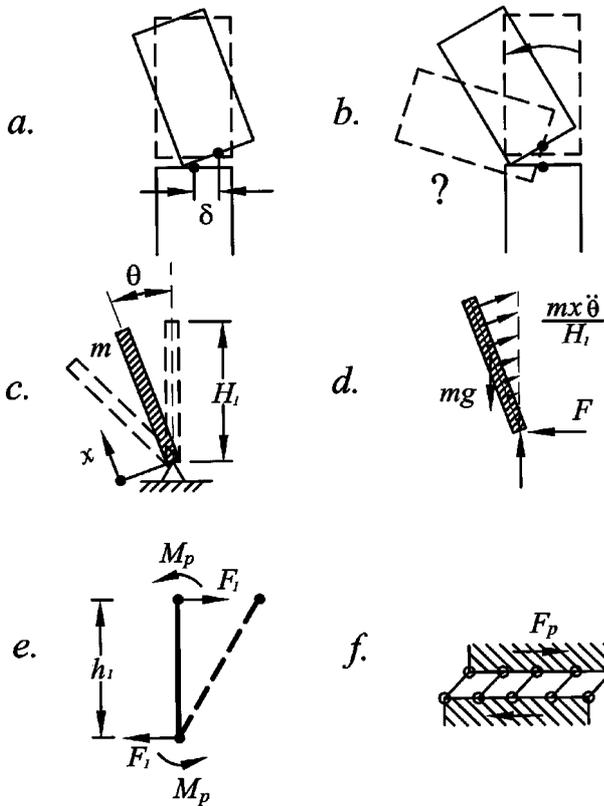
**Fig. 3.** Pivoting of upper part of tower about its base, (a,b) with and without horizontal shear at base; (c) Model for simplified analysis; (d) Free-body diagram with inertia forces; (d,e) Plastic horizontal shearing of columns in critical floor at base

Since the top part of the South Tower tilted [Fig. 3(a)], many people wonder: Why didn't the upper part of the tower fall to the side like a tree, pivoting about the center of the critical floor? [Fig. 3(b)]. To demonstrate why, and thus to justify our previous neglect of tilting, is an elementary exercise in dynamics.

Assume the center of the floor at the base of the upper part [Fig. 3(b)] to move for a while neither laterally nor vertically, i.e., act as a fixed pivot. Equating the kinetic energy of the upper part rotating as a rigid body about the pivot at its base [Fig. 3(c)] to the loss of the gravitational potential energy of that part (which is here simpler than using the Lagrange equations of motion), we have  $mg(1 - \cos \theta)H_1/2 = (m/2H_1) \int_0^{H_1} (\dot{\theta}x)^2 dx$  where  $x$  = vertical coordinate [Fig. 3(c)]. This provides

where  $\theta$  = rotation angle of the upper part;  $H_1$  = its height; and the superposed dots denote time derivatives [Fig. 3(c)].

Could the combined plastic shear resistance  $F_p$  of the columns of one floor [Fig. 3(f)] sustain this horizontal reaction? For plastic shear, there would be yield hinges on top and bottom of each resisting column; Fig. 3(e) (again, aiming only at an optimistic upper bound on resistance, we neglect fracture). The moment equilibrium condition for the column as a free body shows that each column can at most sustain the shear force  $F_1 = 2M_p/h_1$  where  $h_1 \approx 2.5 \text{ m}$  = effective height of column, and  $M_p \approx 0.3 \text{ MN m}$  = estimated yield bending moment of one column, if cold. Assuming that the resisting columns are only those at the sides of the framed tube normal to the axis of rotation, which number about 130, we get  $F_p \approx 130F_1 \approx 31 \text{ MN}$ . So, the maximum horizontal reaction to pivoting would cause the overload ratio

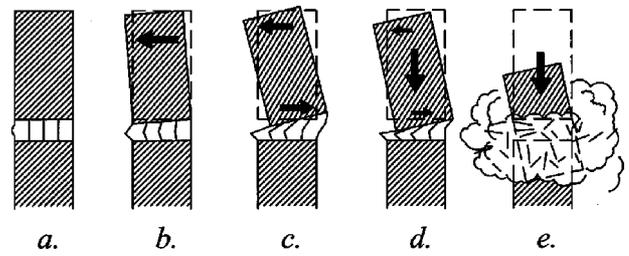
**Fig. 4.** Scenario of tilting of upper part of building (South Tower)

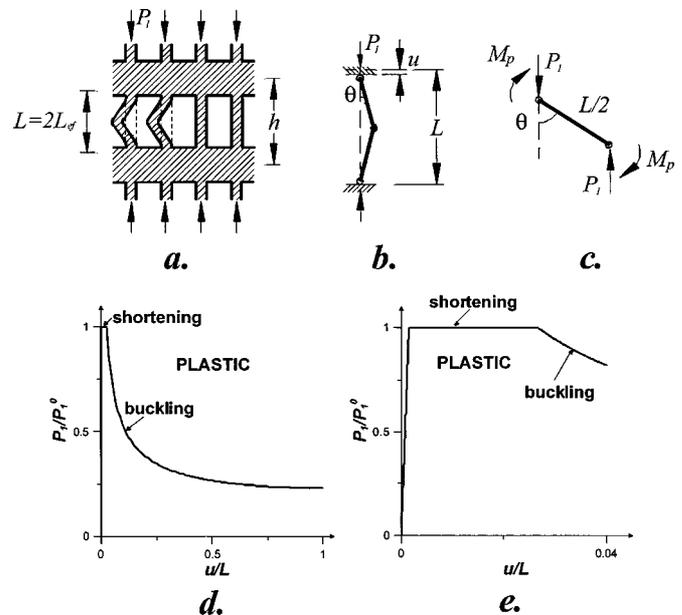
**Fig. 5.** (a) Plastic buckling of columns; (b) Plastic hinge mechanism; (c) Free-body diagram; (d) Dimensionless diagram of load  $P_1$  versus axial shortening  $u$  of columns of the towers if the effects of fracture and heating are ignored; and (e) Beginning of this diagram in an expanded horizontal scale (imperfections neglected)

Normal design deals only with initial bifurcation and small deflections, in which the diagram of load versus axial shortening of an elasto-plastic column exhibits hardening rather than softening. However, the columns of the towers suffered very large plastic deflections, for which this diagram exhibits pronounced softening. Fig. 5 shows this diagram as estimated for these towers. The diagram begins with plastic yielding at load  $P_1^0 = A_1 f_y$ , where  $A_1$  = cross section area of one column and  $f_y$  = yield limit of steel. At axial shortening 3%, three plastic hinges form as shown in Fig. 5 (if we assume, optimistically, fixed ends). From the condition of moment equilibrium of the half-column as a free body (Fig. 5),

which defines the curve plotted in Fig. 5. This curve is an optimistic upper bound since, in reality, the plastic hinges develop fracture (Bažant and Planas 1998), and probably do so already at rather small rotations.
