**Comparison of Measured Crack Response in Diverse Structures to
Dynamic Events and Weather Phenomena**

A Thesis

Field of Civil Engineering

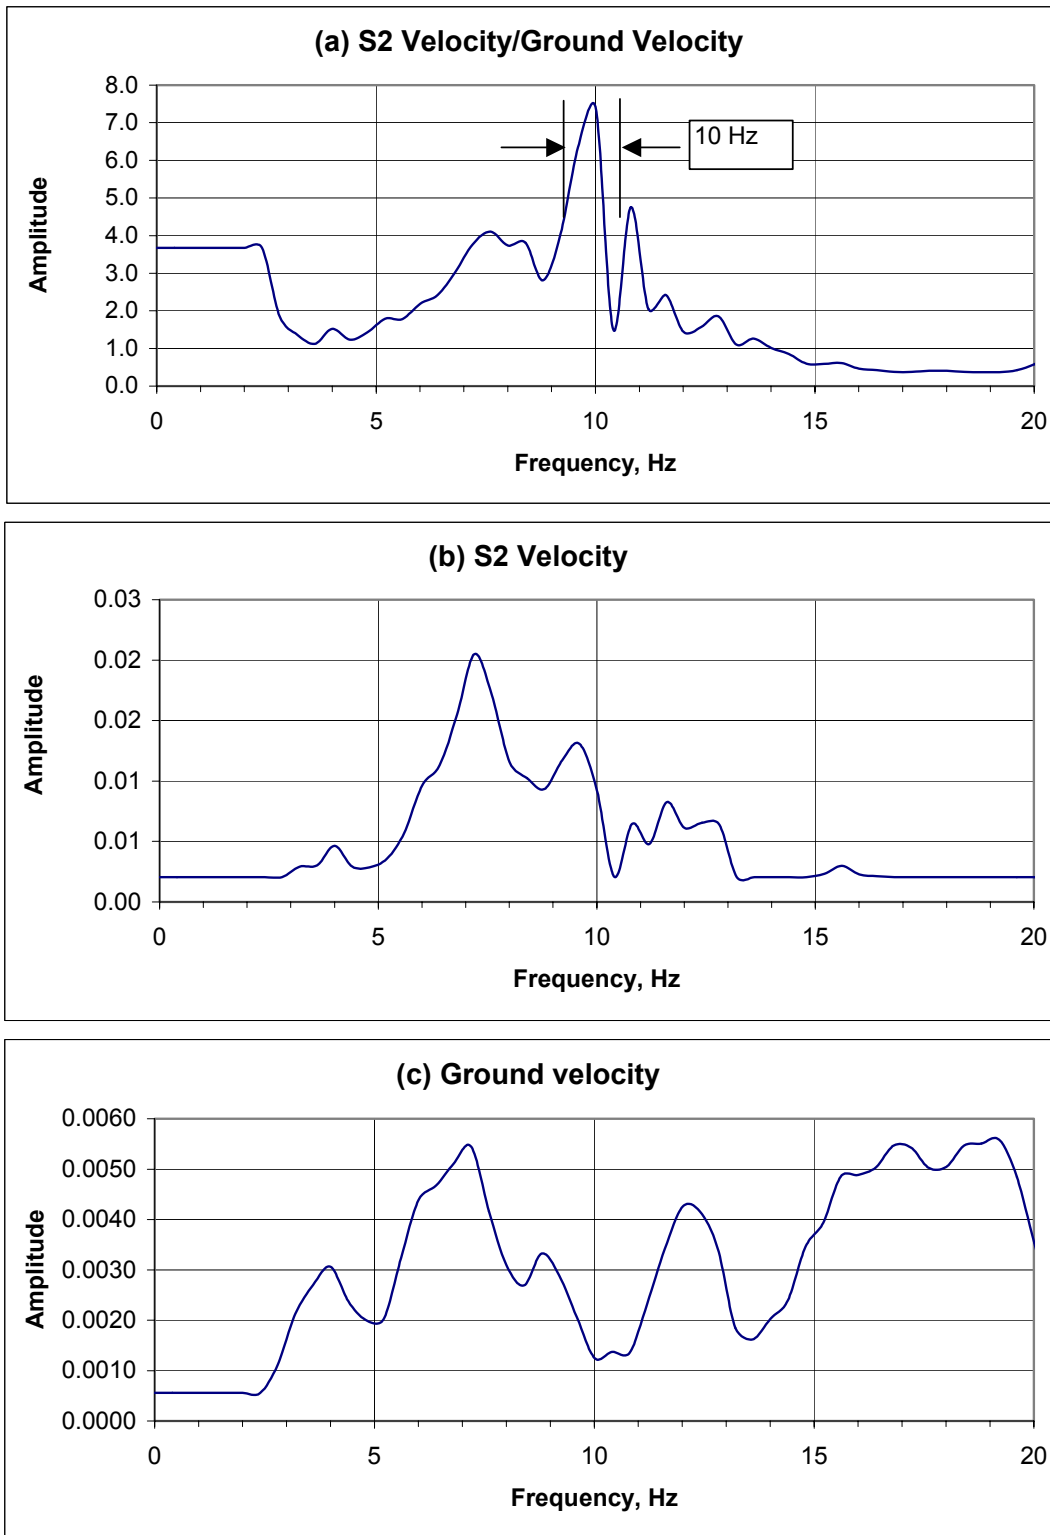
Figure 3.9 Spectra of ratio of S2 velocity FFT and ground velocity FFT, S2 FFT, and ground FFT

Dominant response frequencies estimated from ratios of these moderated FFT spectra of upper structure response and ground motion were approximately 8 to 10 Hz for all responses in the radial direction. As seen in Figure 3.9a, the dominant response frequency for the blast on 22 May at 12:16 was 10 Hz. For this case both the FFT and zero crossing methods yielded the same dominant frequency, 8 to 10 Hz.

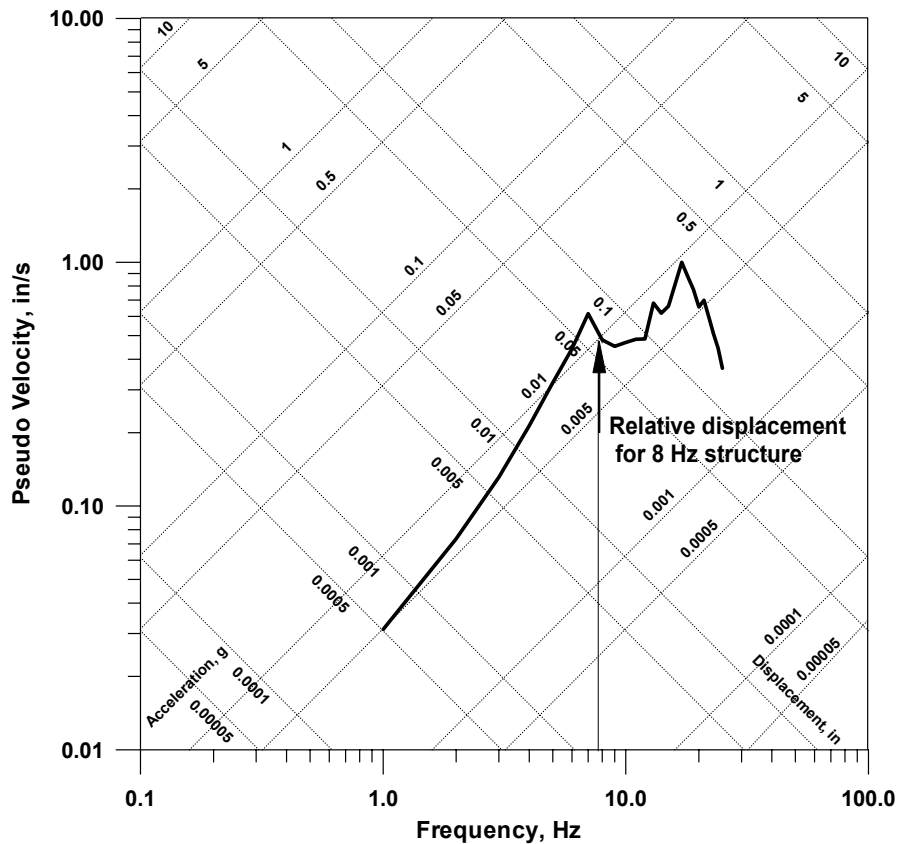
Figure 3.10 Single Degree of Freedom response spectrum of radial motion produced by blast on 5/22/2001 at 10:38, showing estimated relative displacement of an 8 Hz structure

The SDOF response spectrum for the radial ground motion produced by the 22 May blast at 10:38 is displayed as Figure 3.10. A damping coefficient of 5% was assumed in determining the response spectra for all of the ground motions analyzed in this thesis, based on average values from previous studies. By calculating this coefficient from some of the time histories exhibiting free response, this assumption proved to be valid. The approximate dominant (natural) frequency of the Pennsylvania trailer was 8 Hertz (as determined above), therefore, the estimated displacement of the structure relative to this ground motion was 9600 μin (243 μm), as shown by the intersection of the vertical 8 Hertz line with the response spectrum.

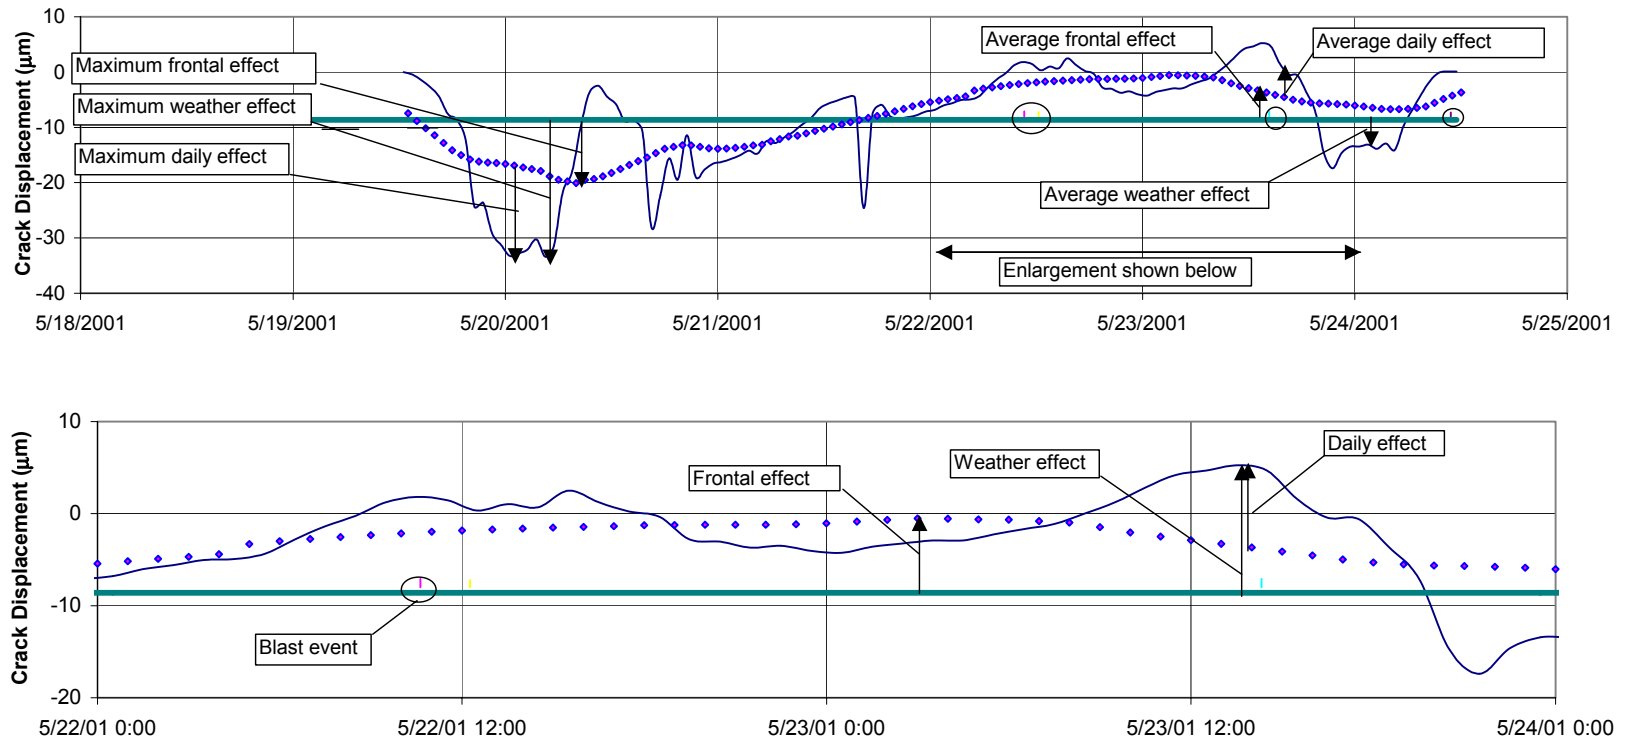
Figure 3.12 Typical crack displacements due to long-term phenomena and maximum zero to peak dynamic blast events

In Figure 3.12, the crack displacements due to different weather phenomena measured over the entire monitoring period are compared to those from the blasts. The magnitude of each dynamic response to a blast event corresponds to the absolute, maximum zero-to-peak displacement of the crack during the five seconds of resulting vibratory motion. In order to display the relatively, small responses associated with the blasts, the blast-induced responses (illustrated with vertical lines) are encircled and the two day period of blasting is magnified in Figure 3.12(b). The zero-to-peak values are shown originating from the overall average line in order to emphasize the large difference in magnitude (between long term and dynamic response) pictorially. The maximum dynamic crack displacement of 0.92 μ m or 36.3 μ in (associated with a peak radial ground motion of 0.32 ips from the blast on 23 May 2001 at 14:19) is small compared to the average and maximum crack displacements due to computed weather effects of 7 and 24 μ m (277 and 948 μ in), respectively. The maximum weather front is almost 25 times this particular crack response.

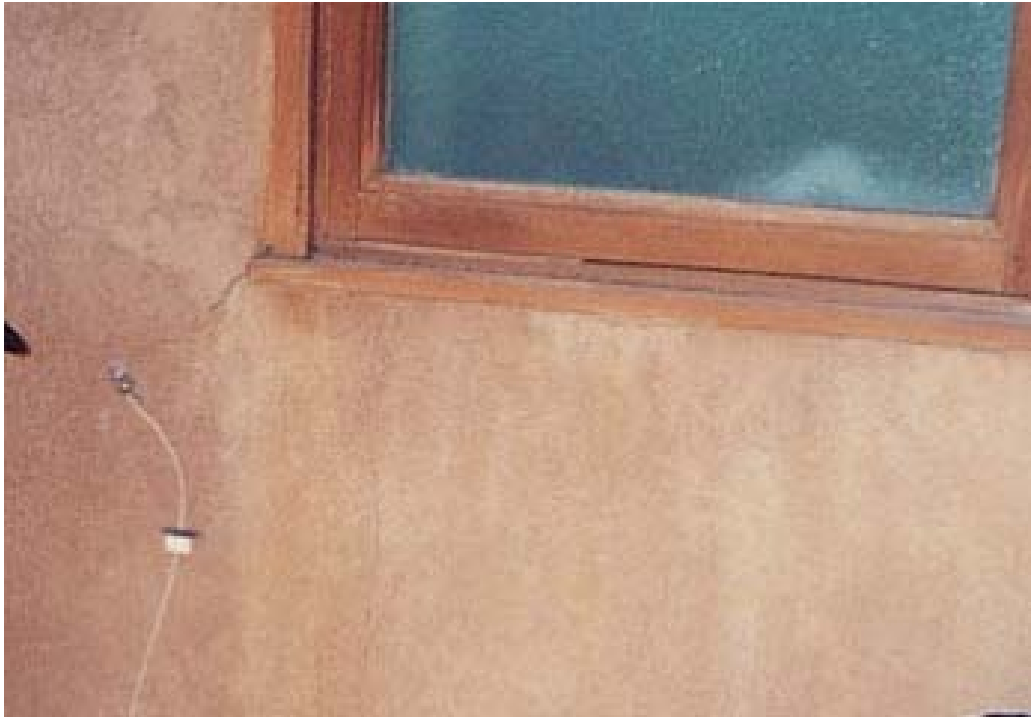
Figure 4.4 Kaman crack displacement sensor

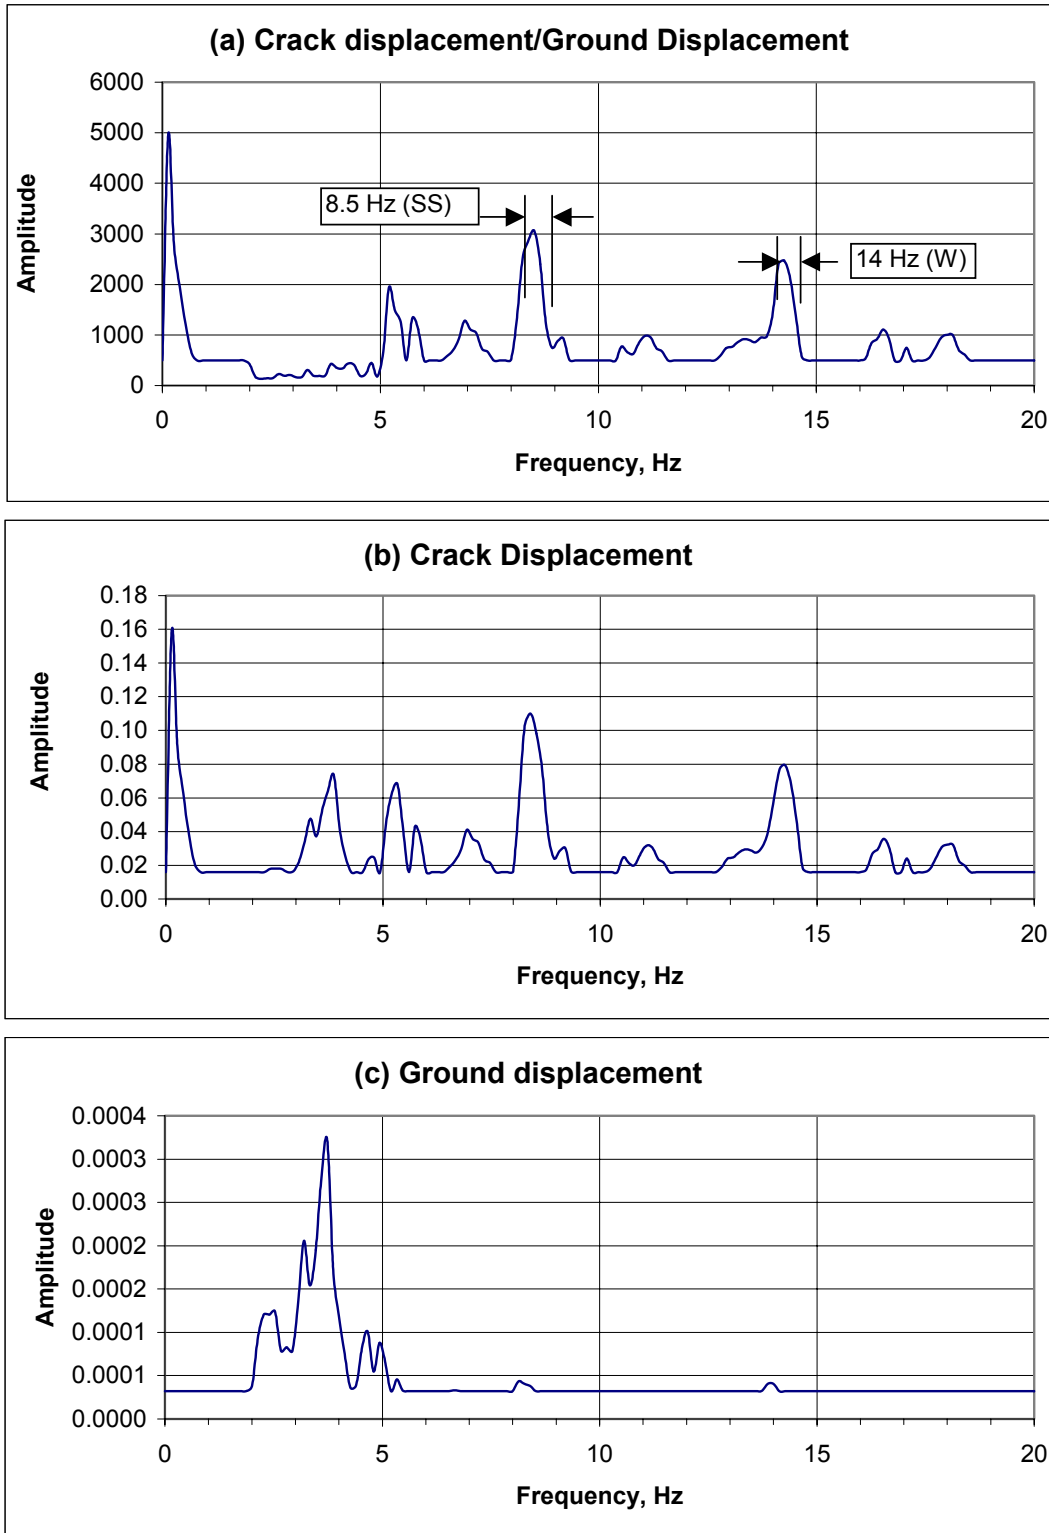
Figure 4.9 FFT Crack displacement ratio, crack displacement FFT, and ground displacement FFT for 5 July blast

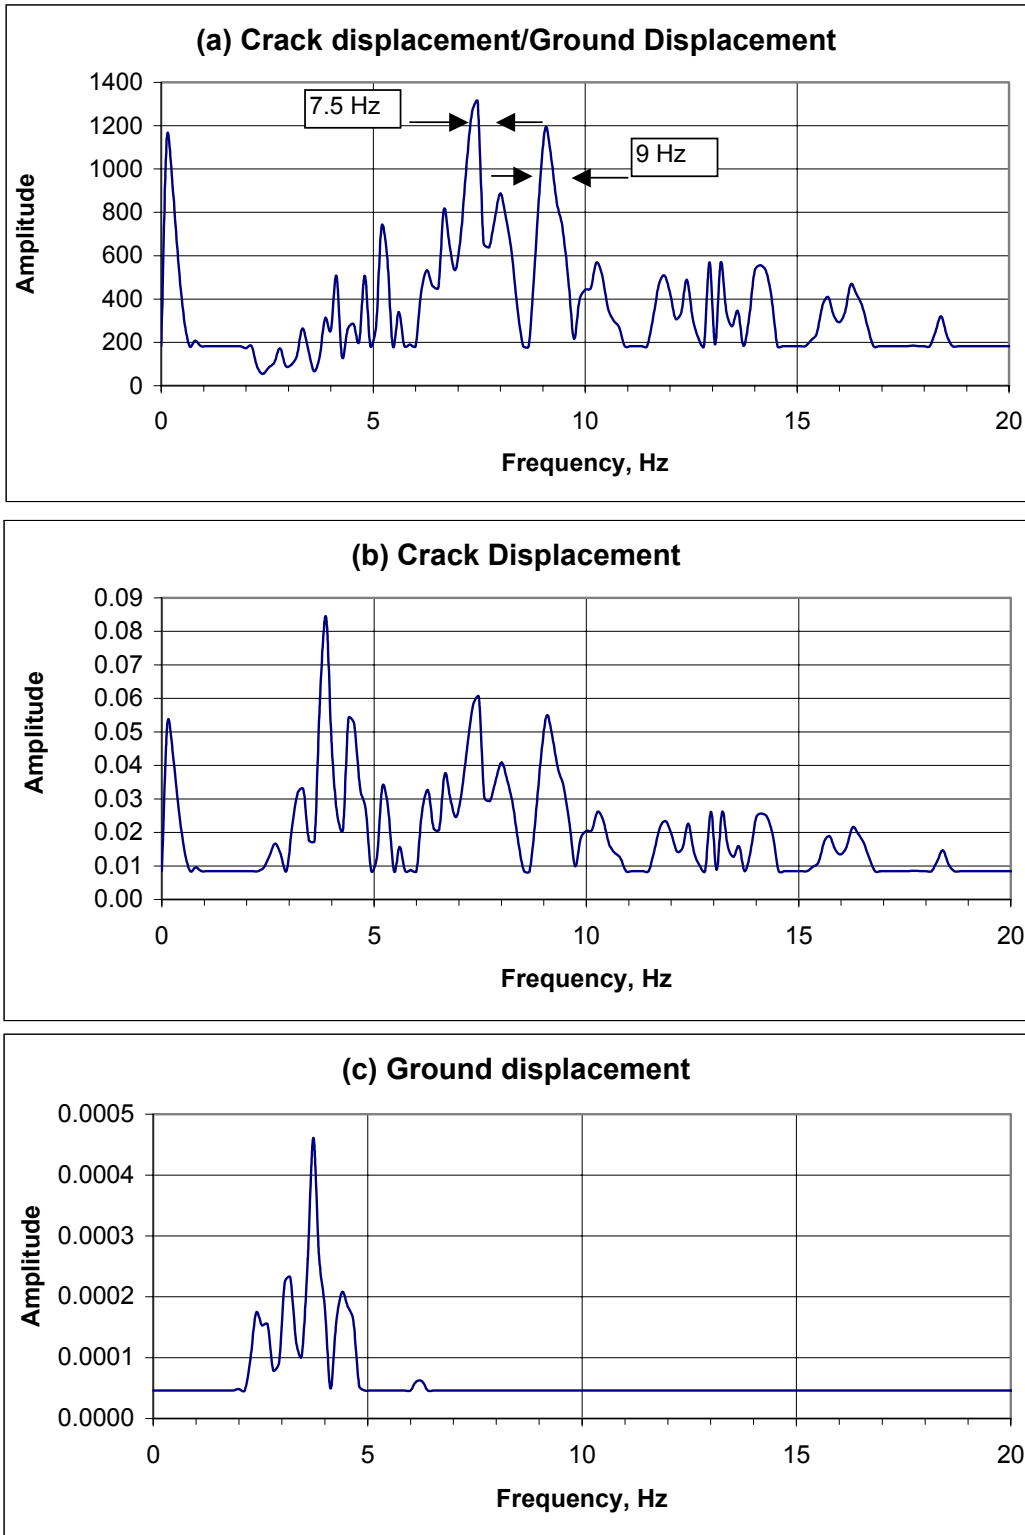
Figure 4.10 FFT crack displacement ratio, crack displacement FFT, and ground displacement FFT for 17 July blast

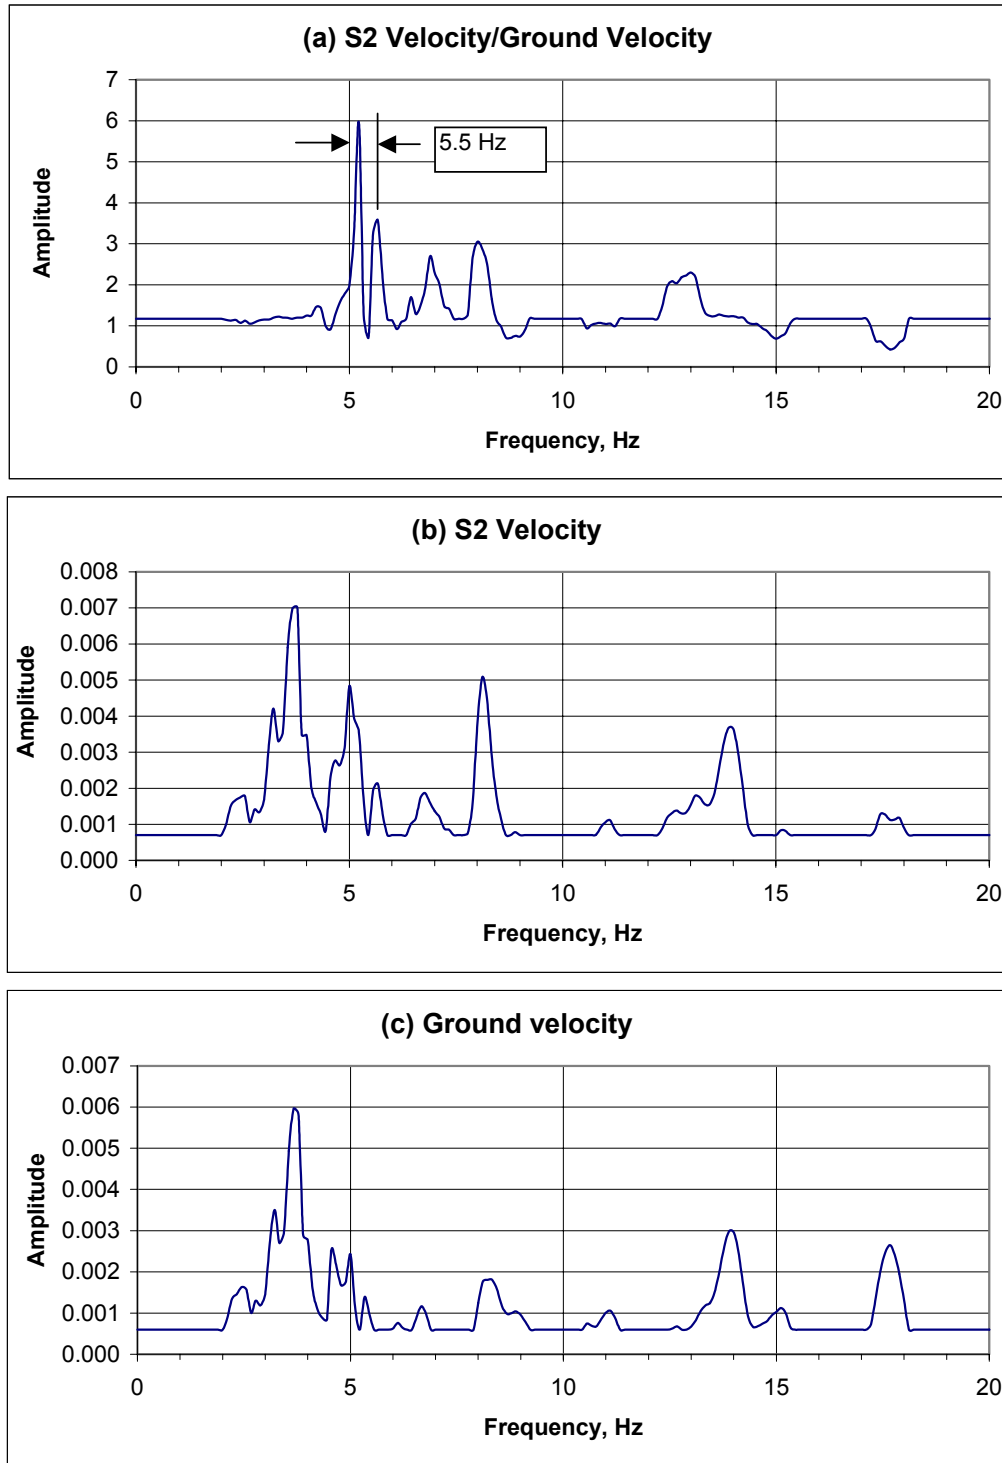
Figure 4.11 FFT superstructure response ratio, S2 response FFT, and ground motion FFT for 5 July blast

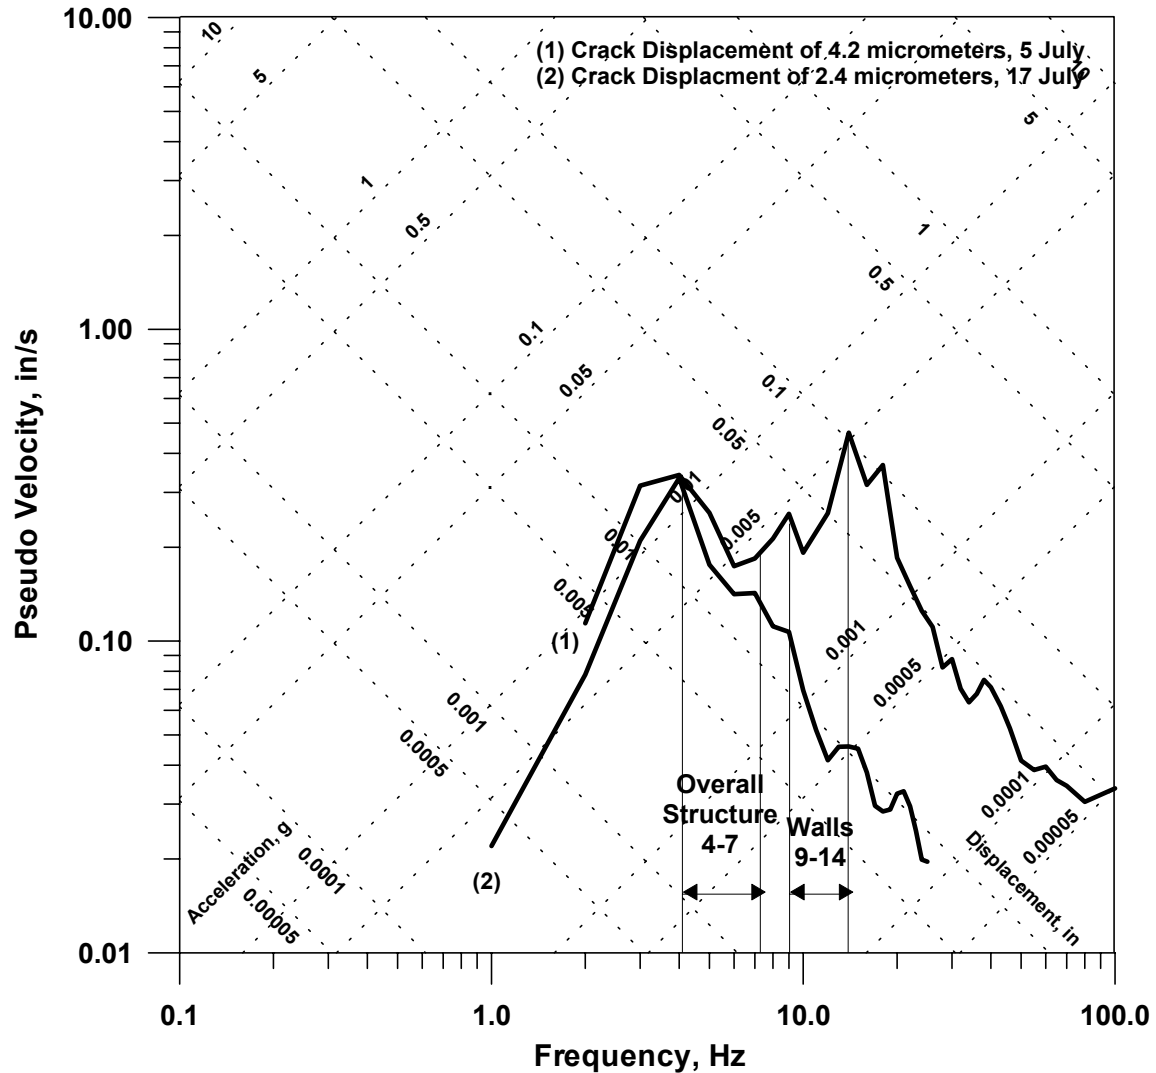
Figure 4.13 Single Degree of Freedom response spectrum of radial motion produced by maximum blast on 7/5/01 at 15:03 and an average blast on 7/17/01 at 12:51, showing estimated relative displacements for the superstructure and the wall

The effect of the higher response frequency for the wall is illustrated on the response spectra of the radial ground motions in Figure 4.13. At 14 Hz, the dominant frequency of the wall, the response spectrum of the 17 July radial ground motion is significantly less than that of the 5 July ground motion. This difference corresponds to the difference in measured crack displacements as reported in Table 4.1. The effect of the lower response frequency for the overall structure is also illustrated in Figure 4.13. In the 5 Hz range, the 5 July ground motion also produces its largest response spectra amplitudes. This difference corresponds to the measurements of radial structural response reported in Table 4.1.

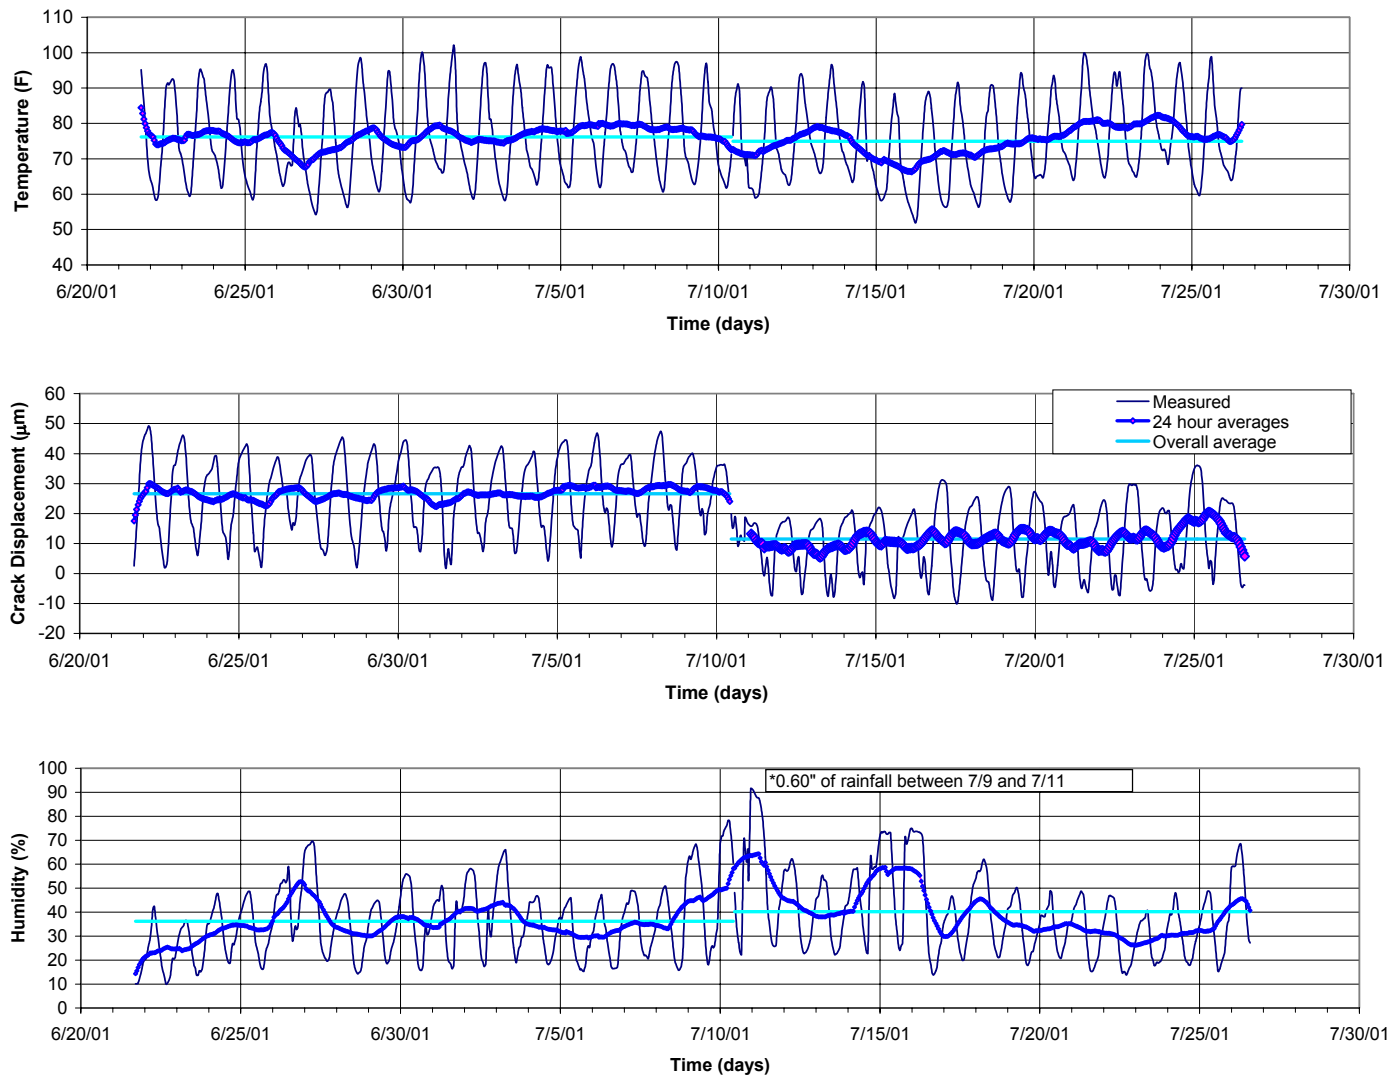
Figure 4.14 Long-term crack displacement and weather versus time

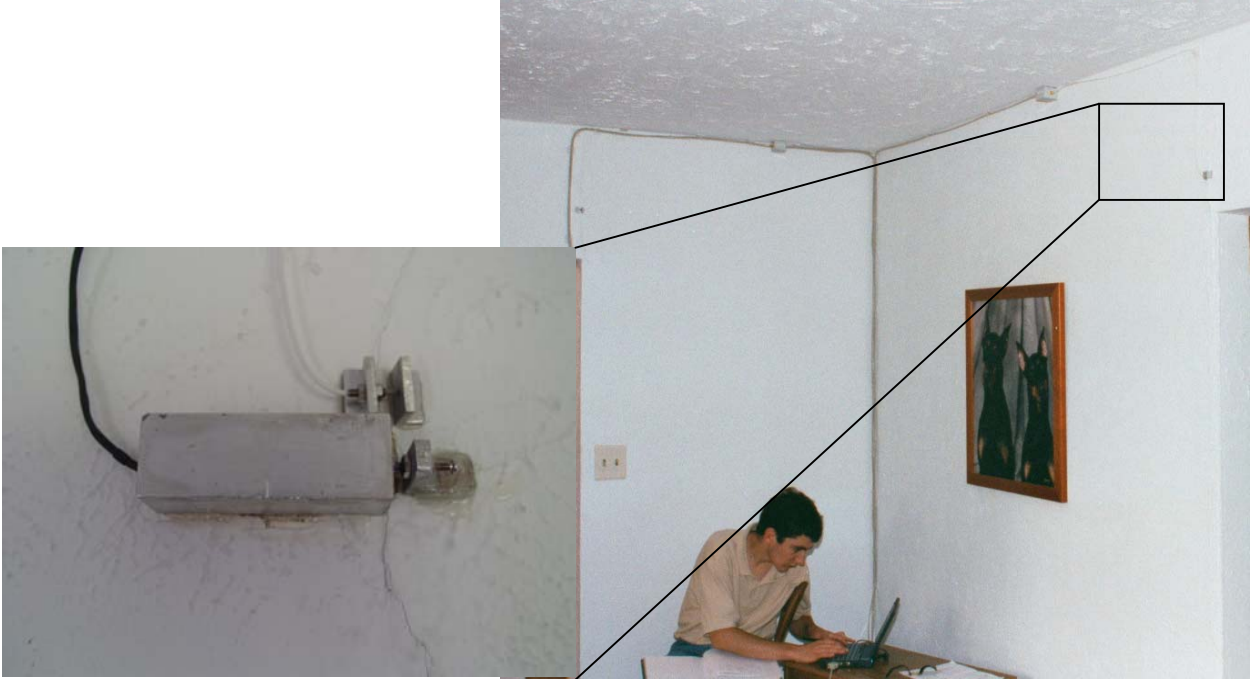
Figure 7.3 Kaman and LVDT displacement sensors spanning Crack 1

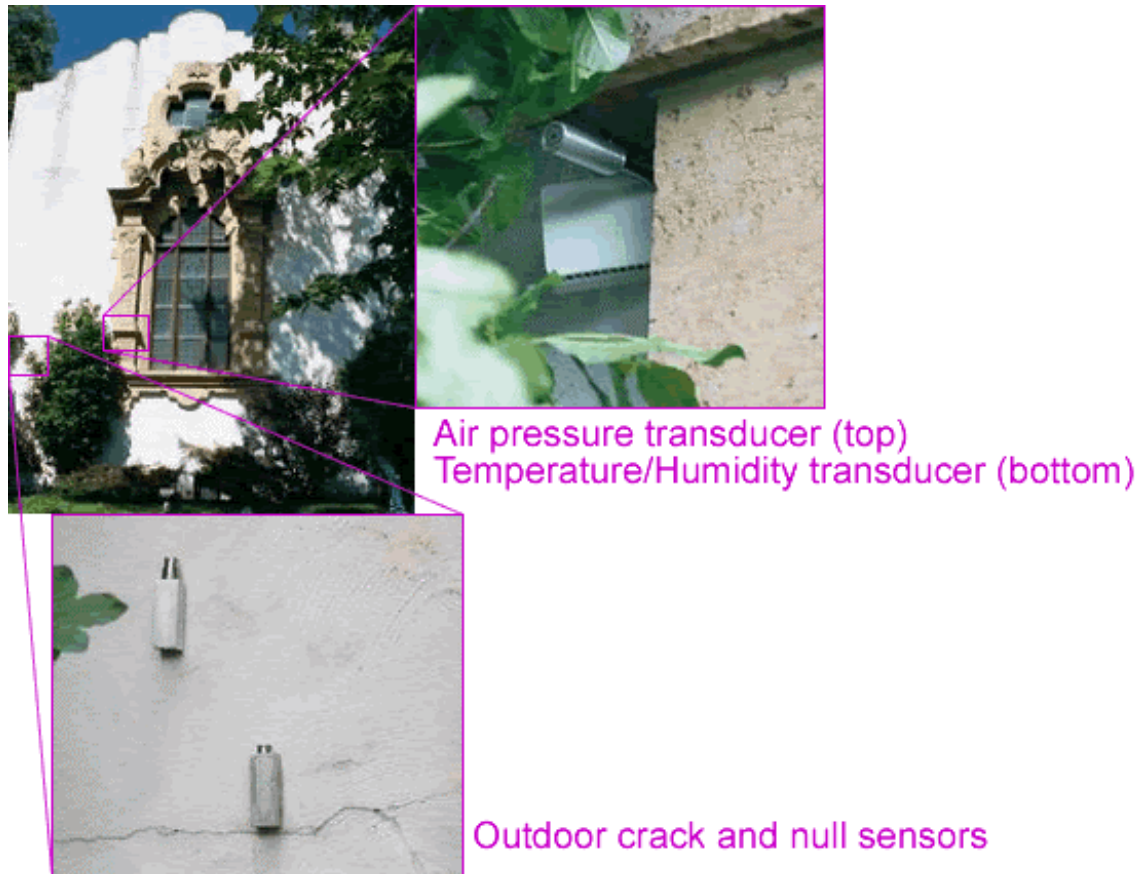
Figure 8.6 Outdoor sensors on Minnesota chapel
